**Erosion Investigation
Armstrong West Revetment - Ausable River, Port Franks, Ontario**

Ecosystem Recovery Inc.

Project Number: 2050

Date: February 1, 2021

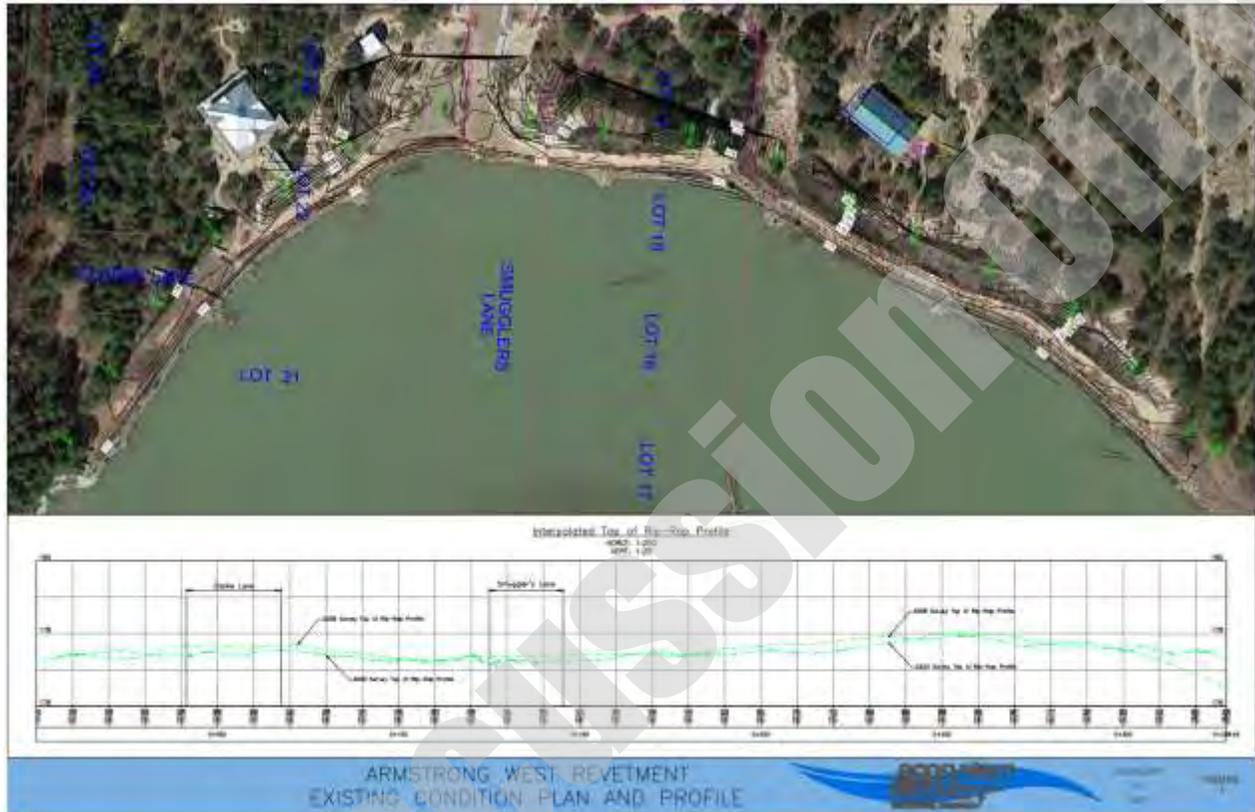
Figure 1 - Existing Condition Survey and As-built Profile

Upon completion of the survey and post-survey data processing the current and as-built top-of-revetment profiles were carefully examined. The comparison process involved plotting several top of revetment profiles for the 2008 and 2020 versions of the surveyed revetment surfaces and using cross-sectional information generated in Autodesk Civil3D to verify that representative points along the revetment were included in the profile data. Several iterations of the 2008 and 2020 top-of-revetment profiles were examined prior to establishing the final horizontal and vertical alignment for the Armstrong West revetment structure. **Figure 1** illustrates the final 2008 and 2020 versions of the top-of-revetment profiles along the full length of the Armstrong West structure. It is noted that despite the fact that the horizontal alignment of the top-of-revetment profiles differed slightly within Reach 2 of the Armstrong West structure the 2008 as-built survey top-of-revetment elevations were compared directly to the profile generated by the 2020 survey points. **Table 1** summarizes the elevations of the 2008 and 2020 top-of-revetment surveys on ten-meter intervals for the full length of the Armstrong West structure. The horizontal alignment stationing starts at the southerly end of the structure and follows the 2020 survey points defining the limit of the existing rip-rap. The table is broken up into the subject reaches (1-3) for clarity. A negative value indicates that the 2020 top-of-revetment survey points were found to be at a lower elevation than the 2008 as-built survey. The purpose of this examination

was to determine if settling or displacement of the existing rip-rap channel bank revetment had occurred since construction and to establish a current profile for future comparisons to be based on.

- The existing top of revetment is generally situated below the 2008 as-built top-of-revetment on average of about 10 cm and ranged from 2 cm above to about 24 cm below the as-built survey records from the site. The elevations ranges noted in the tables fall outside of the expected error tolerance of the GPS survey equipment.
- In a number of instances, the revetment is currently 24 cm below the 2008 as-built top-of-revetment profile while other areas were recorded as being up to 8 cm above the original profile.

- Lake Huron water levels observed during the month of December had a mean of 177.14. This mean lake level is approximately 10 cm below the lowest point on the top of revetment (2020) corresponding to the Smuggler's Lane Right-of-way (ROW)

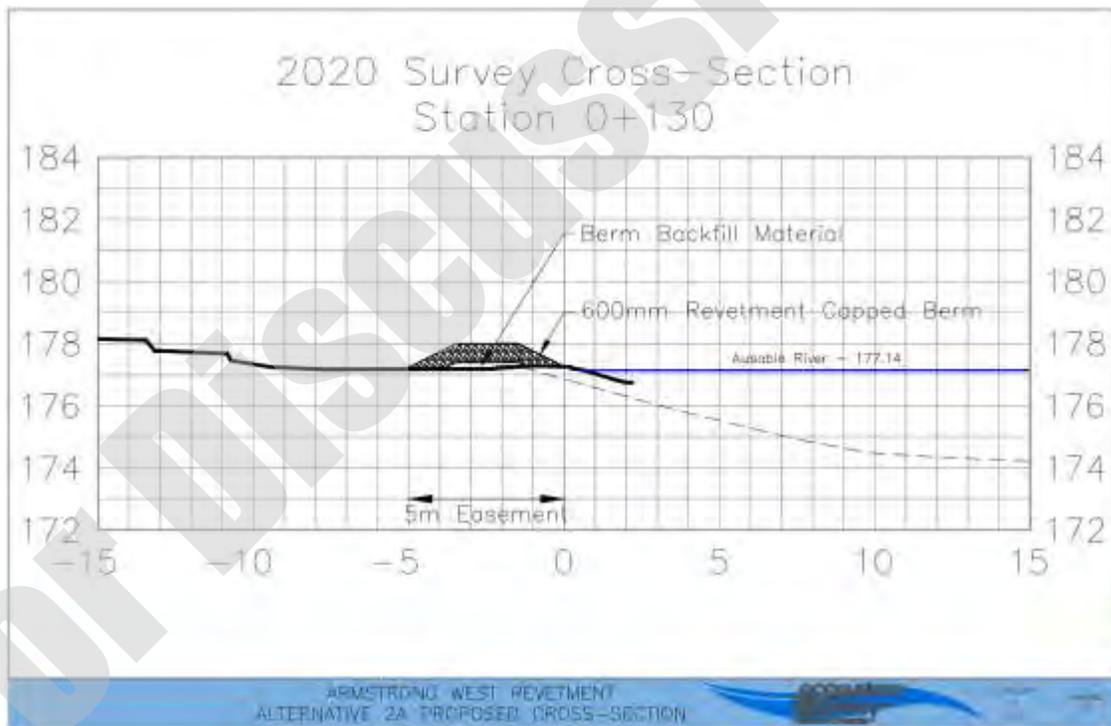
Figure 2 - 600mm Revetment Capped Berm

Figure 2 illustrates the general configuration of a berm having a 2.0 m top width and 2:1 side-slopes occupying a majority of the 5.0 m wide ABCA easement. The berm would consist of a 600 mm thick layer of rip-rap over a core of native fill material.

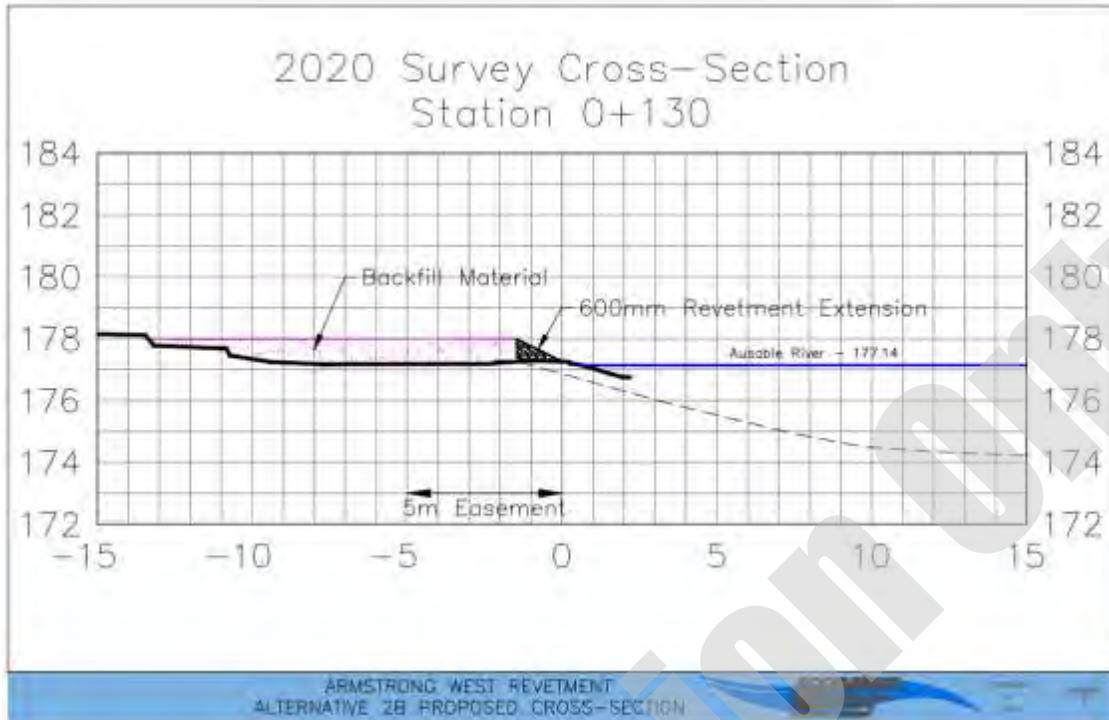
Figure 3 - 600mm Revetment Extension with Backfill

Figure 3 illustrates the general configuration of a 2:1 revetment extension to an elevation of 178.00 and backfilled with native fill material. The revetment extension, similar to that of the original erosion control structure, would consist of a 600 mm thick layer of rip-rap and terminate at the fill level of 178.00.

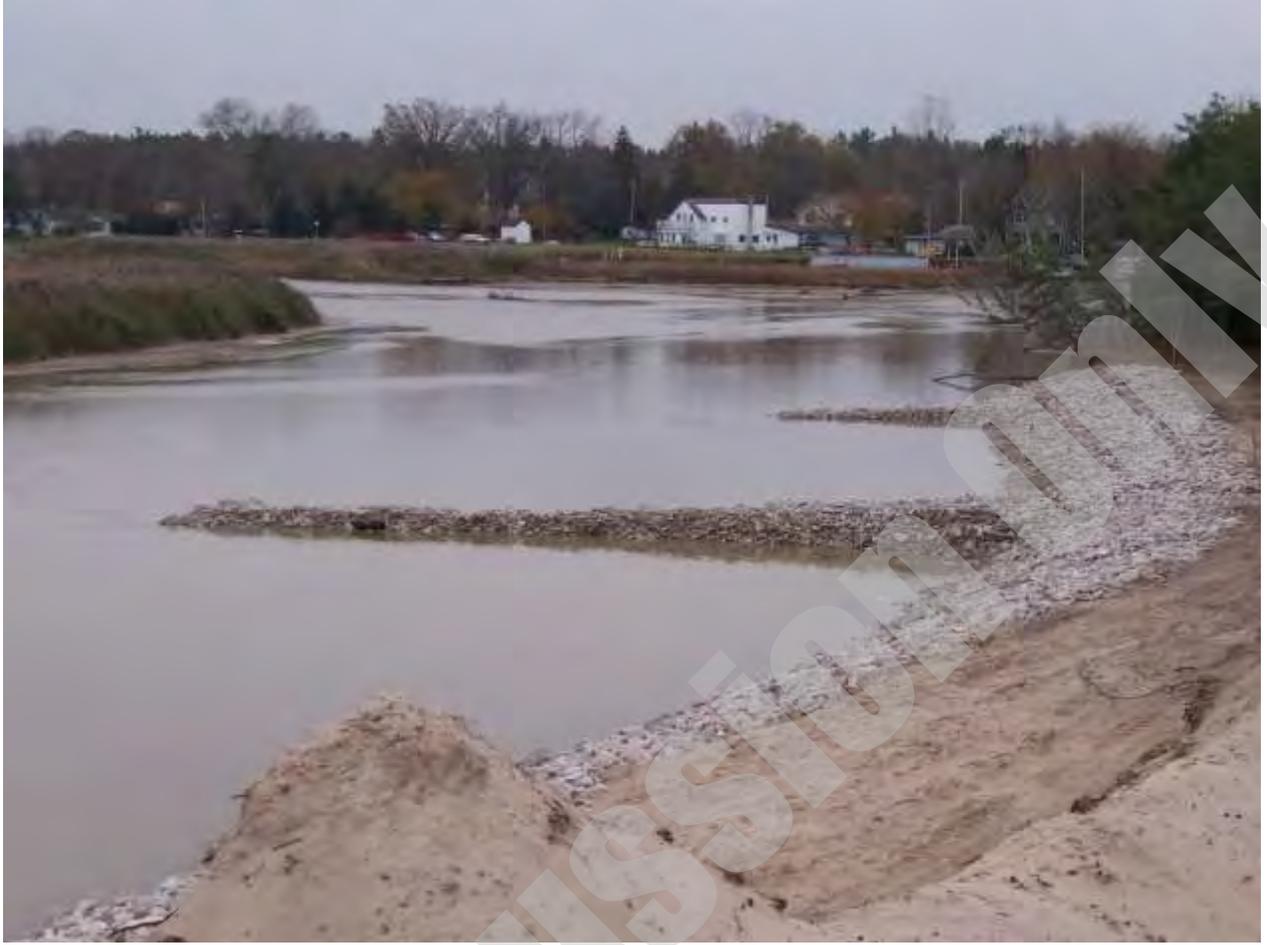
Photo A-1: Post-construction rock revetment and bend way weirs, looking south (taken 2006)

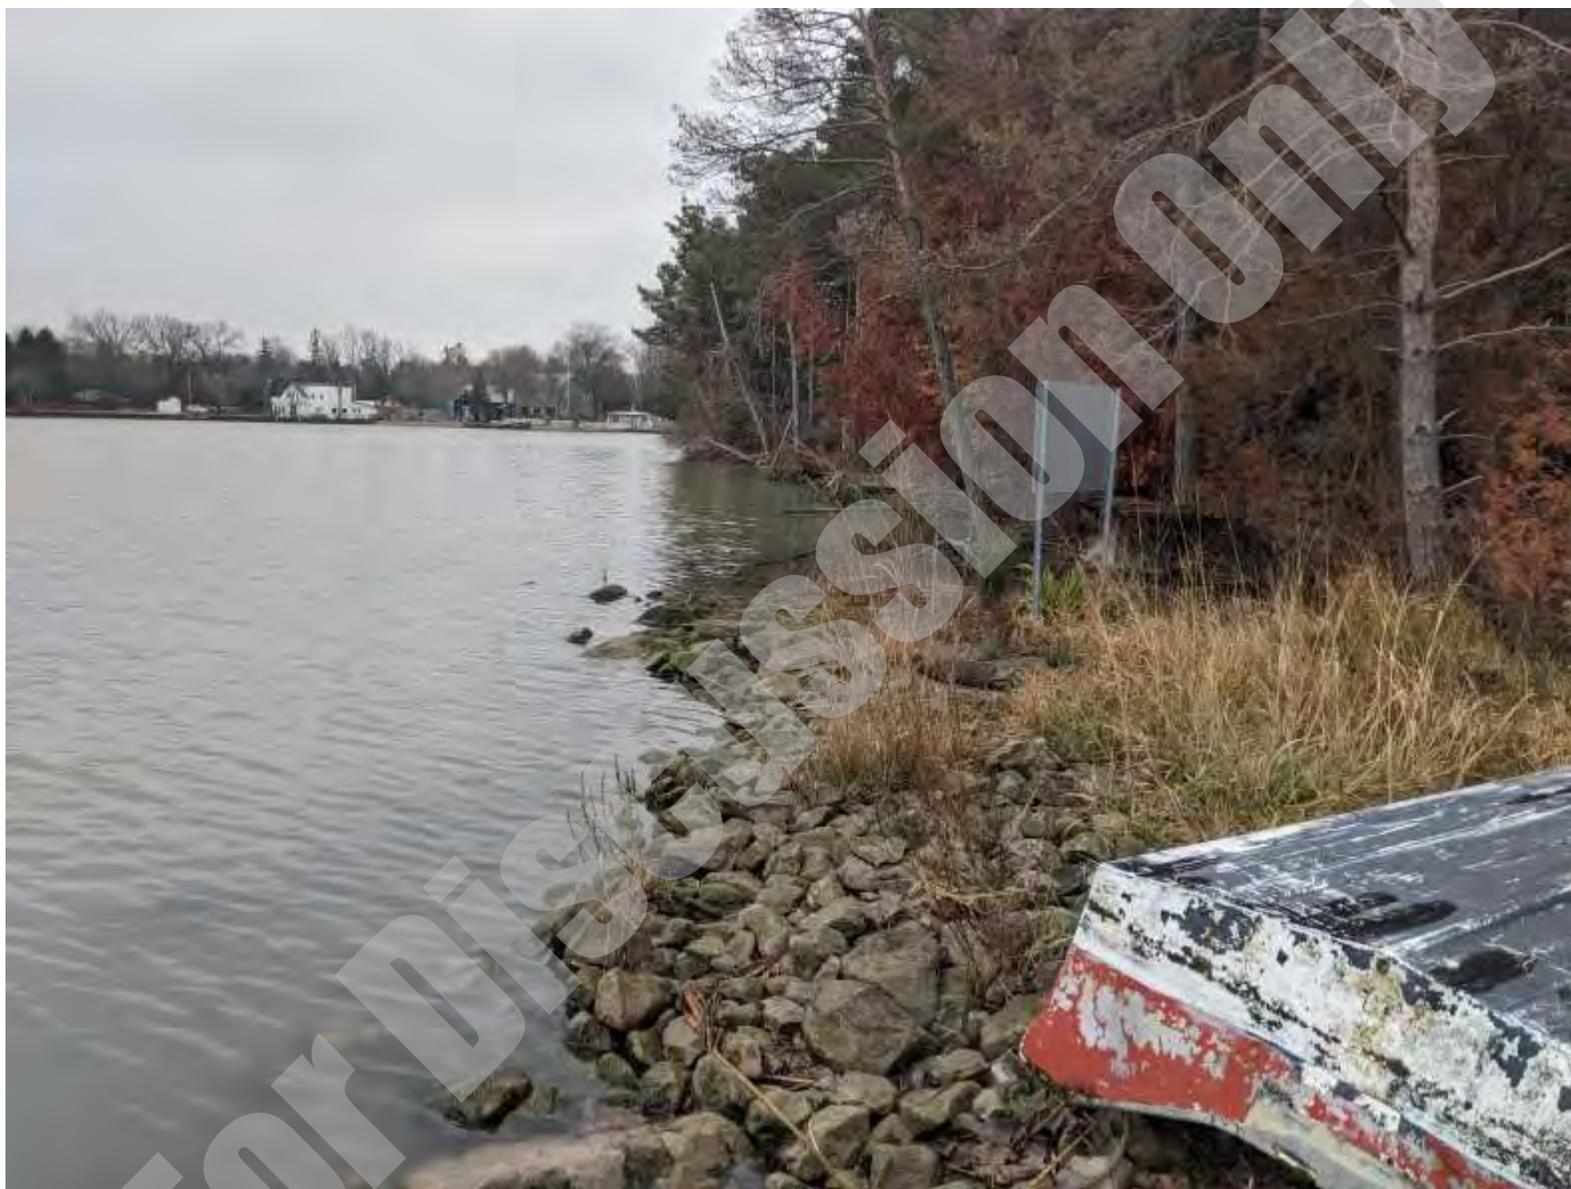
Photo B-1: Southern end of Reach 1, looking south

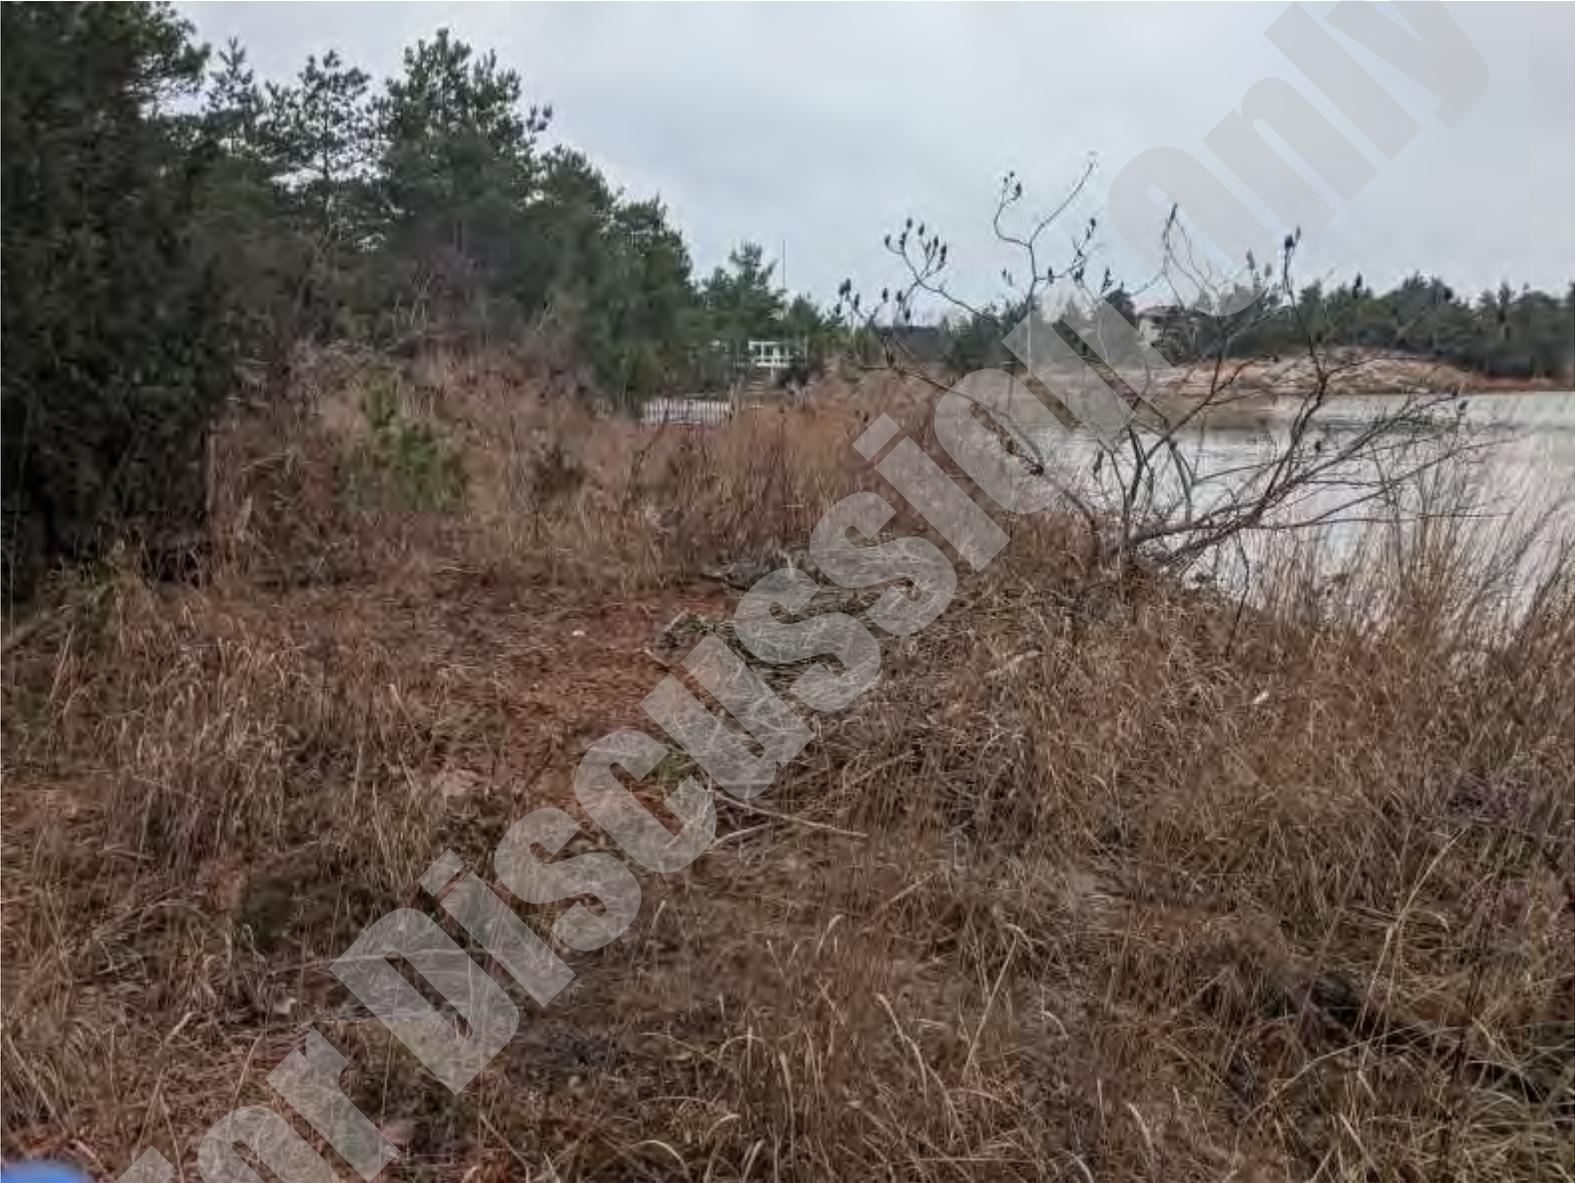
Photo B-3: Vegetated bench of Reach 1, looking north.

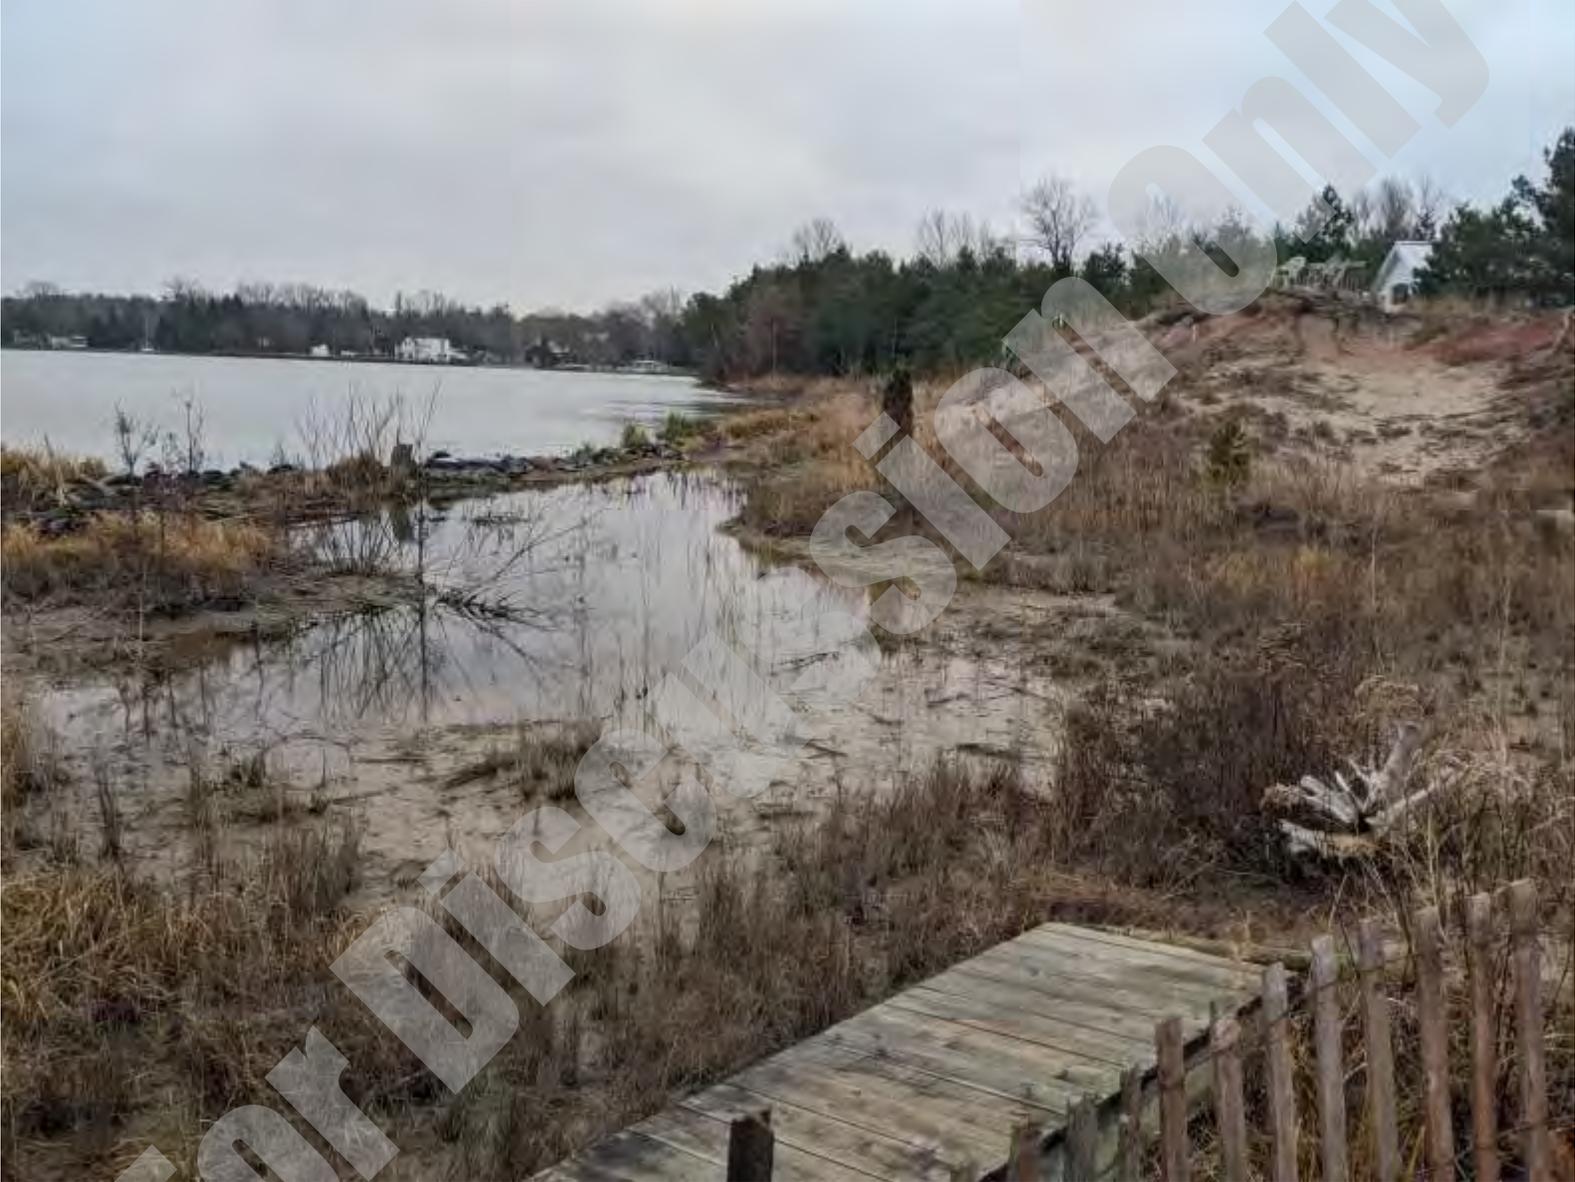
Areas within the extents of the Smuggler's Lane road allowance were generally observed to be low-lying and demonstrated more evidence of river and wave erosion impacts when compared with any other area on the project site. The stone revetment in this area is generally lower than in Reaches 1 and 2, likely due to the pre-2006 topographic conditions that existed within Smuggler's lane and the inability of the contractor to tie into existing ground with the originally proposed top of revetment elevation. This area has also been used as a boat and supply access route to the majority of the dwellings in the area. Ross Wilson of ABCA noted that the residents rely on the use of ATVs to transport people and supplies from the beach area, resulting in the area within and adjacent to Smuggler's Lane demonstrating a variety of erosion issues. A low-lying area was documented behind the erosion revetment in the north-eastern portion of Lot 23. This area is characterized by standing water and saturated sediment/organic muck which appears to have been

deposited in the area as a result of river processes pushing over the stone revetment and the sediment settling within the pool of standing water behind the rip-rap. Since this area also represents the natural low point in the local topography it is plausible that a portion of the accumulated sediment originates from local stormwater runoff and wind-swept debris collecting behind the revetment. The sediment was distinctly different in composition than the predominate sandy soil behind the revetment throughout the project site and is illustrated in **Photo B-7**.

The area of low-lying ground within the Smuggler's Lane right-of-way and a portion of Lots 22 and 23 was noted as being fully saturated with pockets of standing water along the back side of the revetment during field investigations completed in late December 2020. Erosion scars on the dunes beyond ABCA's easement indicate that water levels and wave action had recently overtopped the revetment and inundated the area. The high-water levels within the river, combined with the sandy soil conditions beyond the revetment, results in saturated ground conditions and limited capacity for water to percolate through the upper soil strata. It is anticipated these conditions will persist with high lake levels and standing water will be prevalent as a result of revetment over-topping or the accumulation of surface water runoff from the local drainage area. Raising the top of the revetment would reduce inundation from high water levels or wave action but would have no effect on the elevated groundwater table and the soils ability to freely drain unless the ground surface was raised enough to create a positive hydraulic gradient from the ground surface to the water levels within the adjacent channel. For the low-lying ground around Smuggler's Lane, this would require the placement of approximately 0.5 – 1.0m of fill over an area of approximately 1,700 square meters.

Photo B-7: Low-lying area on Lot 23, looking south.

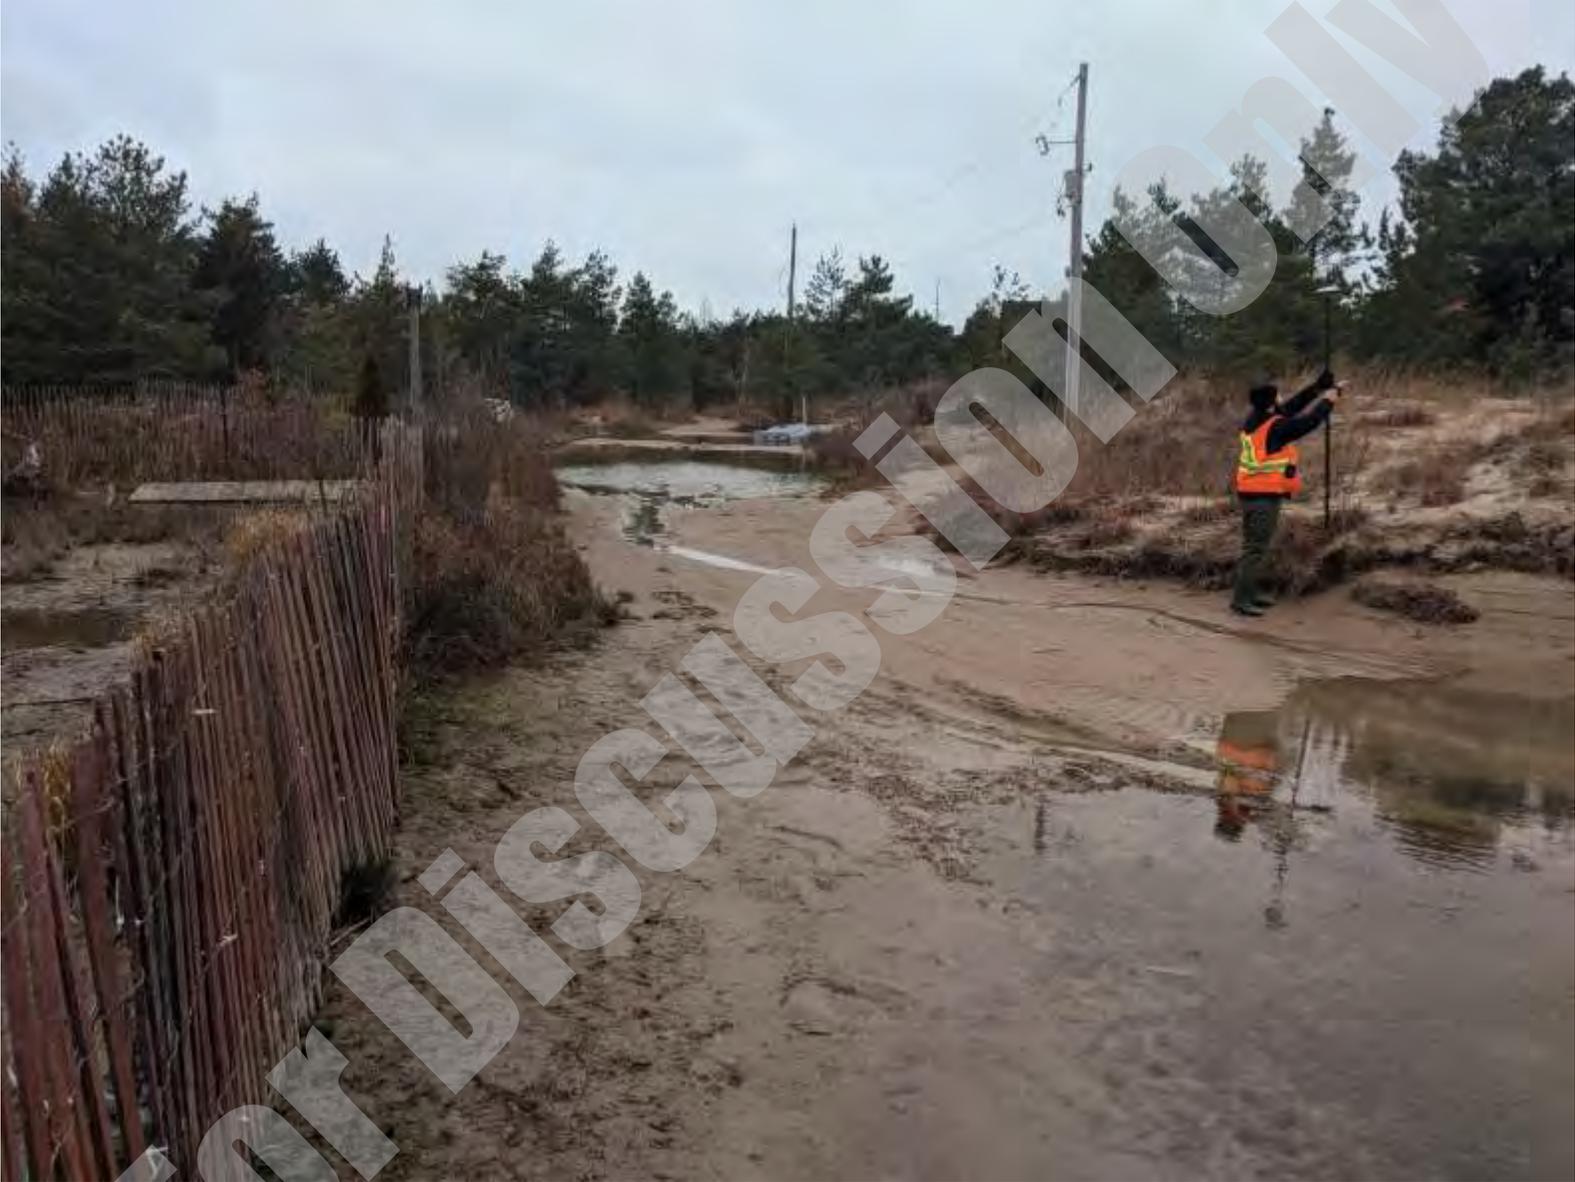
Photo B-8: Smuggler's Way, looking west

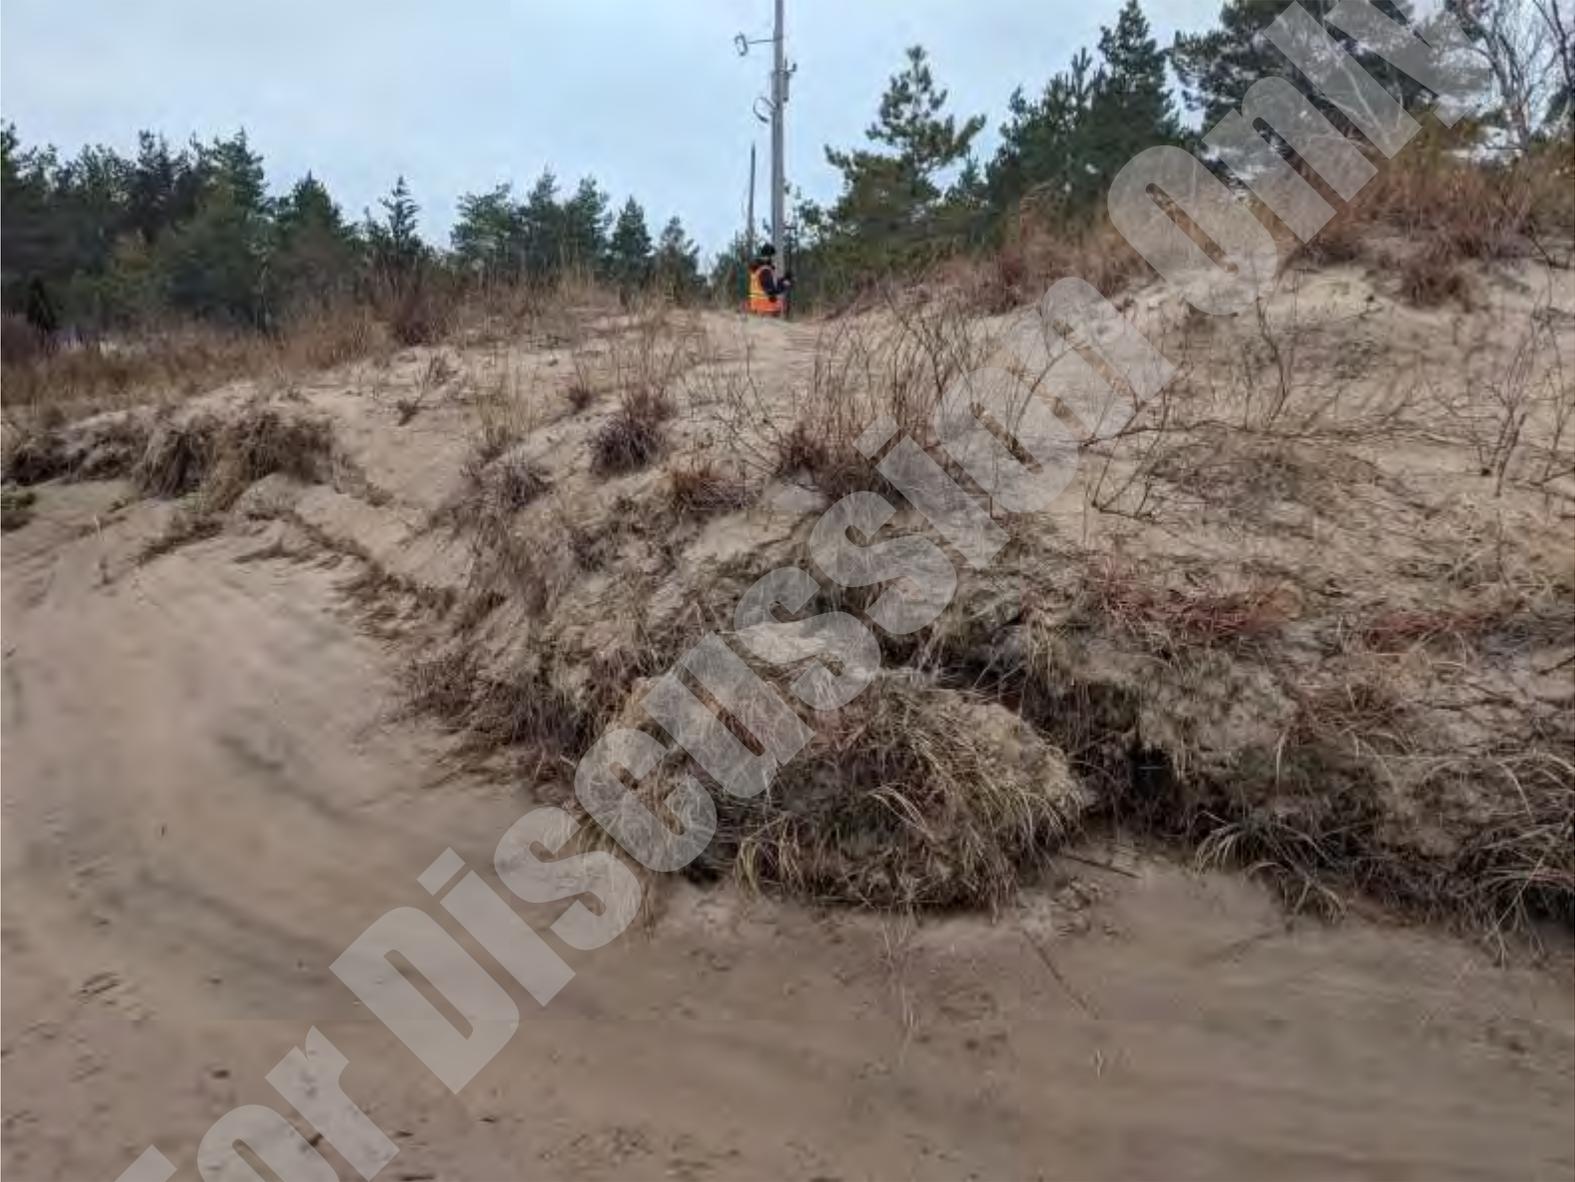
Photo B-10 illustrates a lengthy erosion scar that is evident along the majority of the central portion of the revetment. The erosion scar was also observed along the toe of the sand dunes on the east side of Smugglers Lane adjacent to the ATV trail located within ABCA's 5 m wide easement. This erosion scar forms a bench in the sandy soils and varied in height between 0.27 and 0.74 m. Based on site conditions it appears that the scar is likely a result of the low-lying nature of the local topography, ATV traffic adjacent to the sand dunes and the erosive forces from high-water wave action experienced through the summer and fall of 2020. The stone revetment in this reach was not as prominent with a lower density of the stone at the top of the revetment compared to that of Reach 1 or Reach 3. Based on site observations it was concluded that this may be a result of continuous wave action (wind and wake) dislodging the stone from the top of the revetment and ice jams/debris pulling stones from the revetment into the river, thus decreasing the stone placement density.

Photo B-10: South end of Lot 14, looking west.

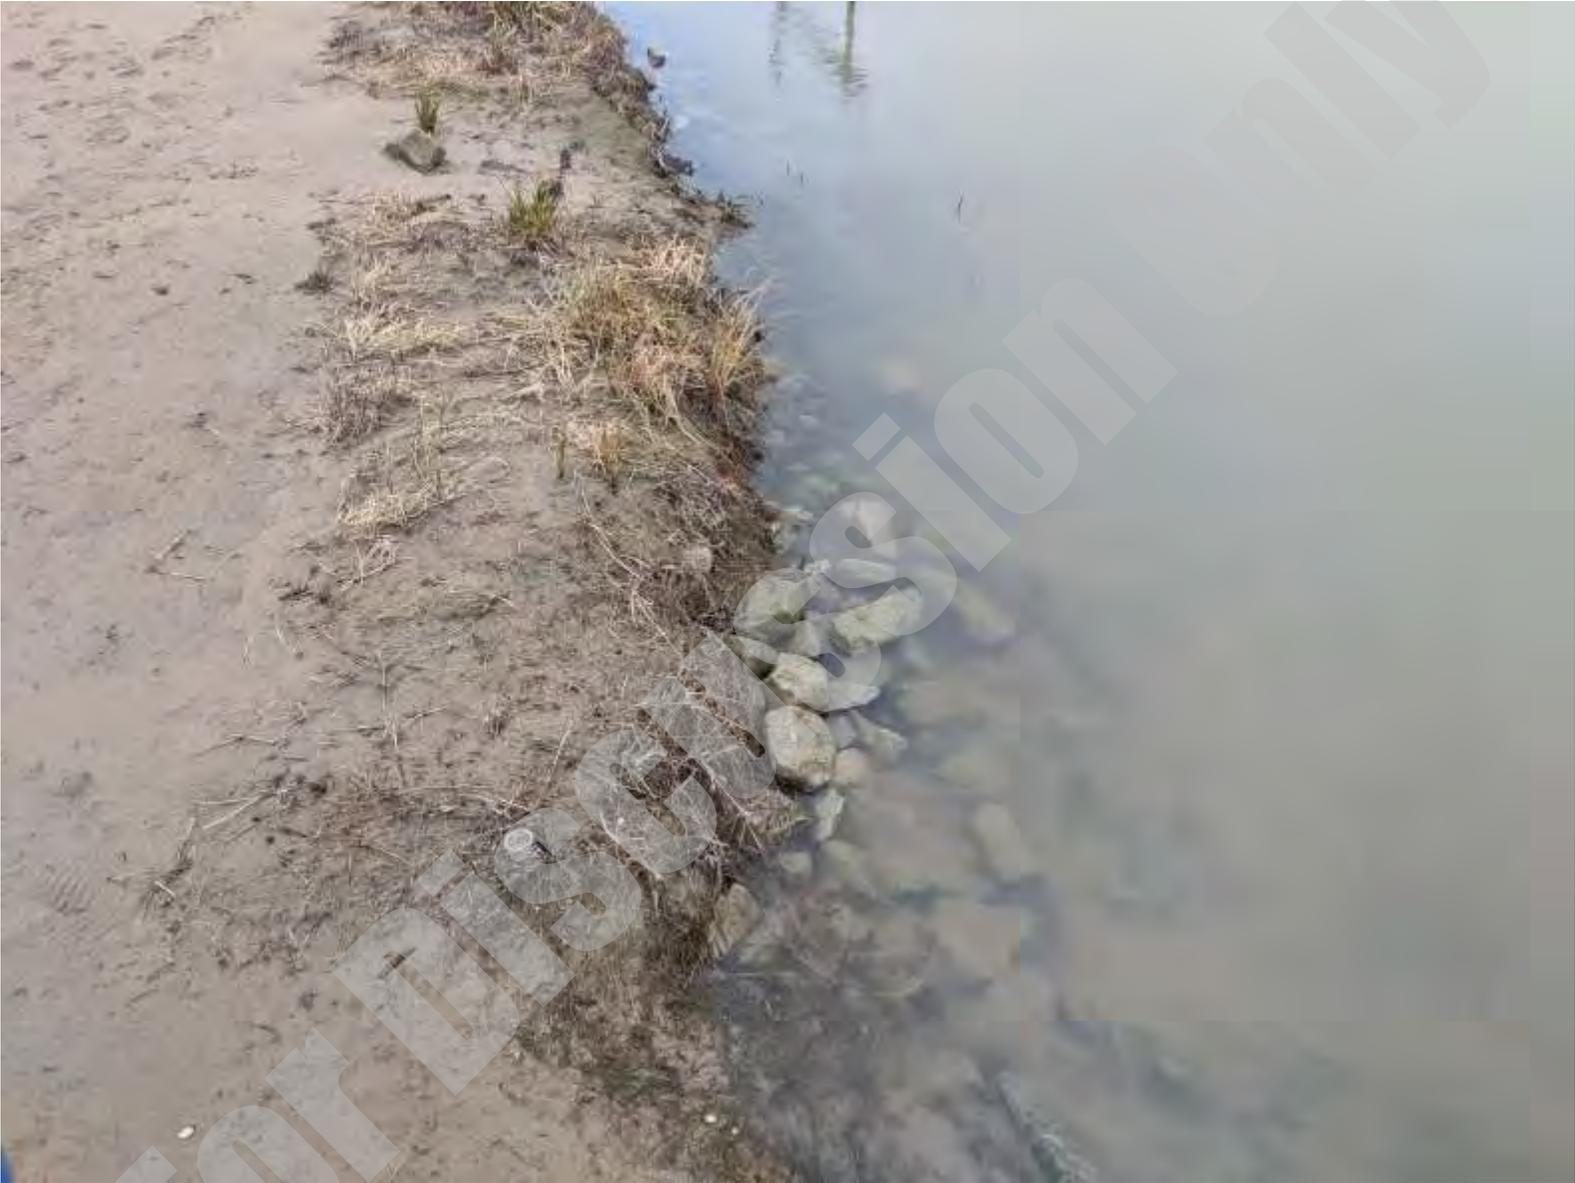
A predominate feature of Reach 3 is the accumulation of sandy soil and debris on top of the stone revetment. As the stone revetment terminates into the existing soils above/behind, a notable step was observed consisting of native sand and organic debris which has built up behind the revetment. It is likely that these sands and organics are perched on top of the revetment as a result of erosion in the adjacent sand dunes and the stepped condition is maintained as new material erodes down the sand dune slopes and moved along the bench towards the river. This 'step up' in soil elevation behind the stone revetment is visible in **Photo B-15** with an observed height of 0.2 – 0.4 m.

Photo B-15: Sand bench above stone revetment.
