Ausable Bayfield Conservation Authority – Shoreline Management Plan Update

Steering Committee Meeting: July 2016

The ABCA Shoreline - Field Observations

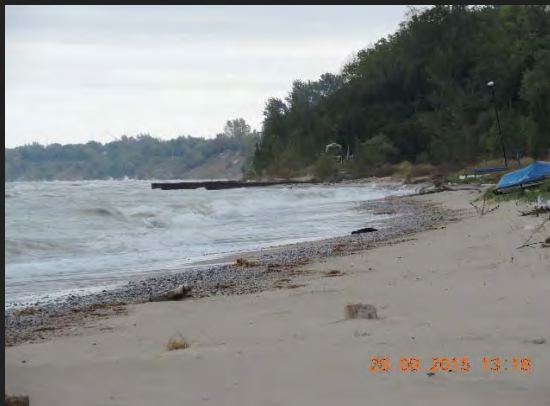
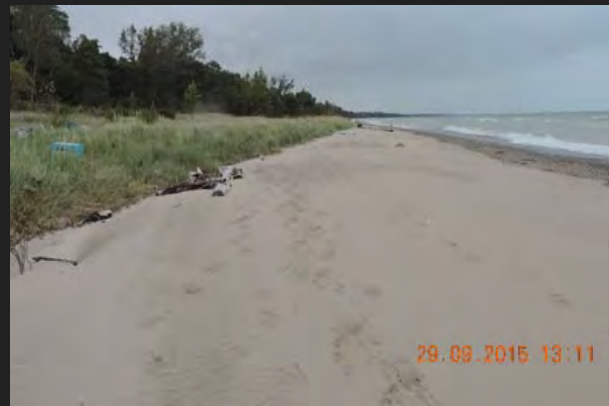
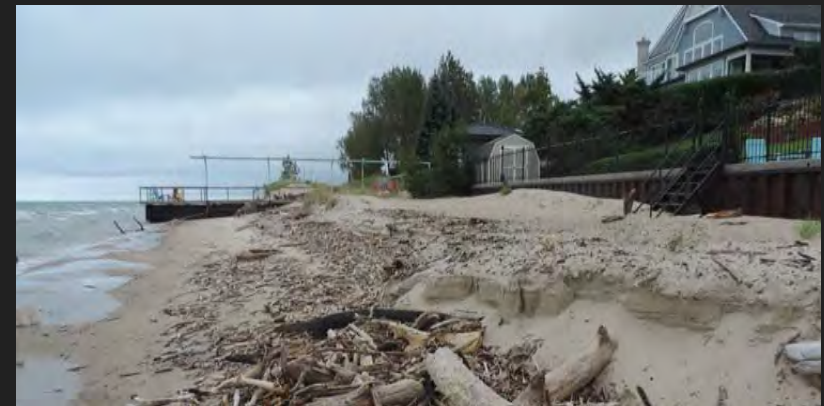
- Shoreline field observations were carried out over a two-day period in September (29th & 30th), 2015
- 1st day - examine flooding and dynamic beach hazards

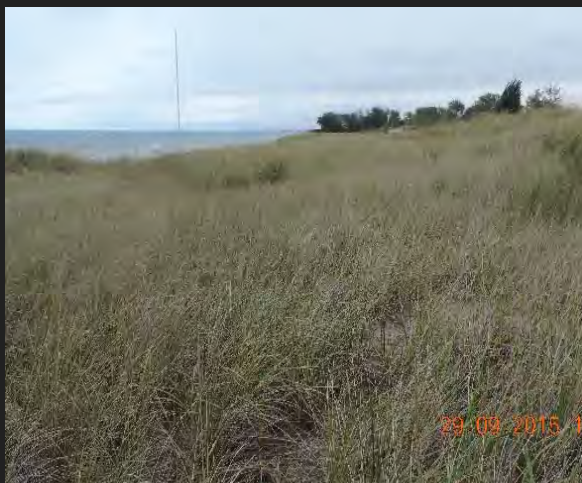
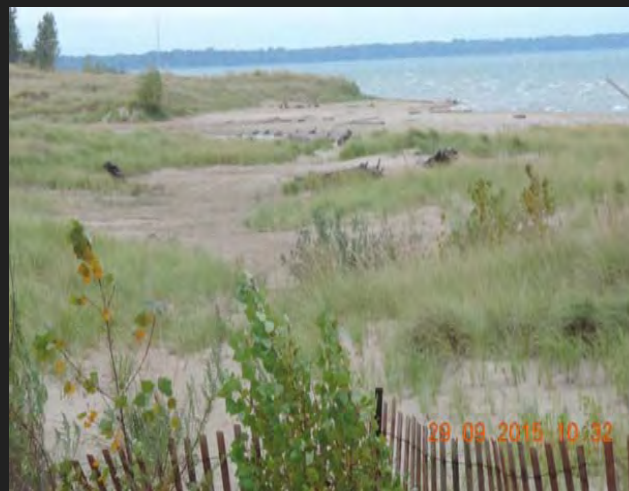
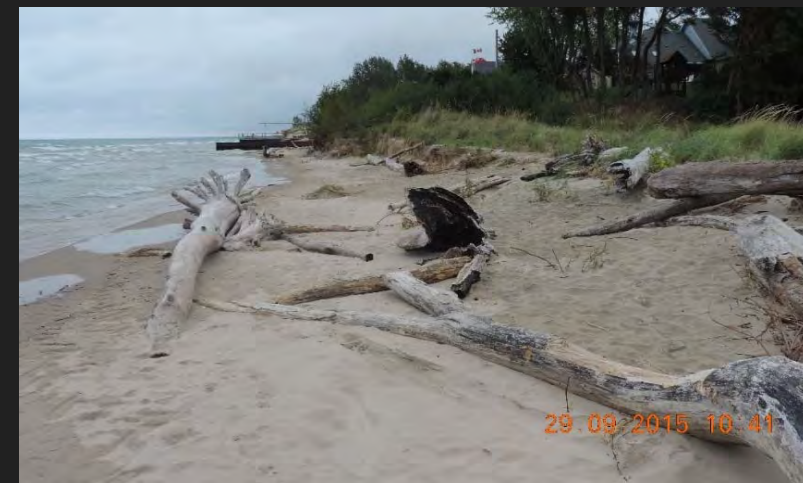
- Transition zones from the Dynamic Beach to the Erosion Hazard areas.

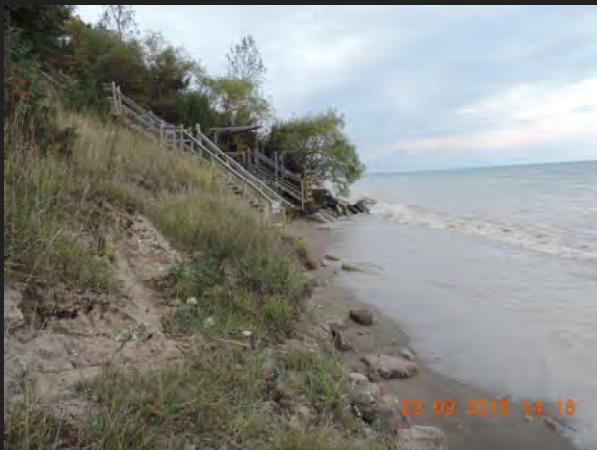
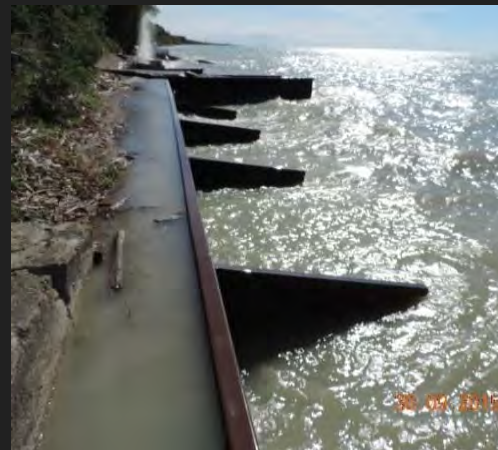
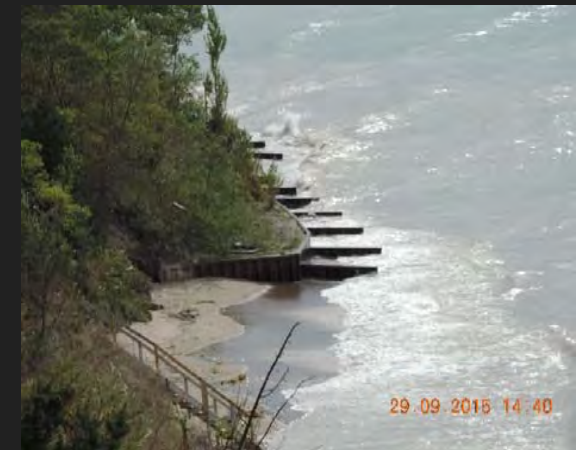
1st Day - several erosion hazard sites

- bluffs and unstable slopes (e.g. Poplar Beach).

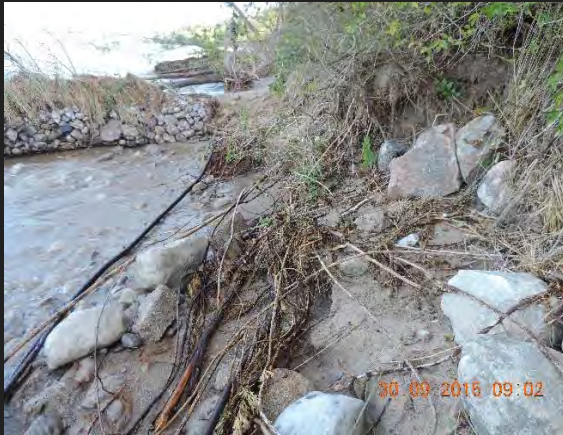
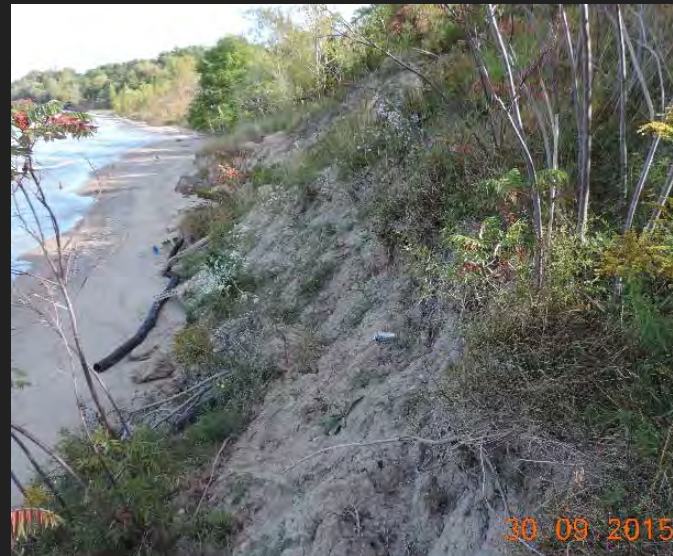
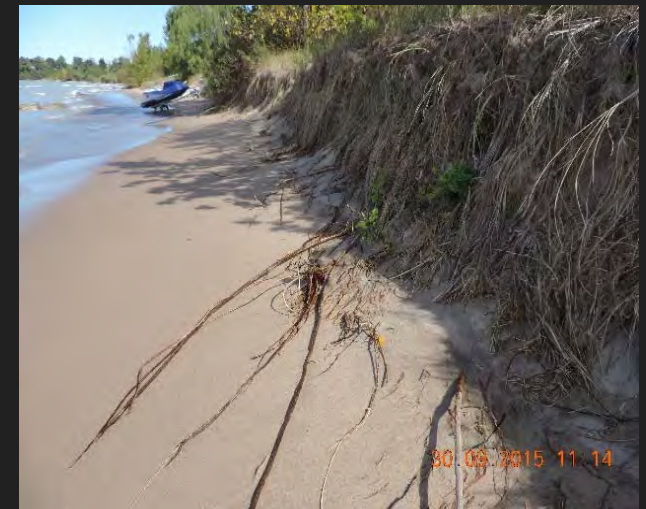
2nd day focused on:

- erosion hazards associated with bluffs and unstable slopes.

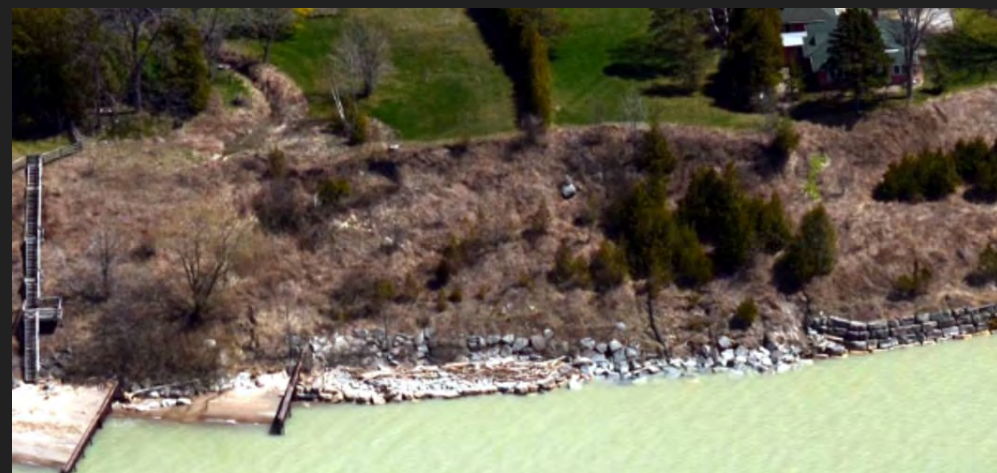
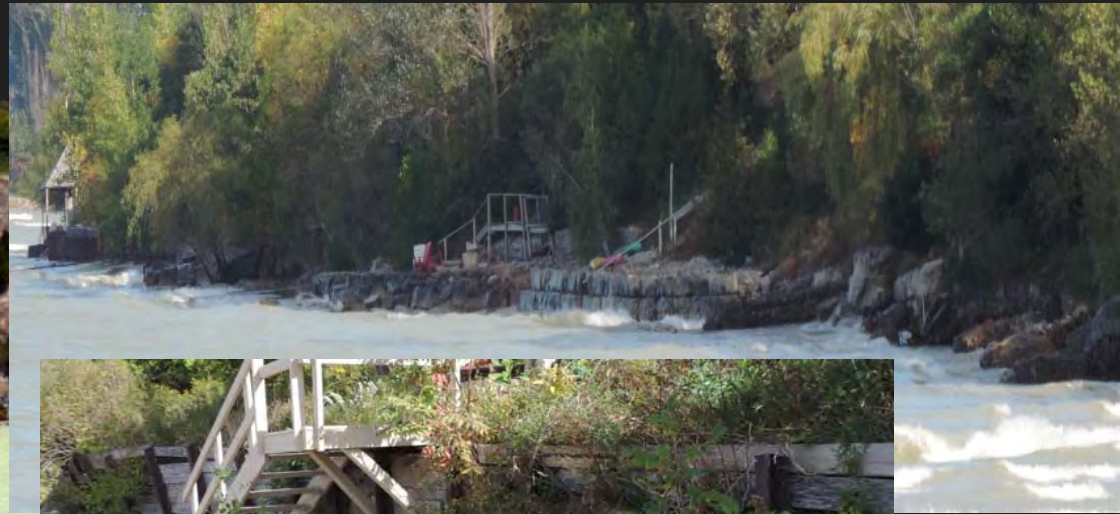
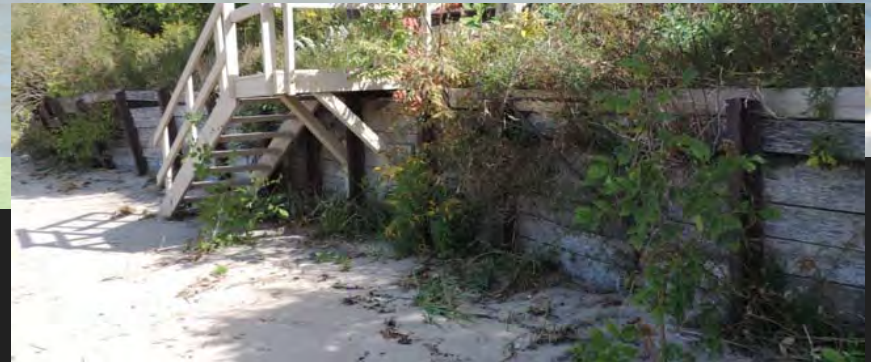
Existing Works:

- variety of inconsistent, piecemeal and ad hoc works.

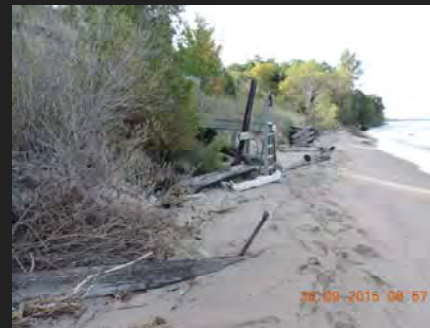
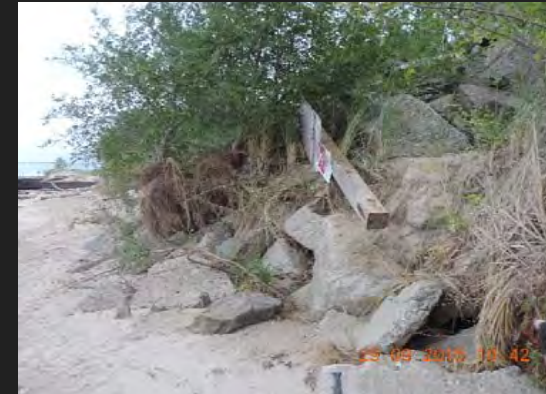
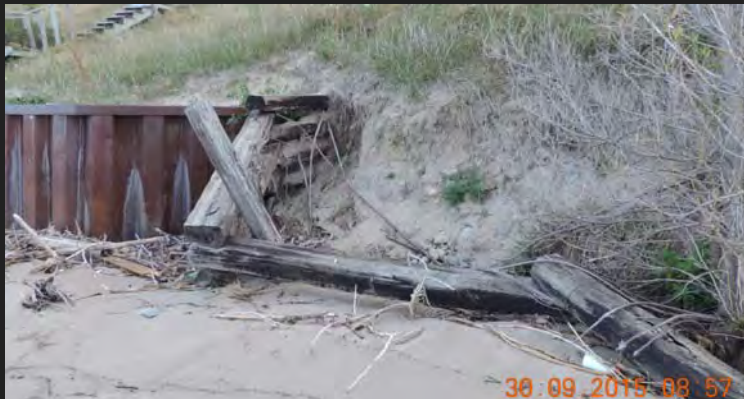
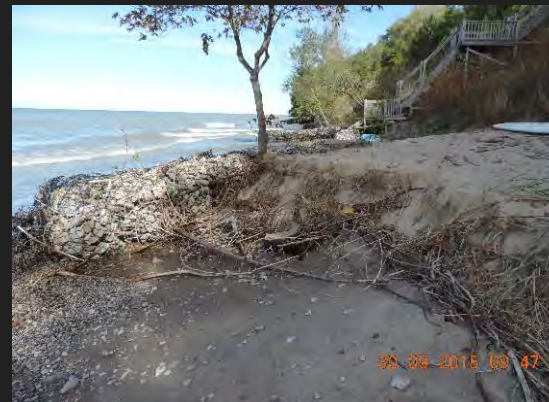
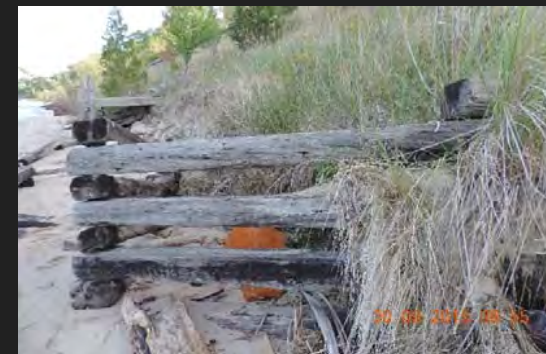
- deteriorated gabion baskets, wooden frames
- insufficient or undersized rock materials

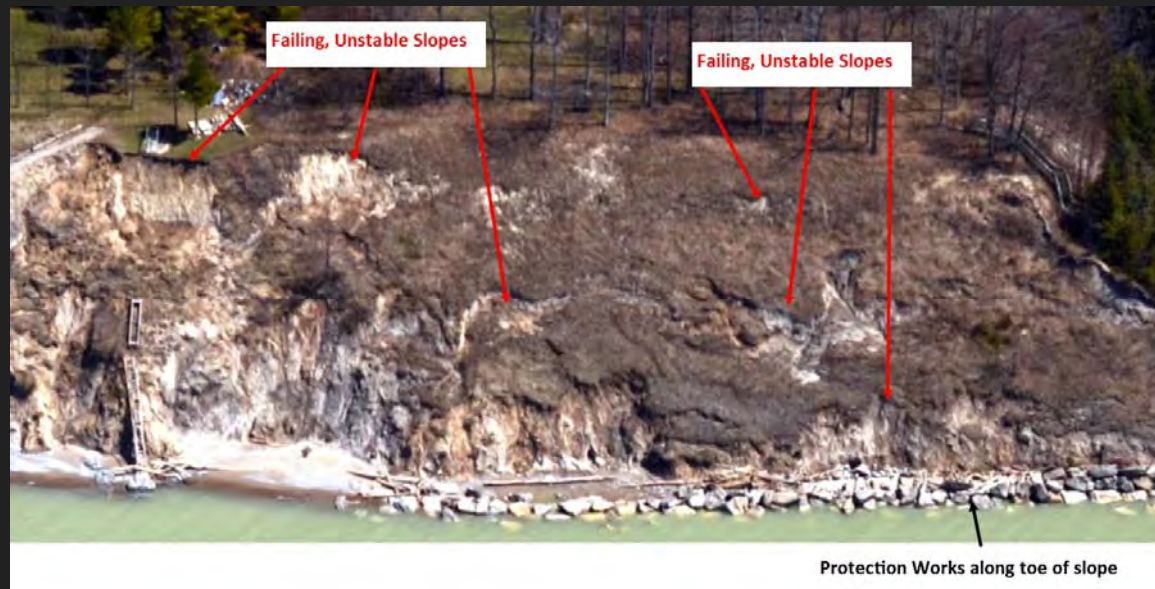
Protection works can give a false sense of security:

Photo Indicates protection works at toe of slope BUT the entire slope is still unstable and failing

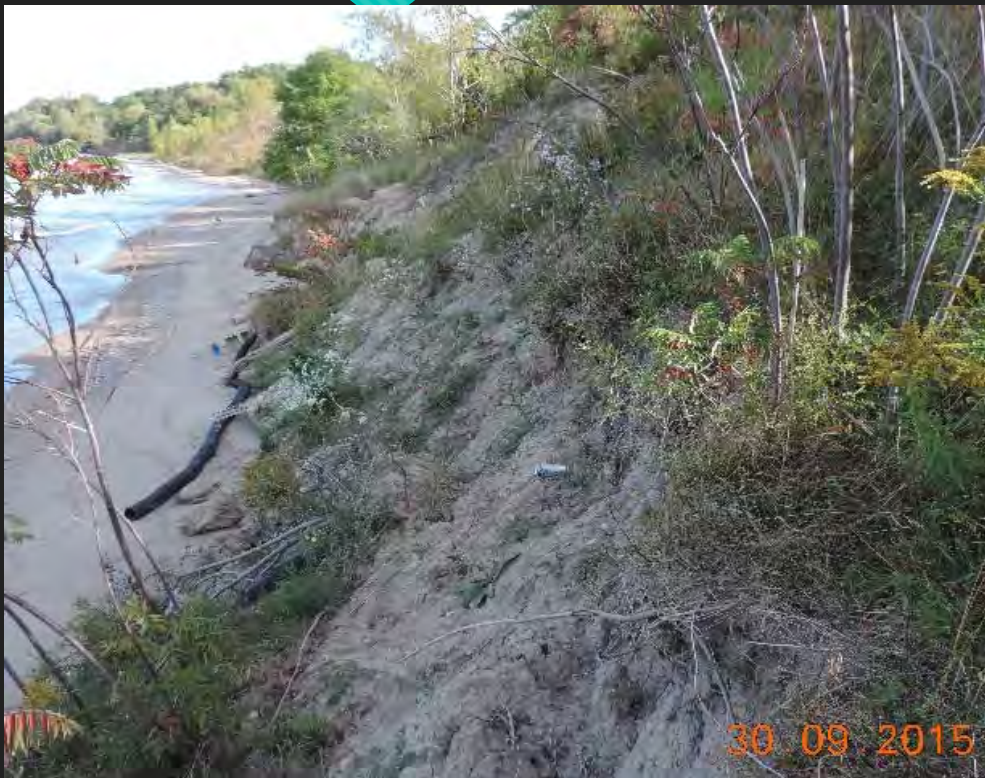
Cohesive Bluff Erosion Processes

- o Three components of cohesive bluff profile
 1. Bluff toe – affected by waves during storms
 2. Bluff slope – affected by slumping and flowing water
 3. Underwater profile – subject to wave action to depth of 6-10 m

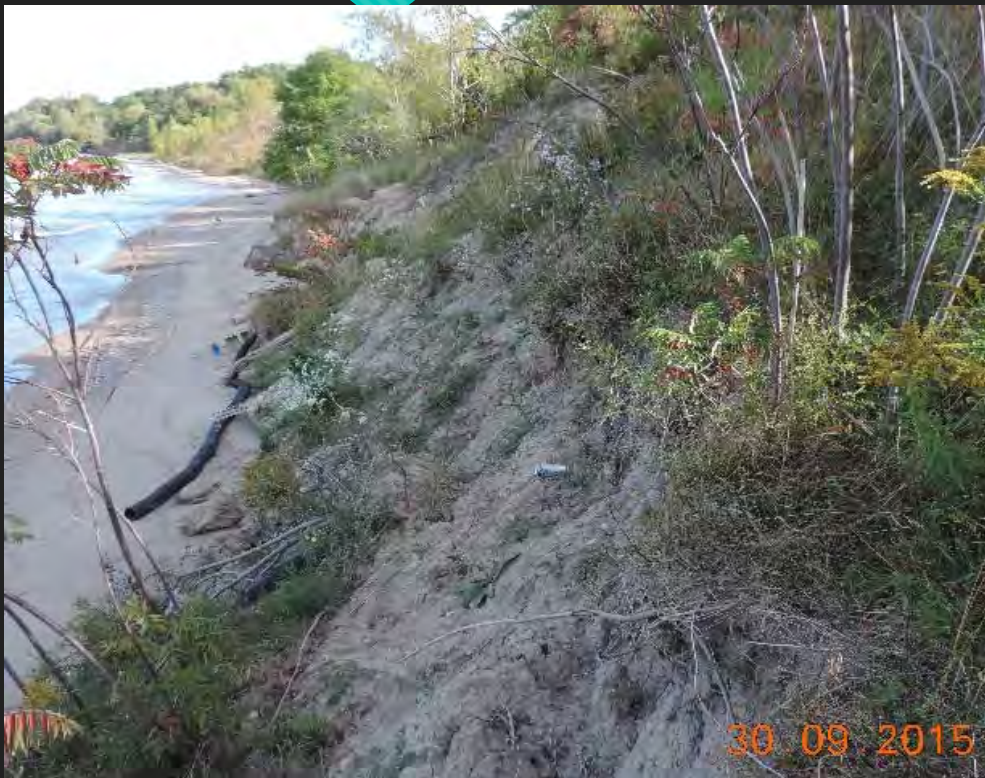
Cohesive Bluff Erosion Processes

- Initiated through toe erosion by waves during storms
- Toe erosion leads to steeper bluff slope, triggers slumping as well as erosion by water on upper slope
- Underwater erosion allows waves to continue to reach bluff toe
- Longshore transport removes eroded material and reduces build up of protective sand cover

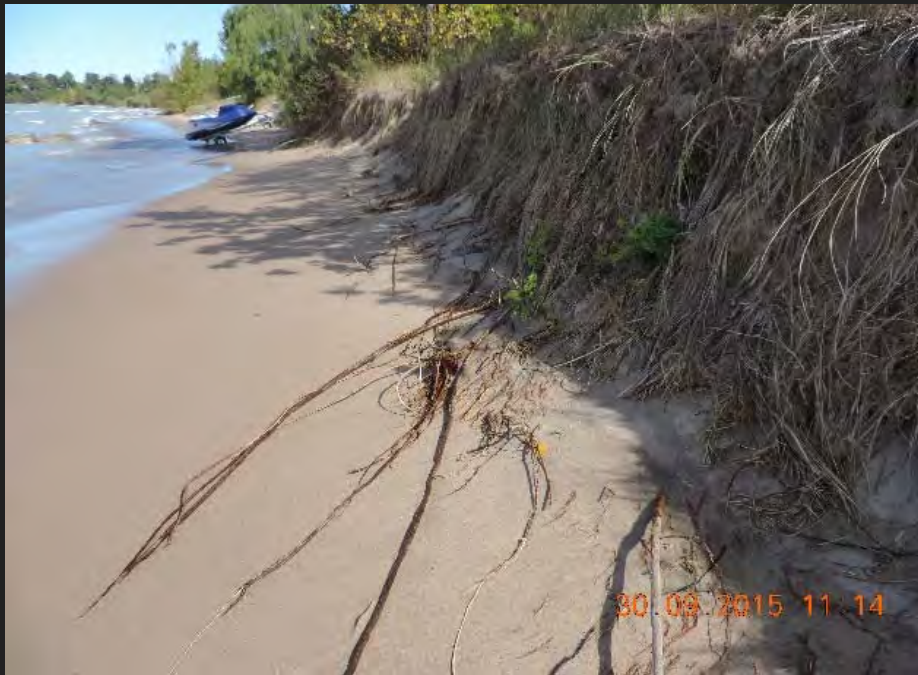
Toe erosion

- Waves erode bluff toe through impact, fluid forces and particularly by abrasion due to sand and gravel
- Erosion aided by weathering of till which leads to a reduction in strength
- More erosion during high lake level

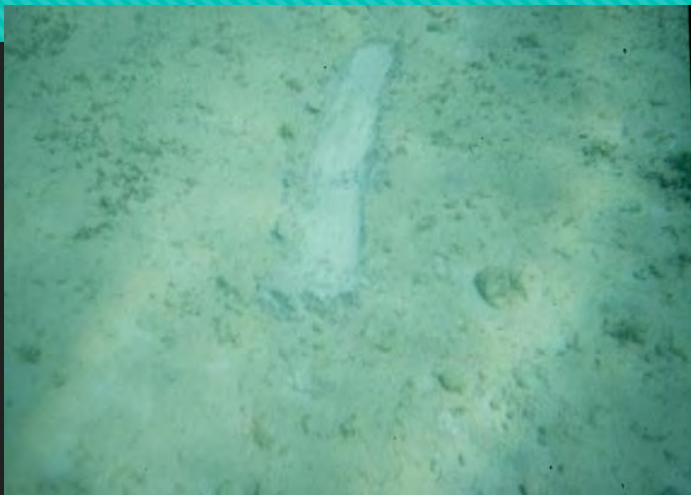
Underwater profile erosion

- Waves erode exposed till on nearshore profile through fluid forces and by abrasion due to movement of sand and gravel
- Erosion aided by softening of till due to expansion and pumping action of waves
- Some erosion occurs whenever there is wave action – 1-20 mm
- Where sand cover is thin average annual erosion greatest close to shore and decreases offshore

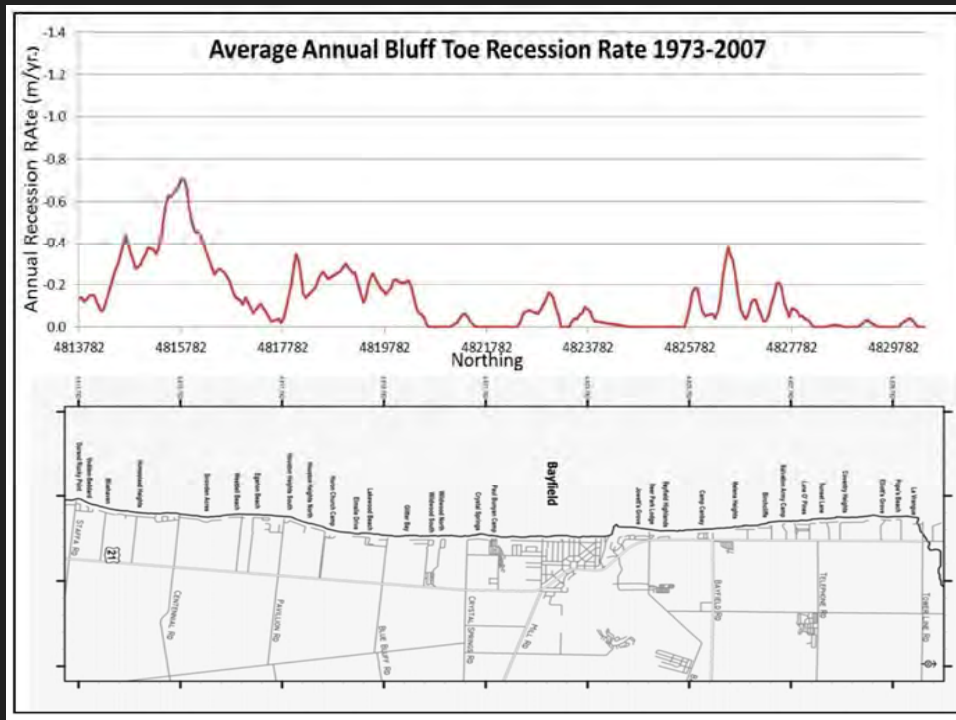
Recession Rates – Northern Section

- Northern Recession Rate Map – Average Annual Bluff Toe Erosion Rates 1973-2007.

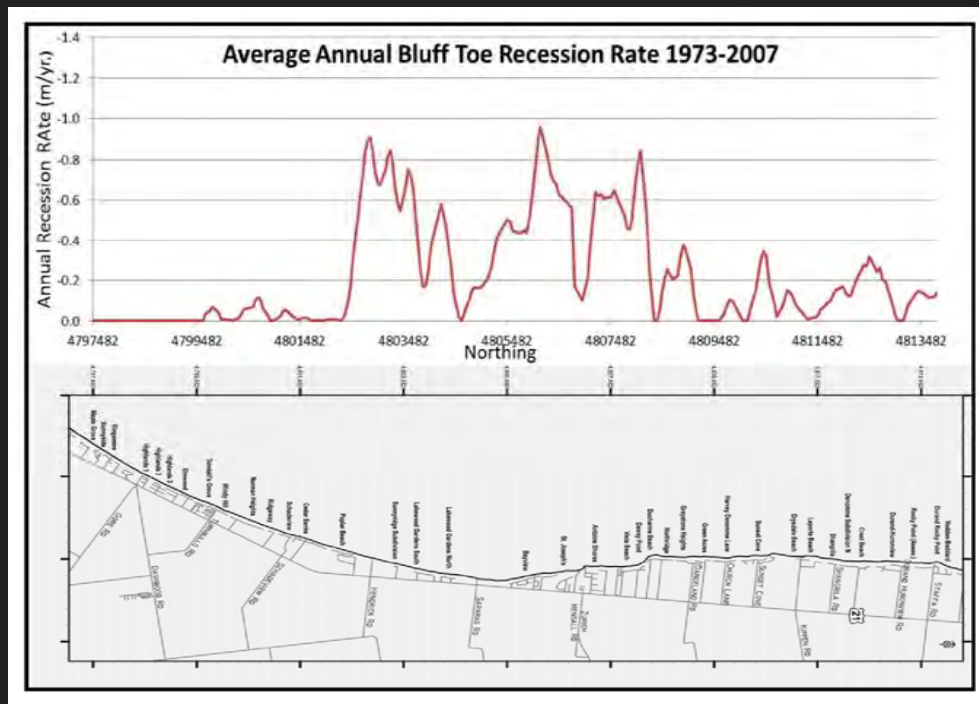
Recession Rates – Southern Section

- Southern Recession Rate Map – Average Annual Bluff Toe Recession Rates 1973-2007.

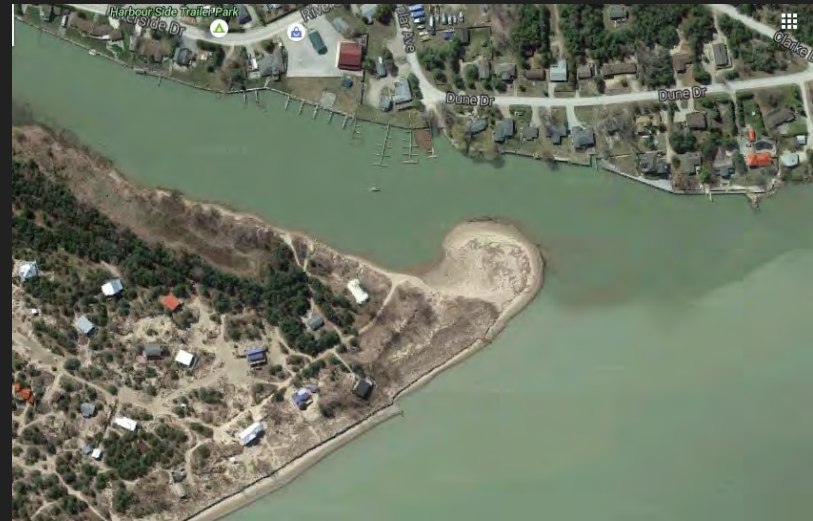
Most of the Flooding Hazards occur in the Port Franks Area:

1. Issues are related to River Flooding and
2. Flooding where the Dynamic Beaches are also at the mouths of rivers (I.e. Barrier Beaches)

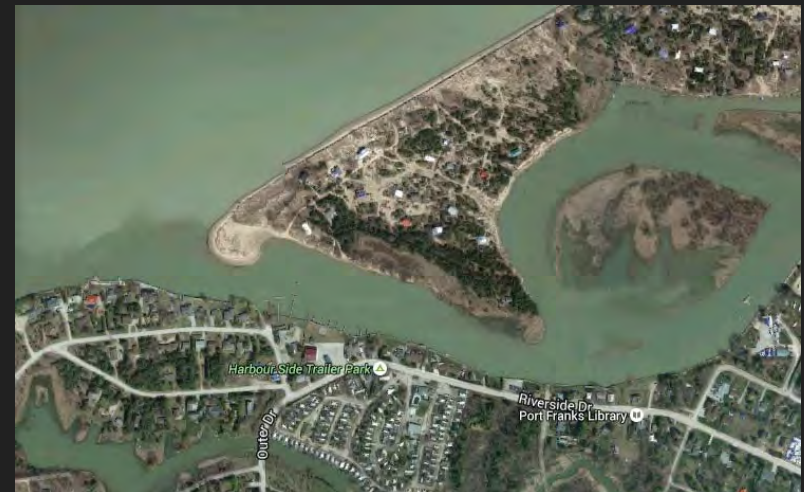
Flooding occurs in the Port Franks Area is related to the combination of the River & Low Lying Dynamic Beach Areas

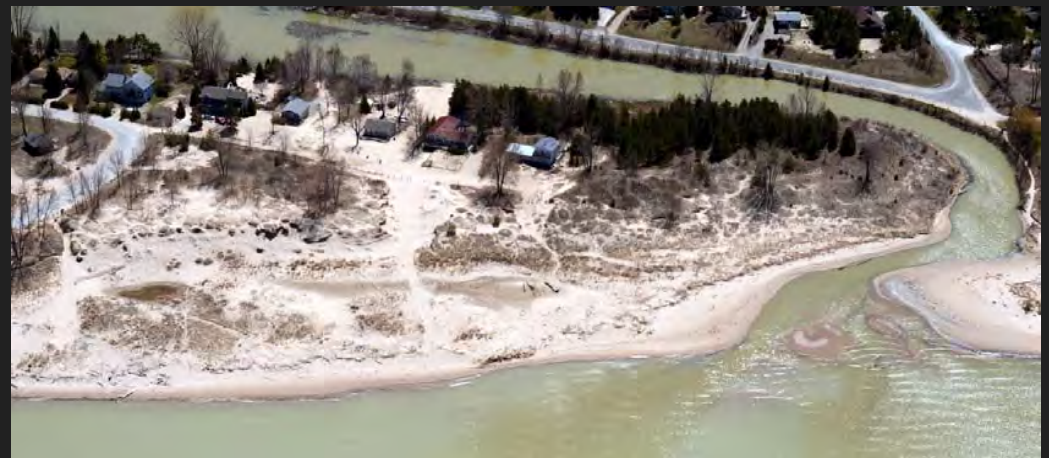
Barrier Dynamic Beach System

Barrier beaches are extremely dynamic and may be completely overwashed during storm events. Especially in the Port Franks area where the Flooding Hazard is also an issue from the river behind the Barrier System

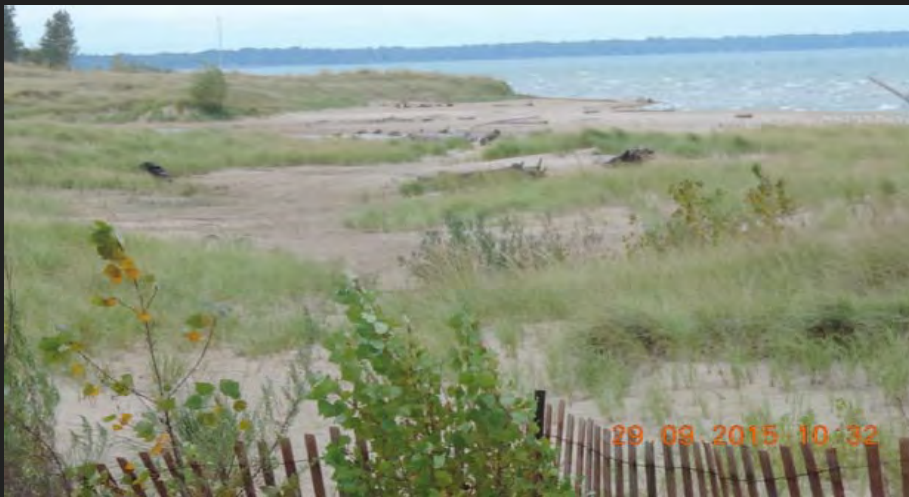
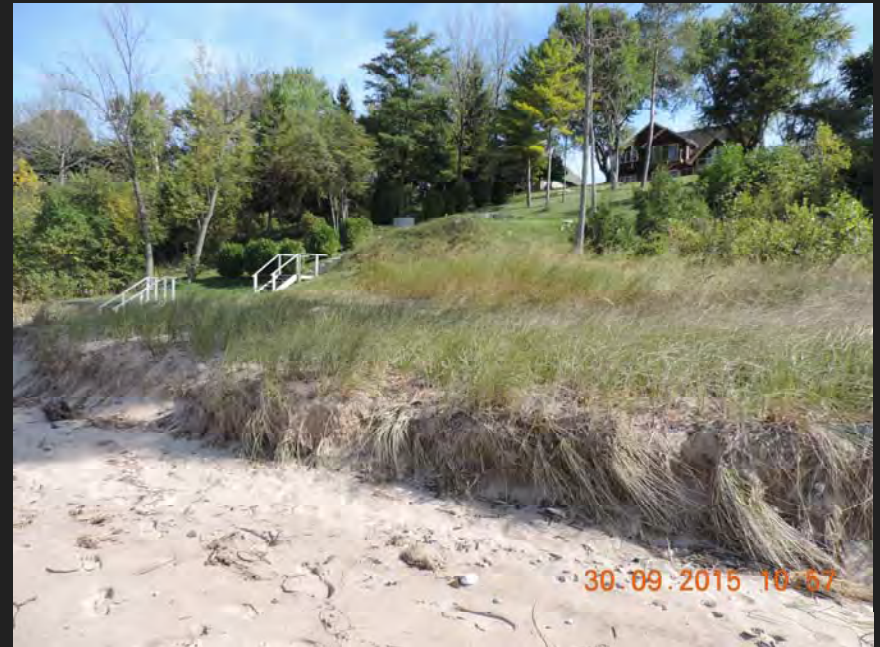
- Dynamic Beach with Sand Dunes
- Cohesive Bluff Shoreline with Dynamic Beach in Front

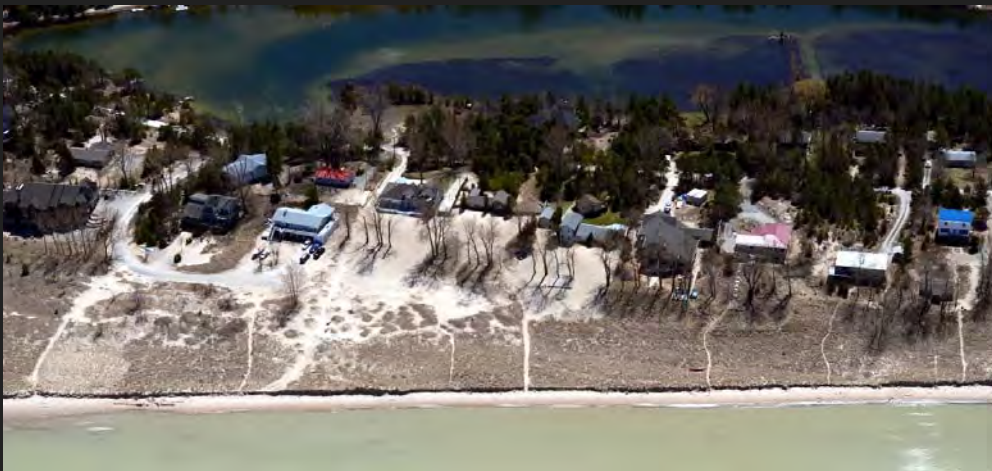
Non-Erosional Dynamic Beaches Hazard limit:

- **Flooding hazard limit**, the **100-year flood level** plus an allowance for wave uprush and other water related hazards of **15 metres** on Great Lakes,
- **plus the Dynamic Beach Allowance (30 m)** on the Lake Huron system.

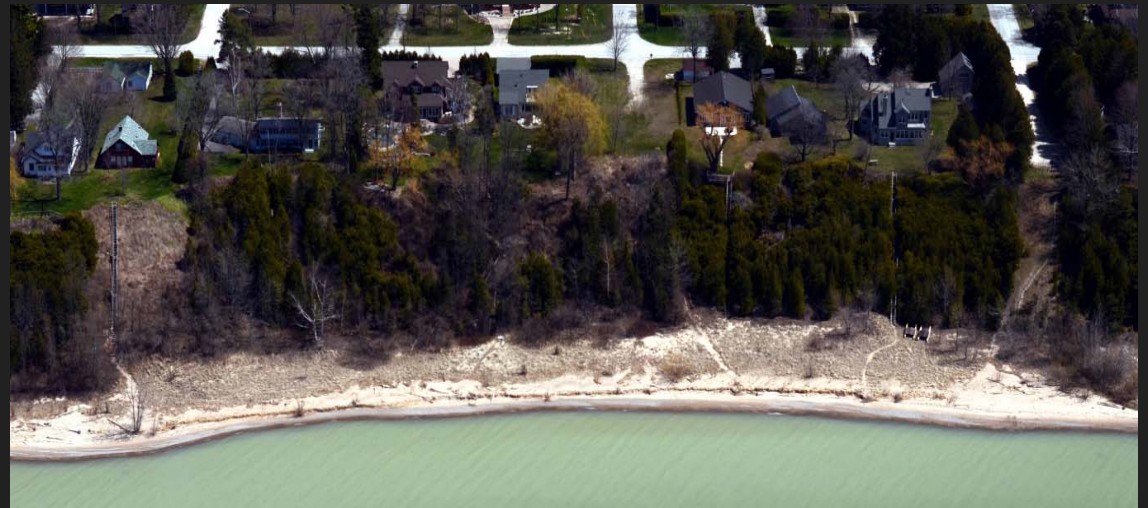
'Dynamic Beach Hazard backed by a Bluff/Cliff' then

ADD the Erosion Hazard

an additional erosion allowance + Slope Stability Allowance associated with the Bluff Erosion

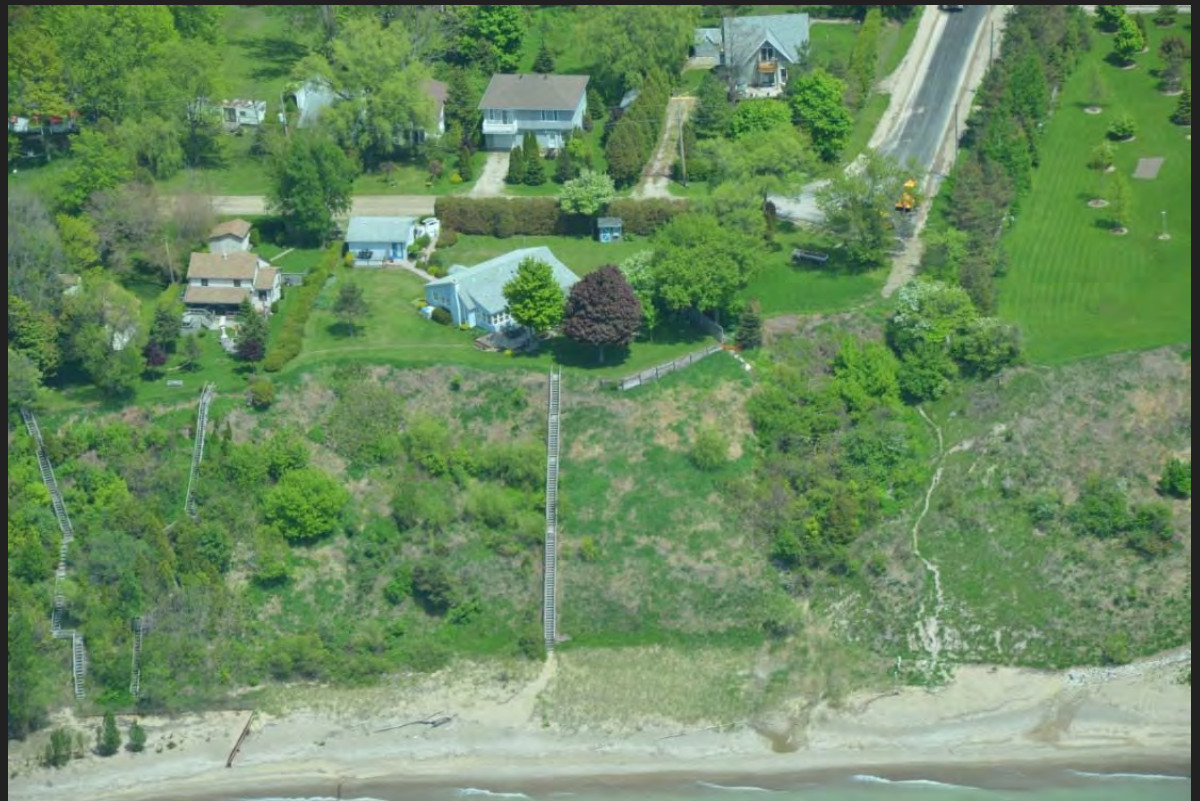
- Oblique aerial photograph of a portion of the ABCA shoreline south of Bayfield showing a dynamic beach backed by an eroding cohesive bluff.

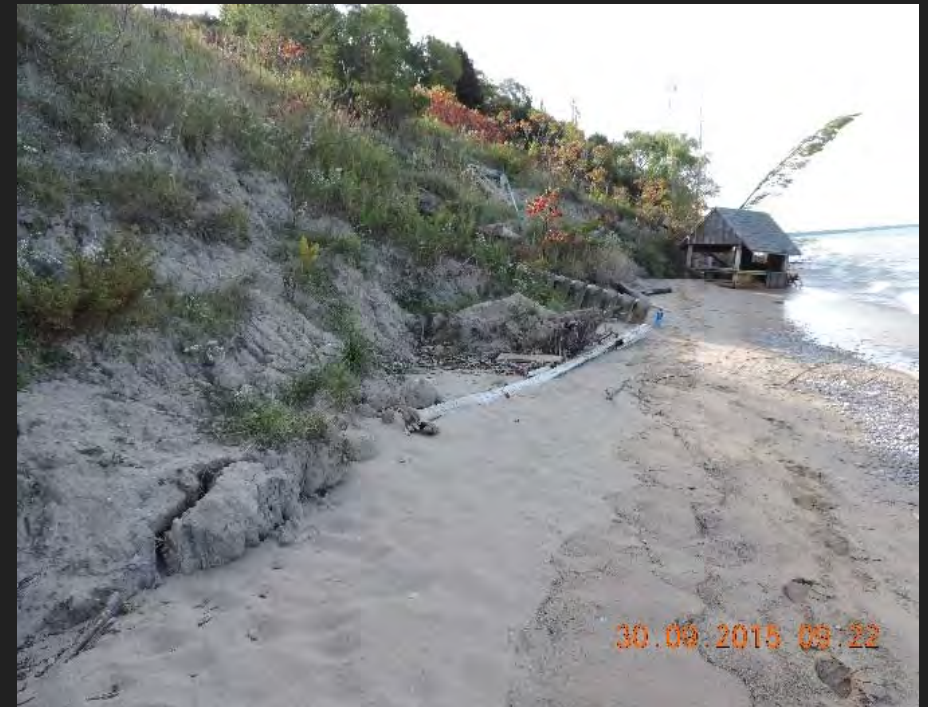
Stable Slope Allowance
PLUS 100 Year Average Annual Recession Rate (AARR)

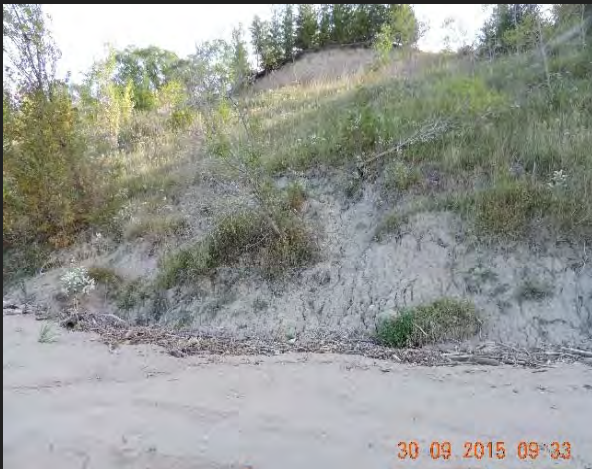
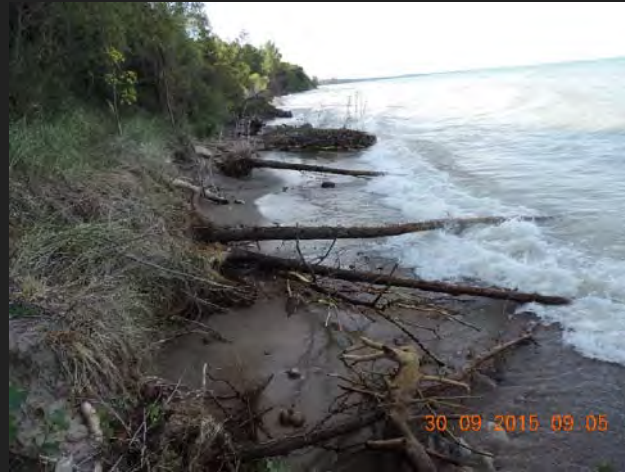
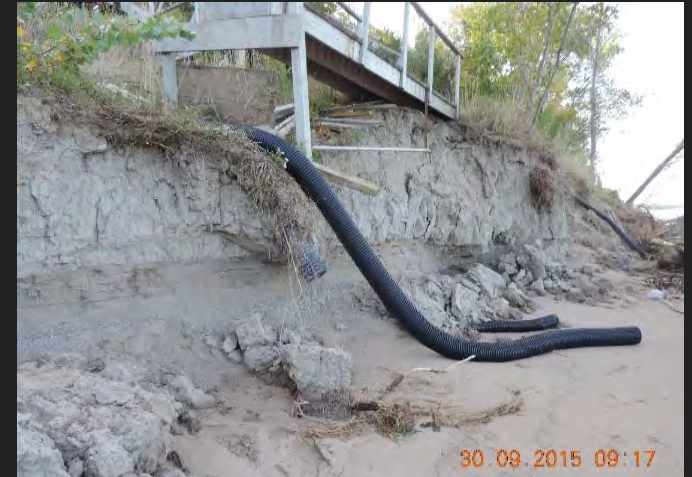
- toe erosion and
- downcutting underneath water along the cohesive shores

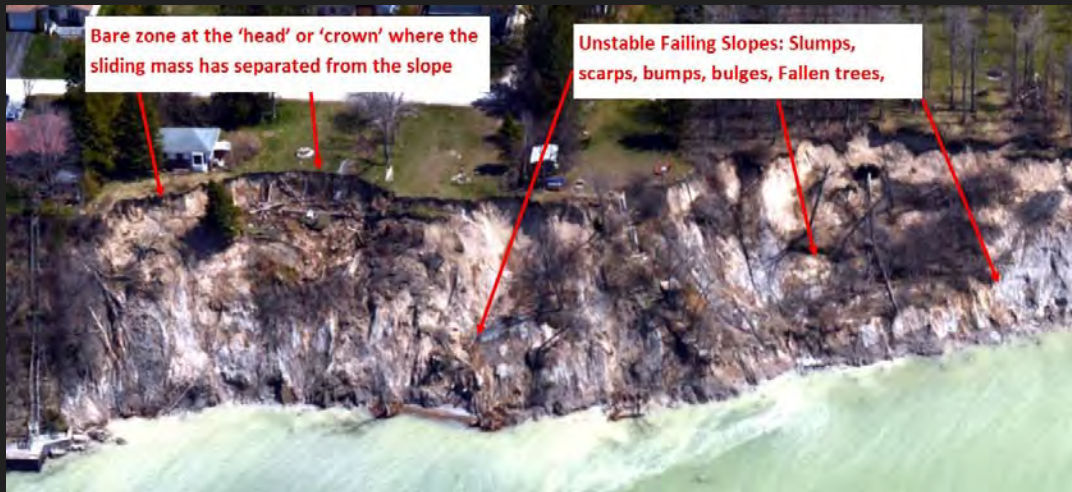
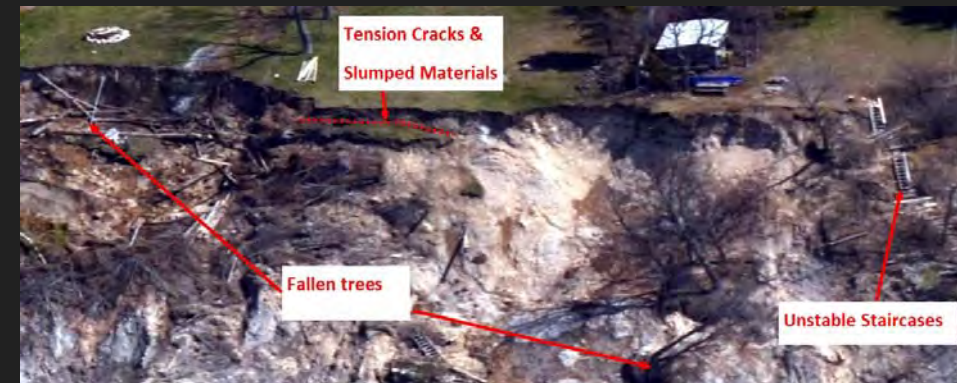
- Failing & Slumping materials, tension cracks,
- scarps, bumps, bulges on the slope face
- Fallen trees, unstable staircases

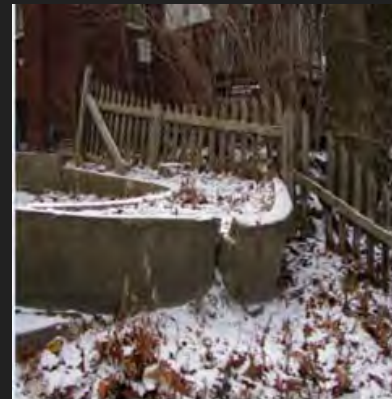
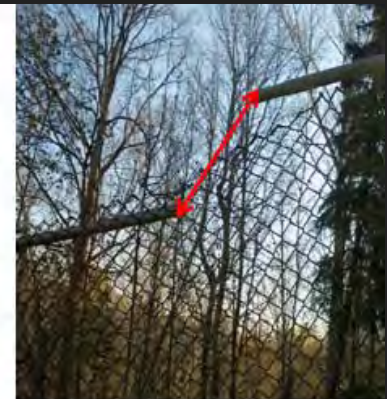
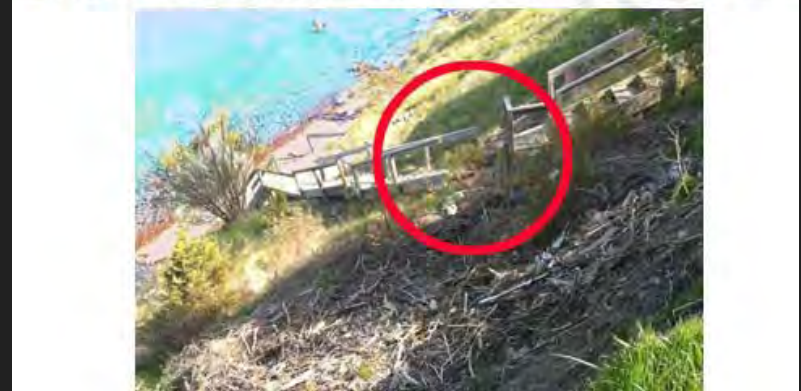
- Cracks in structures,
- Shifting fences
- Unstable staircases

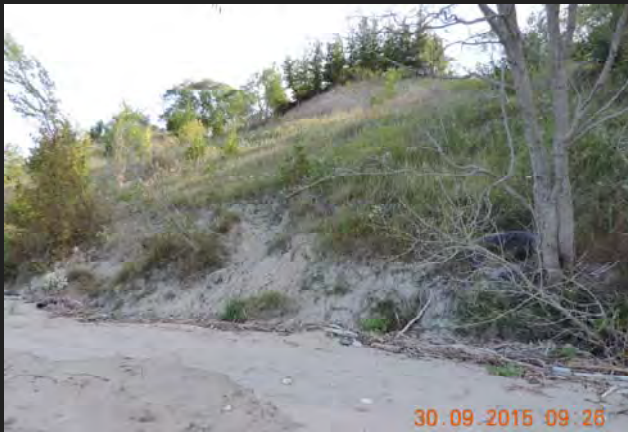
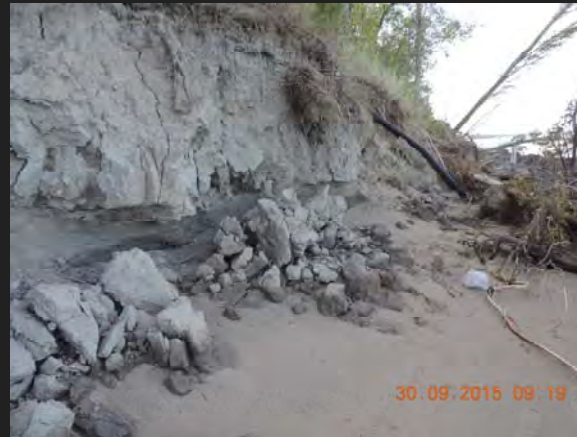
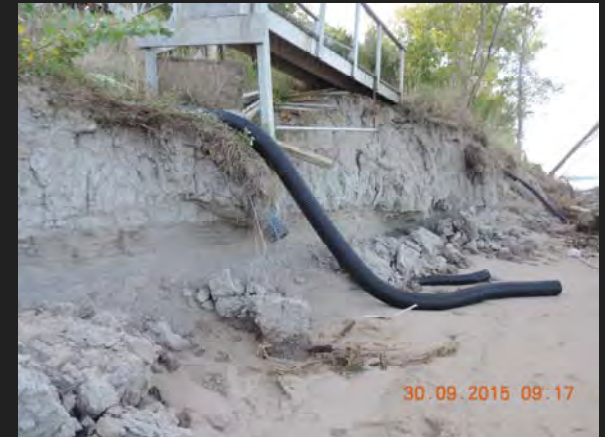
- After a field review of the ABCA shoreline, the consulting team has expressed significant concern about the number of dwellings that were within Lakeshore Area 1 in the bluff area north of Grand Bend.

Schematic showing erosion hazard limit...

- Homes are extremely close to an eroding shoreline and unstable bluff and a further geotechnical investigation has been recommended to qualify and quantify the safety issues, and the extent of these problems.

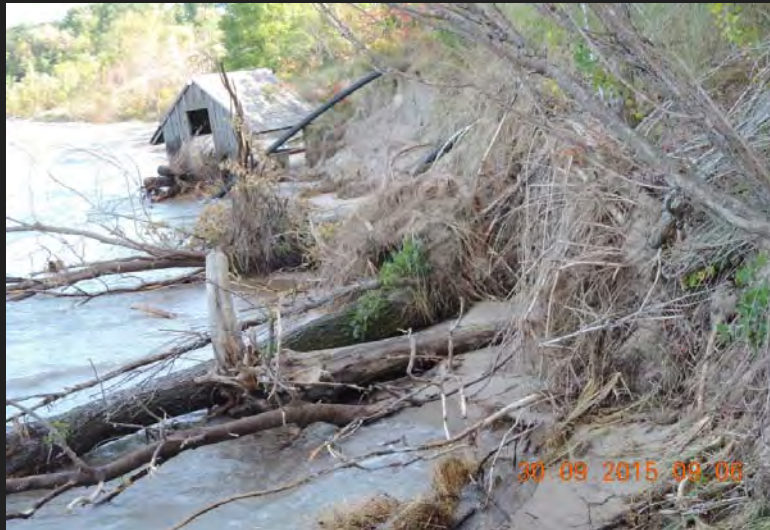
- Slope stabilization may not be feasible on some shorelines such as cohesive shores due to continuous undercutting and erosion occurring offshore (under water) which may impact the long-term stability of the slope.

- On the ABCA cohesive shores, a long term stabilization of the toe of a bluff/slope with shoreline protection works, are not feasible because of this offshore undercutting and erosion.
- Bluff Measures are possible but are only temporary and will not stop the downcutting that is occurring underwater and ultimately will reach the toe of the slope, eventually causing further slope instability

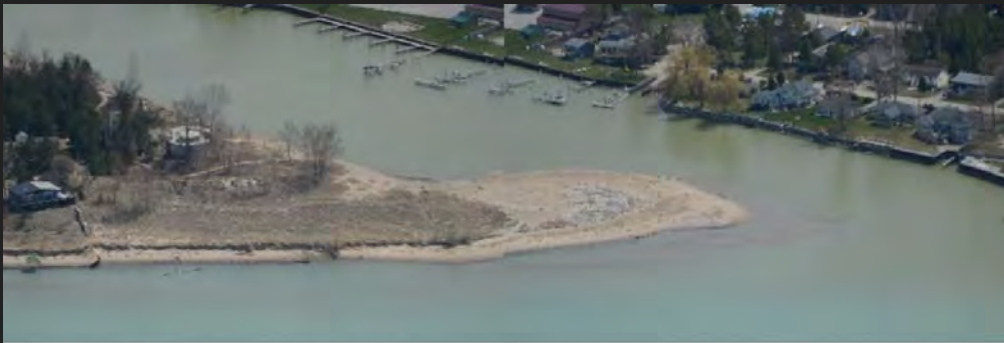
Updrift Side (Left Hand Side) of River Mouth

- General recommendation to direct the material to the south side of the mouth of the river, in this way the sediment would assist in providing material for the properties along this section whose owners feel they are experiencing reduced materials on their beach

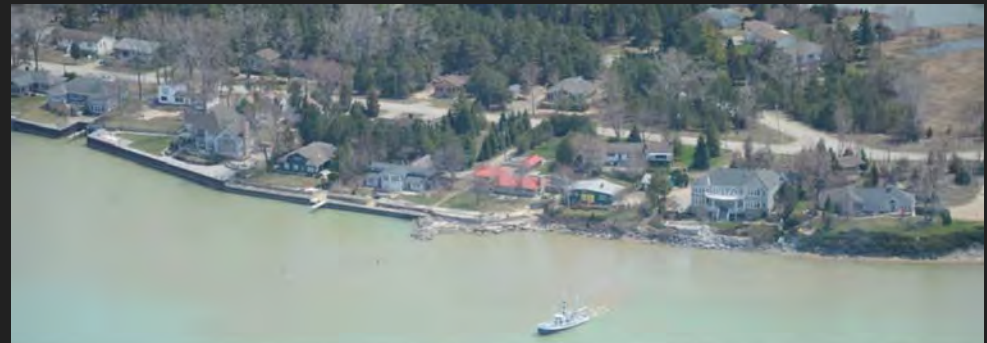
Downdrift Side (Right Hand Side) of River Mouth

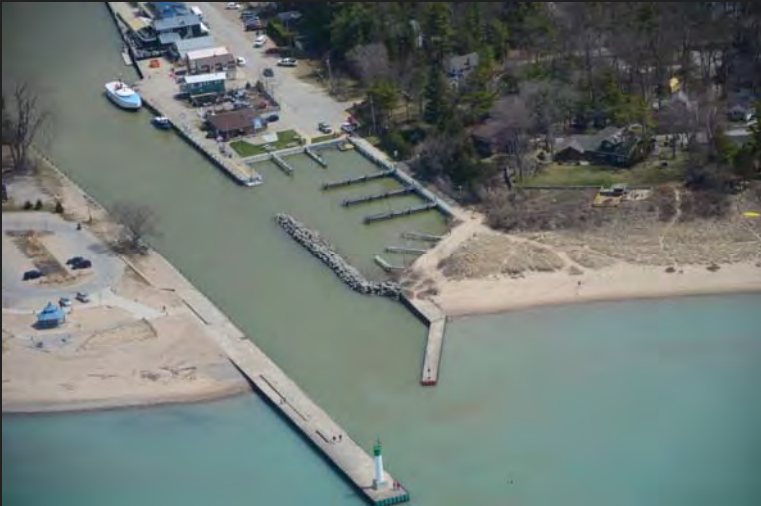
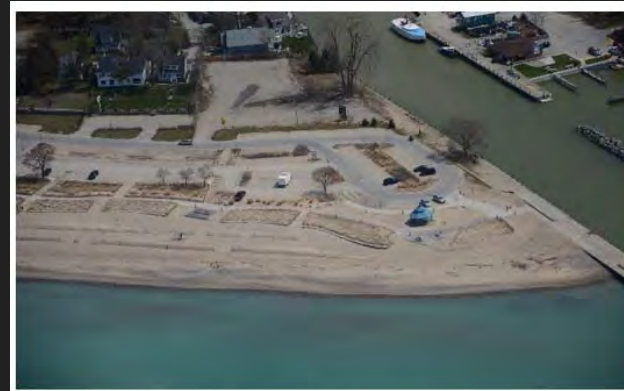
Recommendation: any dredged materials should be returned to the system on the downdrift/ shadow side of the creek or river mouth.

The downdrift/shadow side is on the right hand side of the river mouth.

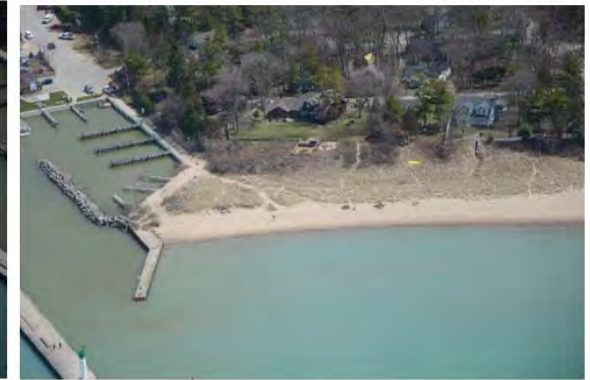
Downdrift Side of River Mouth

Recommendation: Any dredged materials should be returned to the system on the downdrift/ shadow side of the river mouth.

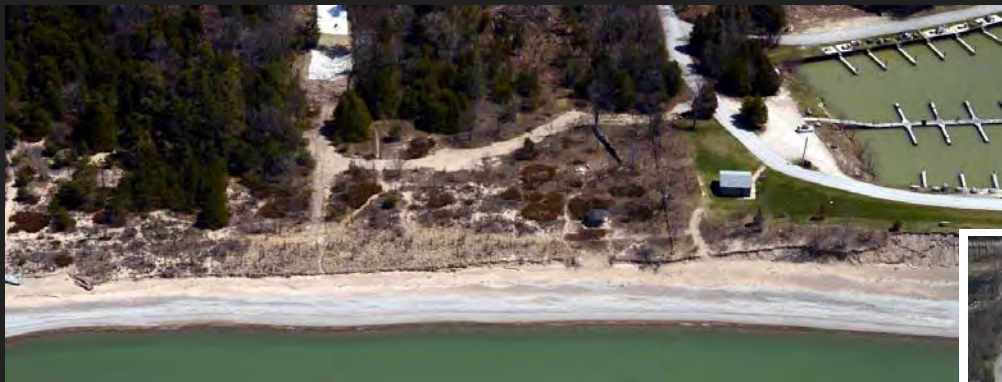
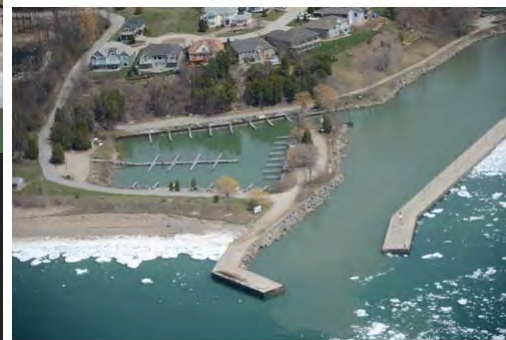
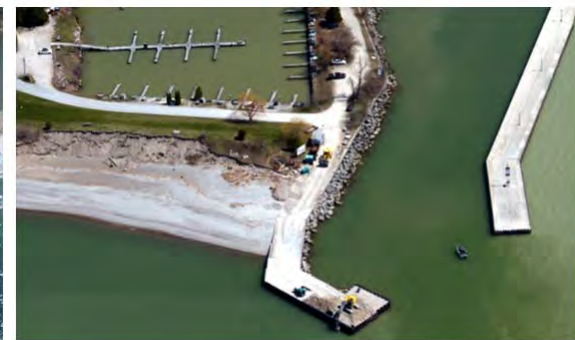
The beach is built up on the updrift- (Left hand side)side of the river mouth.

Left Hand Side is the Updrift side of River Mouth
