Ausable Bayfield Conservation Authority – Shoreline Management Plan Update

Steering Committee Meeting: July 2016

The ABCA Shoreline - Field Observations

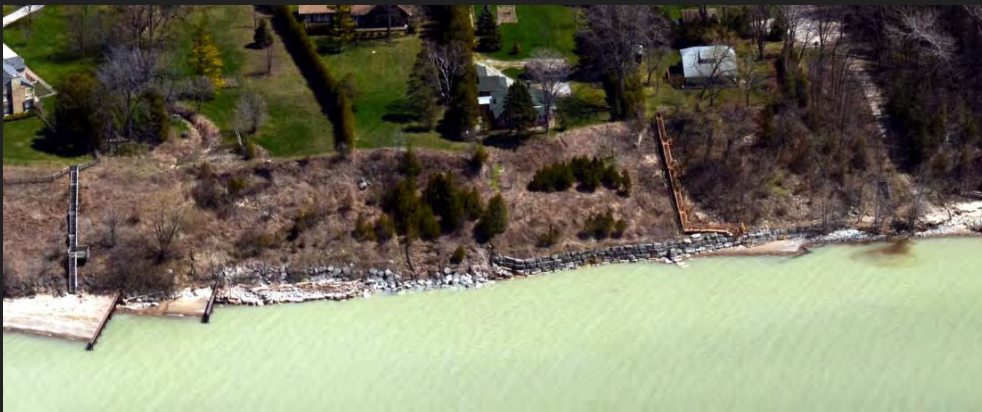
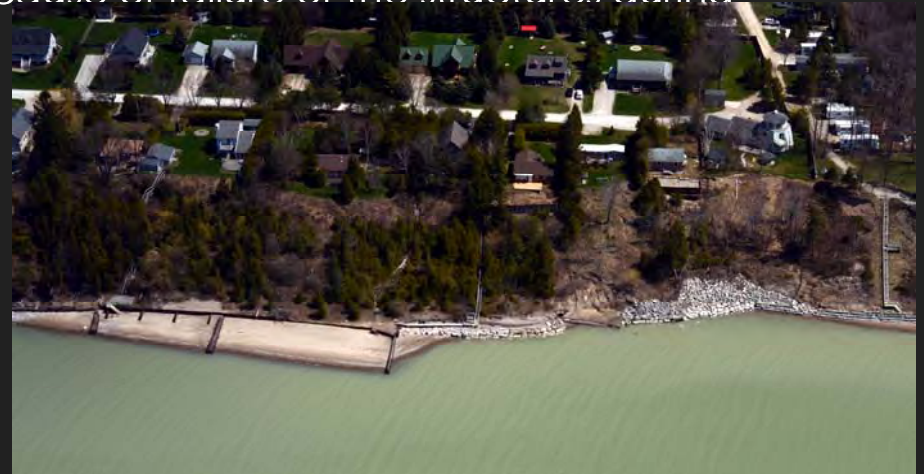
- Hard shore protection structures work best when they are designed by a coastal engineer for the particular coastal conditions, constructed of uniform materials, are continuous alongshore and properly tied in
- Private shore protection along the ABCA coast generally does not meet any of these criteria. They are often unsuited for the environmental conditions, are put in at different times, vary in materials and construction, are poorly tied in alongshore and to the base of the bluff, and thus their lifespan is shortened because of failure of the structures during storms and/or failure of adjacent protection.

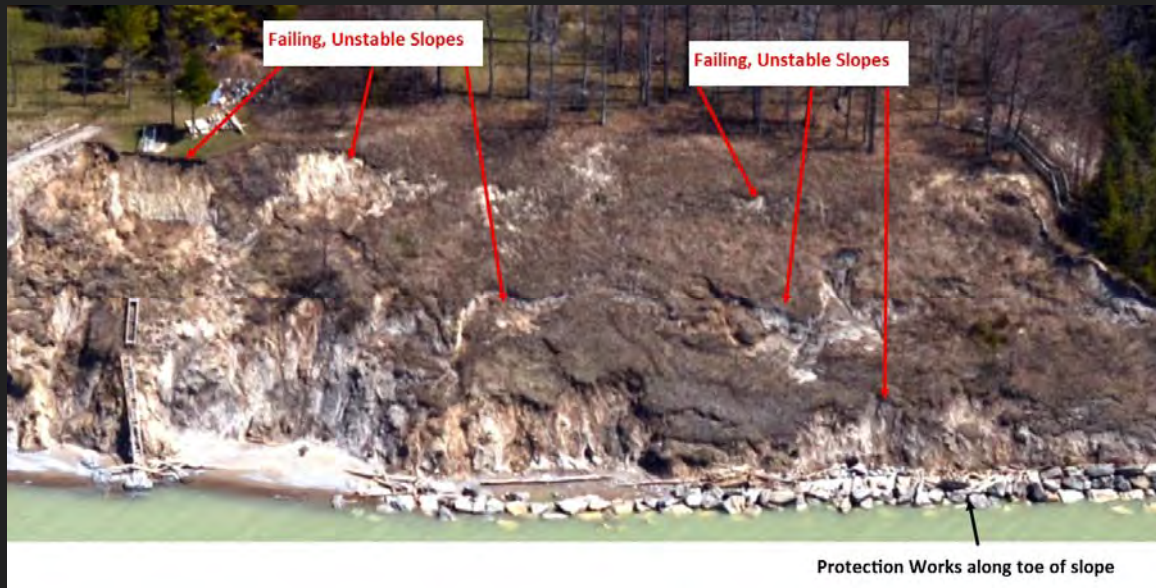
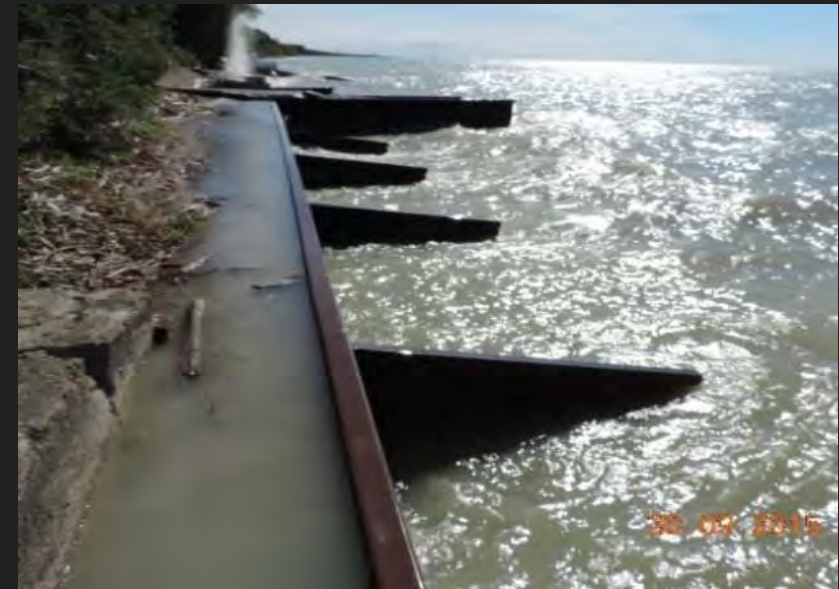
- Private shore protection is often poorly maintained between high lake level periods so is vulnerable when there is a sudden rise in lake level as occurred in 2015. In addition, it is often poorly designed to accommodate the downcutting in the nearshore that occurs during low lake levels and is subject to overtopping by waves

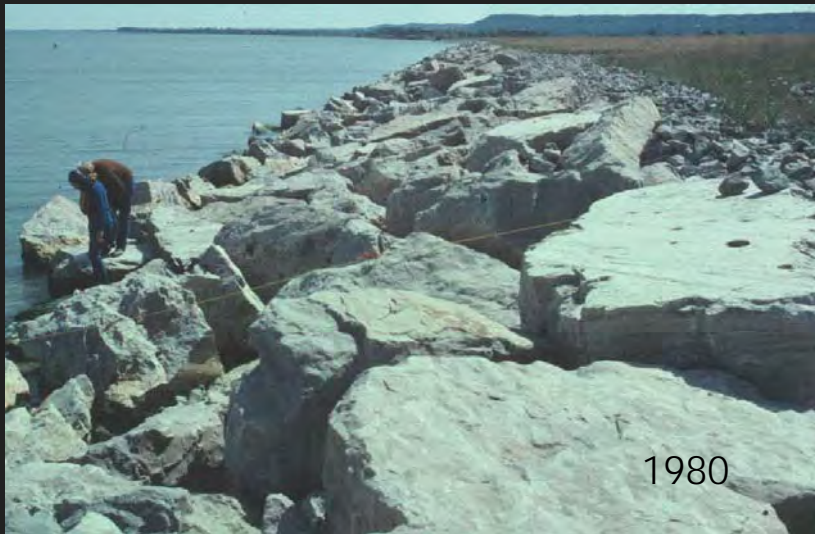
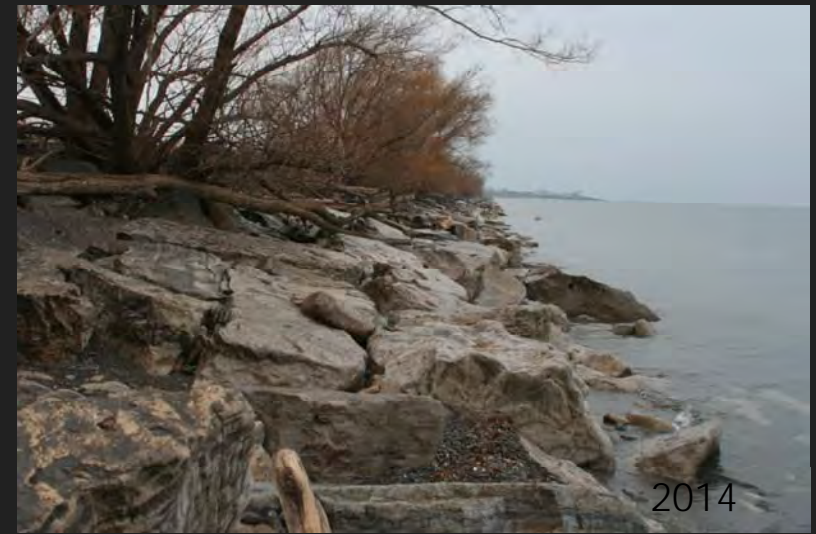
- Ongoing downcutting in the nearshore results in structures being subjected to greater wave attack and erosion of foundations over time. Vertical seawalls are particularly vulnerable to both overtopping and erosion of the foundation as a result
- Practice in the Great Lakes has shown that the most durable and effective structure is an armourstone revetment which has armourstone extending onto the nearshore profile
- These structures cost \$4-6 million dollars per kilometre to construct

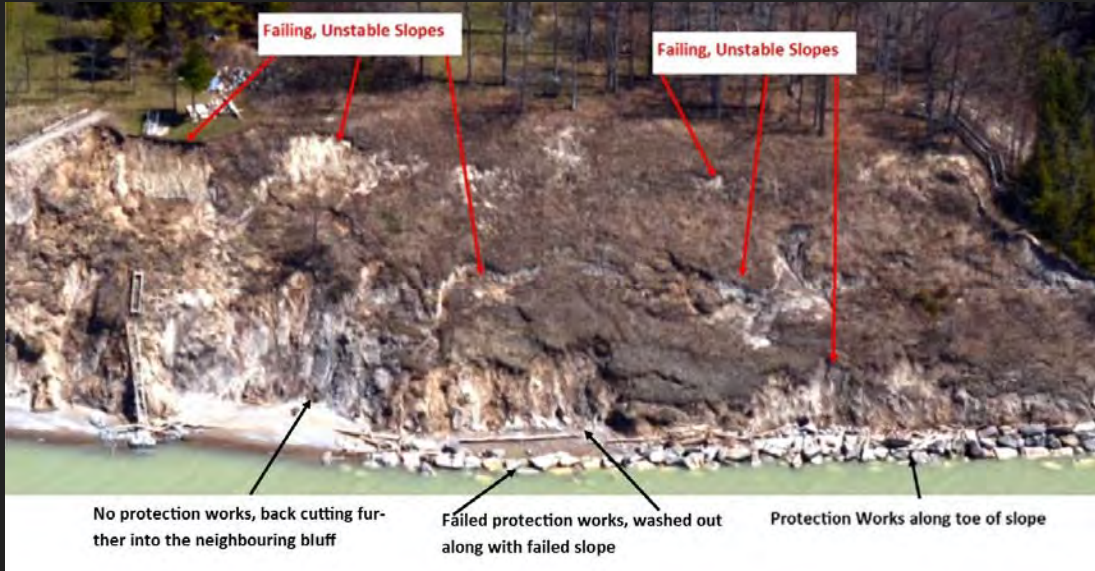
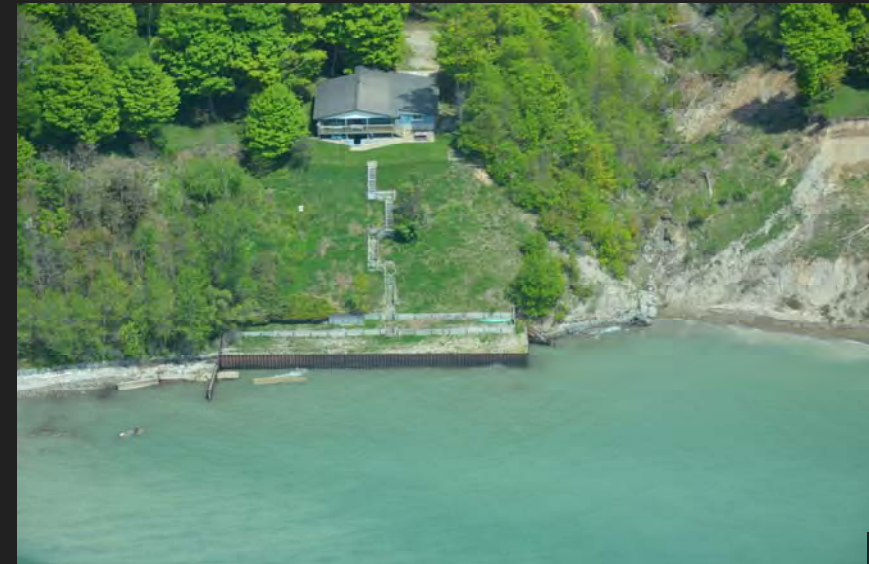
- The ABCA cannot require any property owner to put in shore protection or participate in a group seeking to do this. This makes it difficult to get the alongshore continuity necessary to enhance the design and durability of structures.
- The ABCA cannot enforce maintenance of existing structures which may be necessary to enhance their durability and the level of protection provided

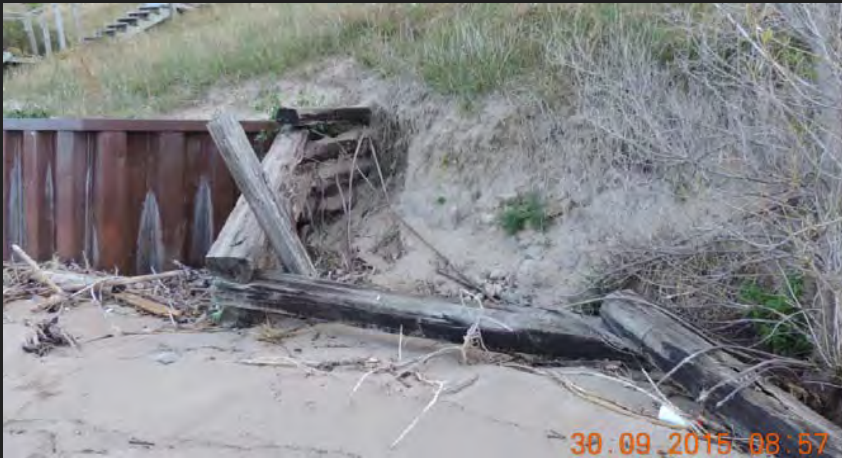
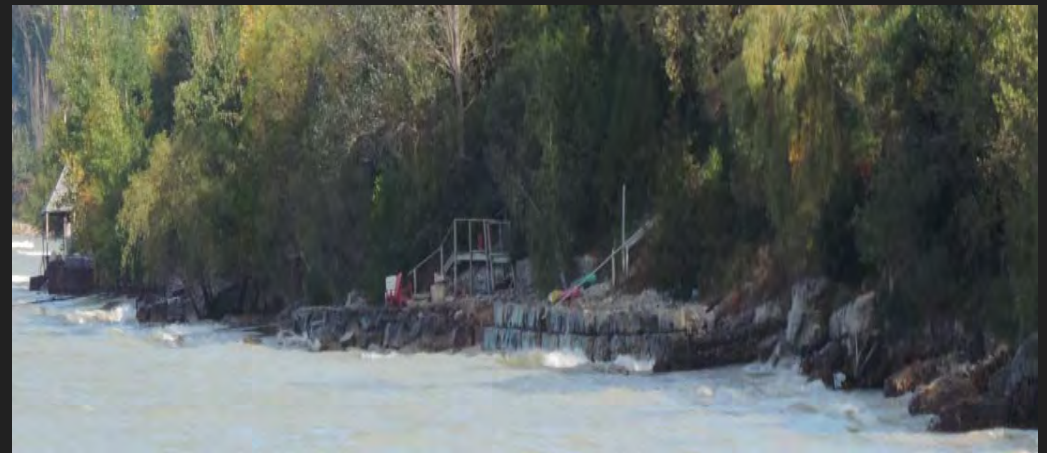
- The presence of structures can have two forms of impact on adjacent properties:
 1. Updrift structures can increase erosion on the adjacent downdrift property by refraction of waves around vertical structures whenever the structures are subject to wave attack. Both vertical structures and groynes can divert sediment away from the downdrift adjacent property thus reducing the protective beach cover;
 2. During periods of high lake level water may reach the base of vertical structure and reflection from the structure enhances the depth of water in front of the structure. As a result the amenity provided by the presence of a beach is affected since it is no longer possible to 'walk the beach'. Because of ongoing underwater erosion these period occur even during moderate to low lake level in some locations.

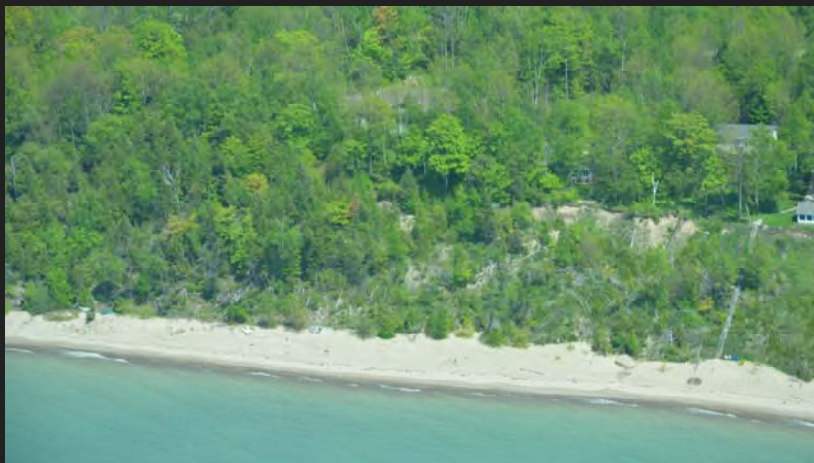
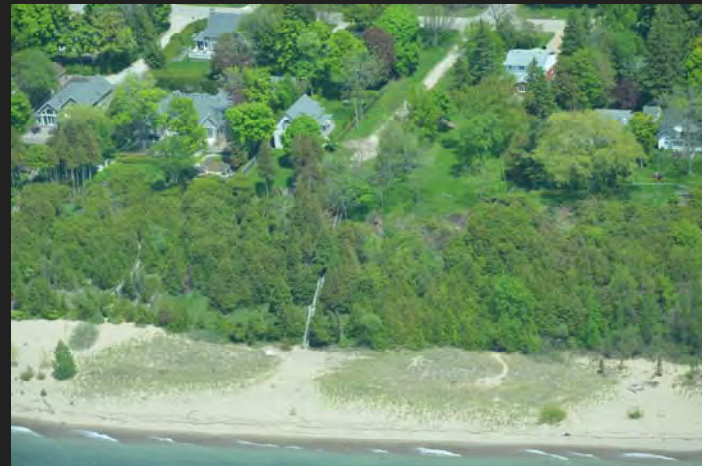
- If large stretches of the cohesive coast have shore protection this reduces the overall supply of sand and gravel to beaches downdrift. This may lead to a decrease in beach width and the thickness of sediment in the nearshore thus enhancing erosion of the bluff toe and downcutting of the nearshore in areas where sediment cover is responsible for relatively low recession
- It may also have the effect of reducing the size of the filet beaches at Bayfield and Grand Bend so that some areas that currently have no erosion may switch to being erosional
- It may also have an impact on the overall stability of the major Pinery sand dune coast.
