MEASURING BLUFF TOE RECESSION RATES: 1973 → 2007

ADAM BONNYCASTLE & ROBIN DAVIDSON-ARNOTT

ESTIMATING SHORELINE EROSION RATES, 1973→2007: METHODOLOGY NOTES

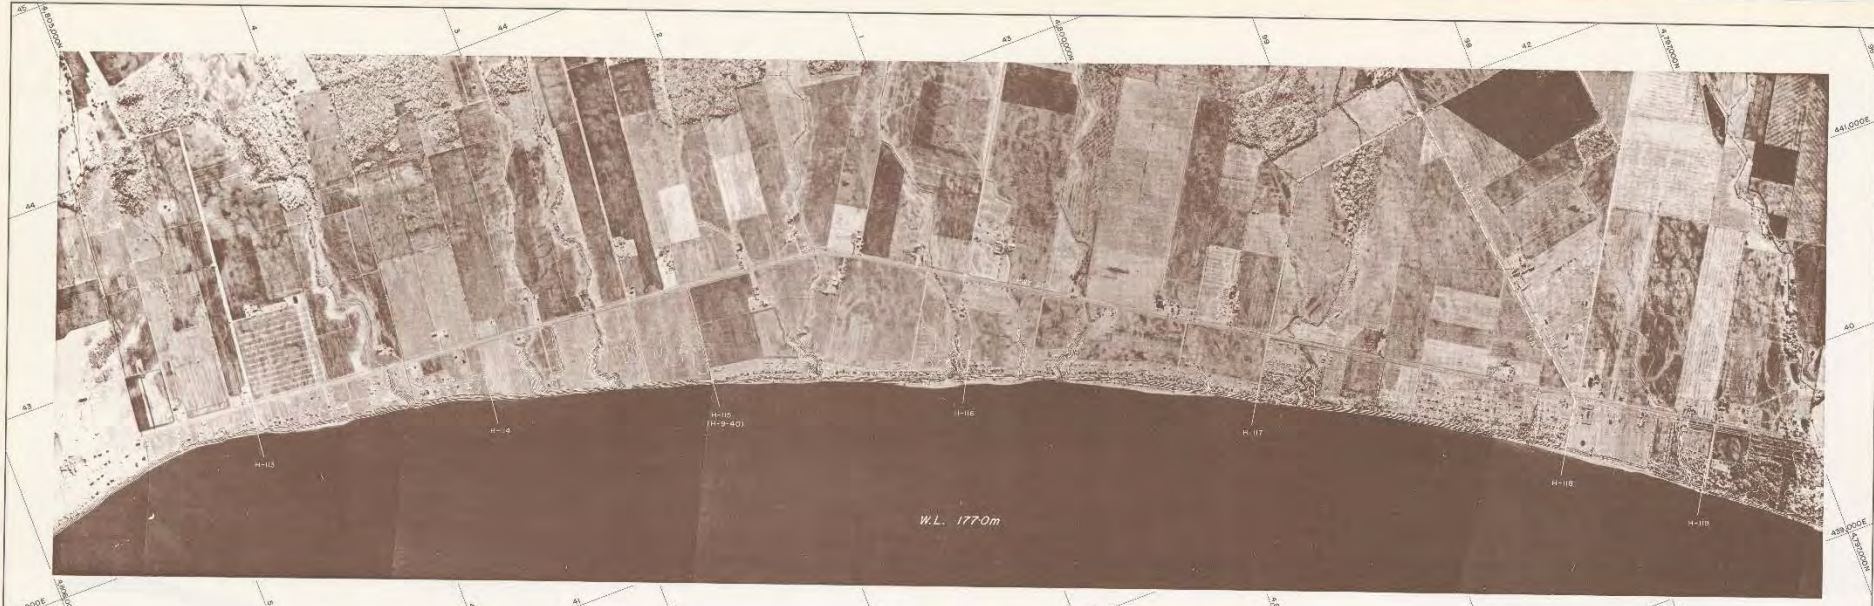
SHEET I-80 **LAKE HURON**

CANADA - ONTARIO
GREAT LAKES SHORE DAMAGE SURVEY - 1973
 COUNTY OF HURON

3 METRE CONTOUR ELEVATIONS AND WATER LEVELS REFERRED TO INTERNATIONAL GREAT LAKES DATUM (IGD85) LAKE ERIE 174.2M.
 WATER LEVEL SHOWN ON PHOTO-MOSAIC IS DAILY MEAN VALUE AT DATE OF AERIAL PHOTOGRAPHY - JUNE 03 1973.
 1000 METRE GRID SHOWN ON A UTM UNIVERSAL TRANSVERSE MERCATOR PROJECTION ZONE 17.

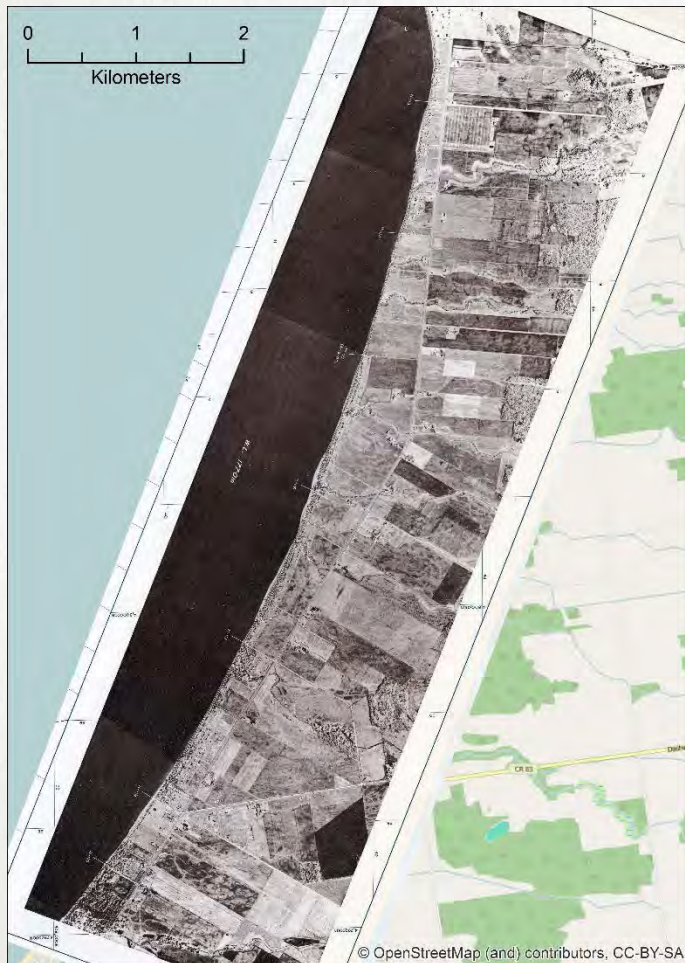
1. Scan Erosion Survey pages @ 600 dpi
2. Crop to image and to map (Photoshop)
3. **Register image (ArcGIS, 1st order polynomial):**
 1. Easting/Northings, then
 2. **ABCA roads & imagery**
4. Register map to image (ArcGIS, 1st order polynomial)
5. Digitize Toe of Bluff from map (ArcGIS)

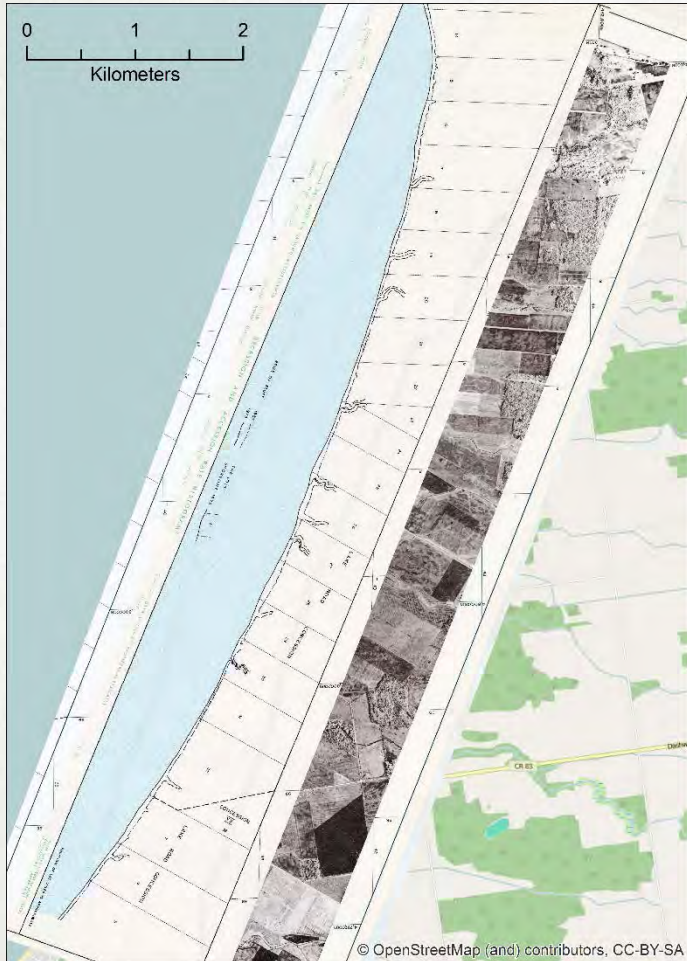
1. Scan Erosion Survey pages @ 600 dpi
2. Crop to image and to map (Photoshop)
3. Register image (ArcGIS, 1st order polynomial):
 1. Easting/Northings, then
 2. ABCA roads & imagery
4. **Register map to image (ArcGIS, 1st order polynomial)**
5. Digitize Toe of Bluff from map (ArcGIS)

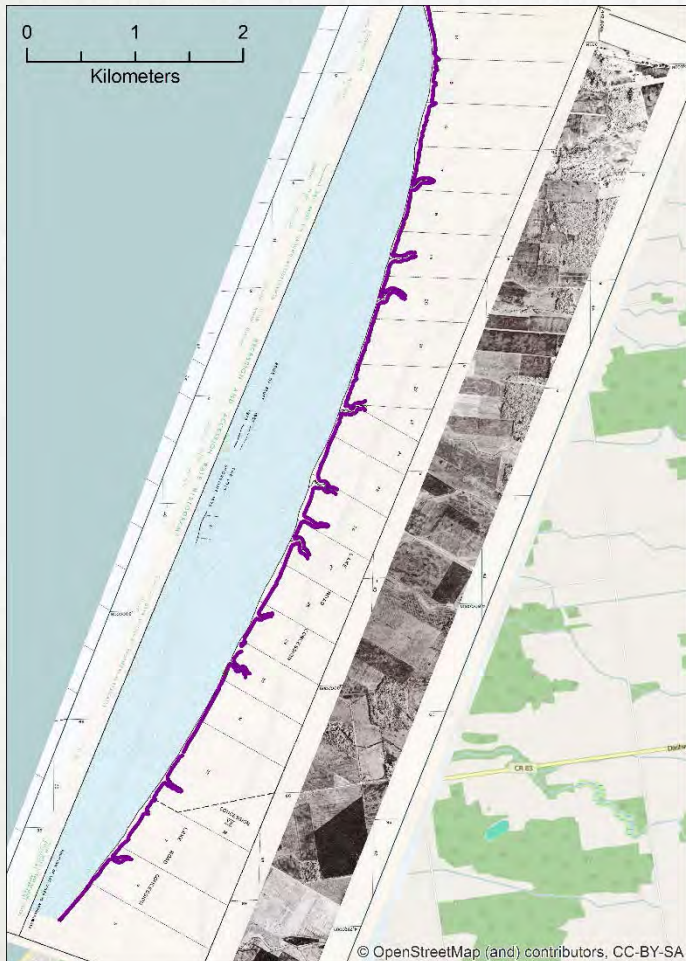
1. Scan Erosion Survey pages @ 600 dpi
2. Crop to image and to map (Photoshop)
3. Register image (ArcGIS, 1st order polynomial):
 1. Easting/Northings, then
 2. ABCA roads & imagery
4. Register map to image (ArcGIS, 1st order polynomial)
5. **Digitize Toe of Bluff from map (ArcGIS)**

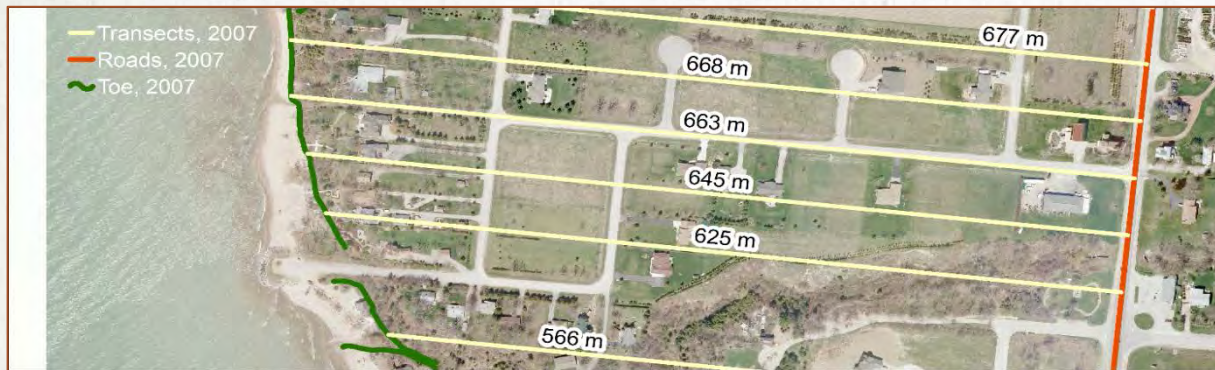
2007 map and Hwy 21 centreline with transects at 50 m intervals showing distance to 2007 toe of bluff

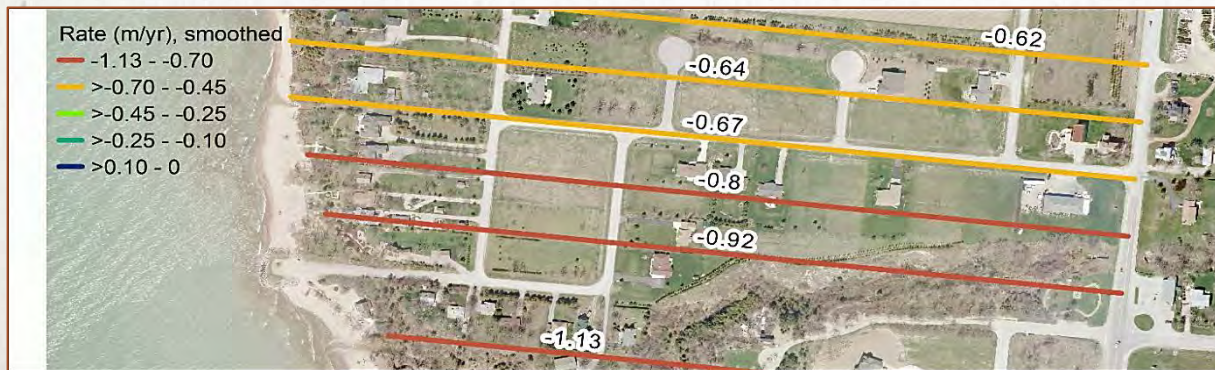
2007 map with transects at 50 m intervals showing final smoothed average annual change rate.

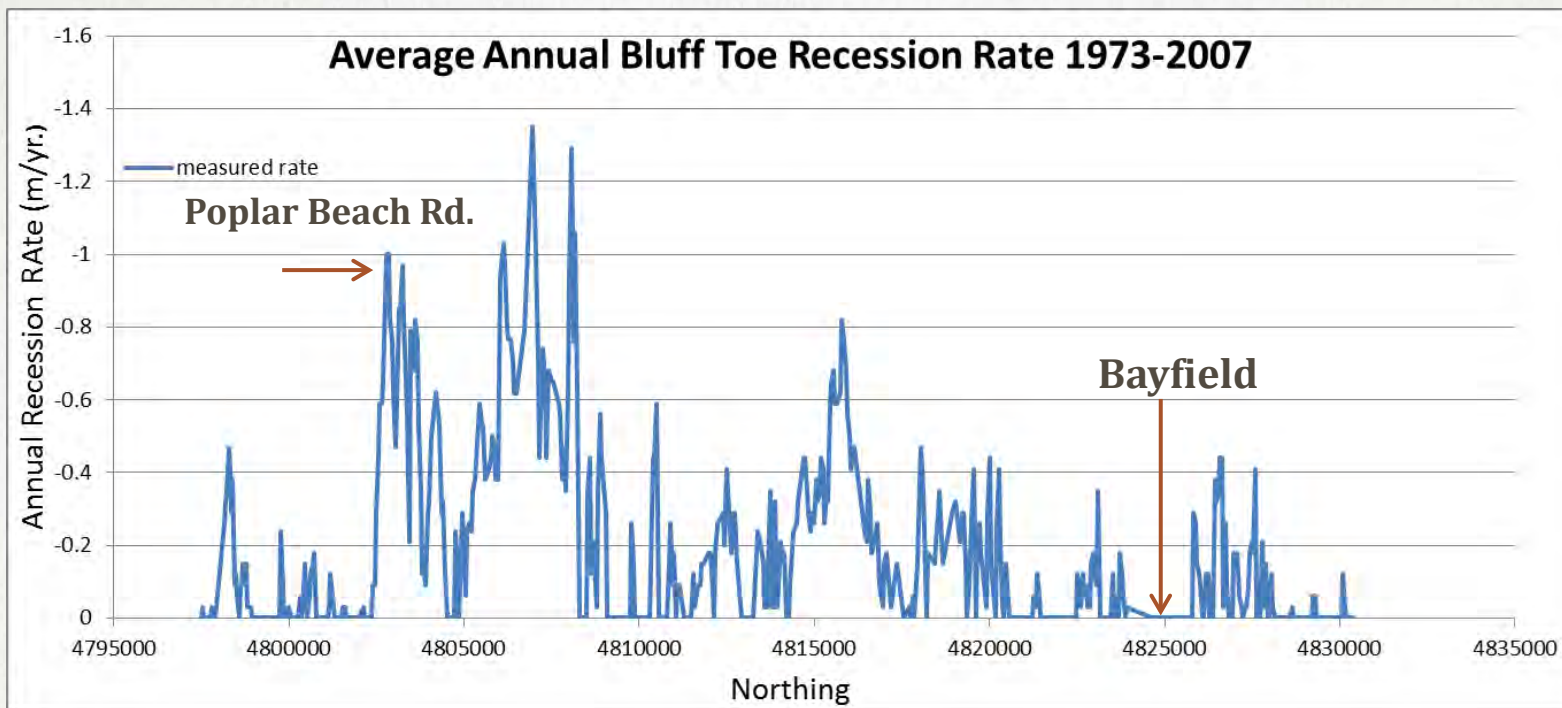
Measured average annual bluff toe recession rates. All positive values (accretion) are set to 0.

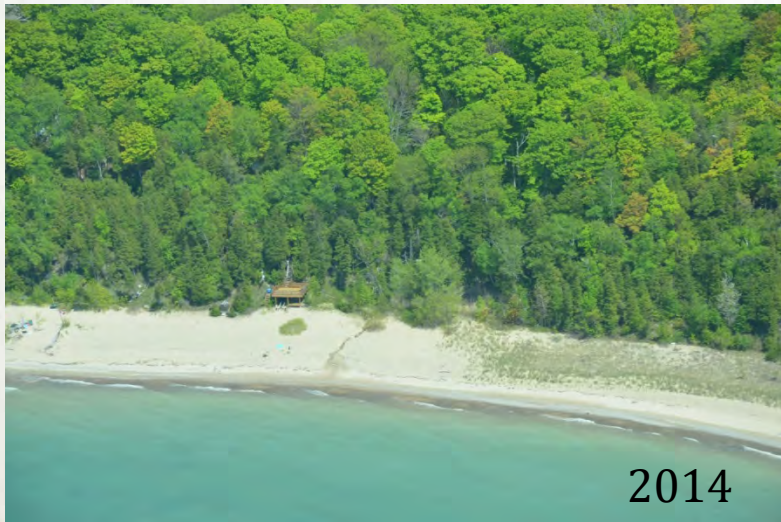
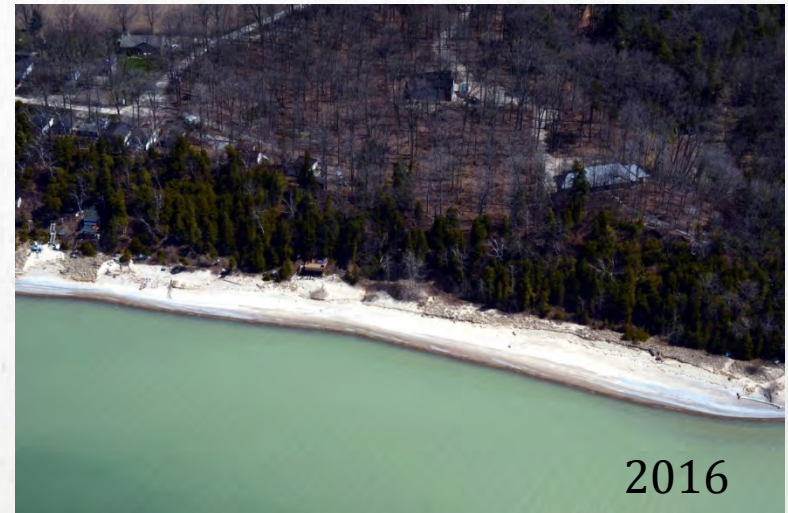
LOW RECESSION RATE

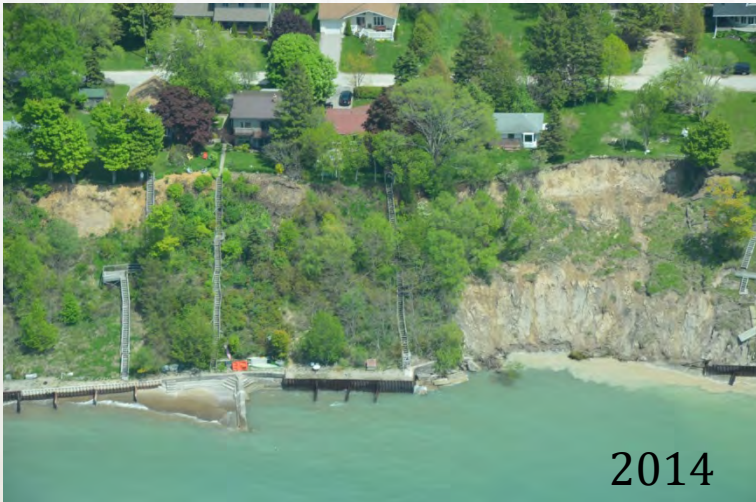
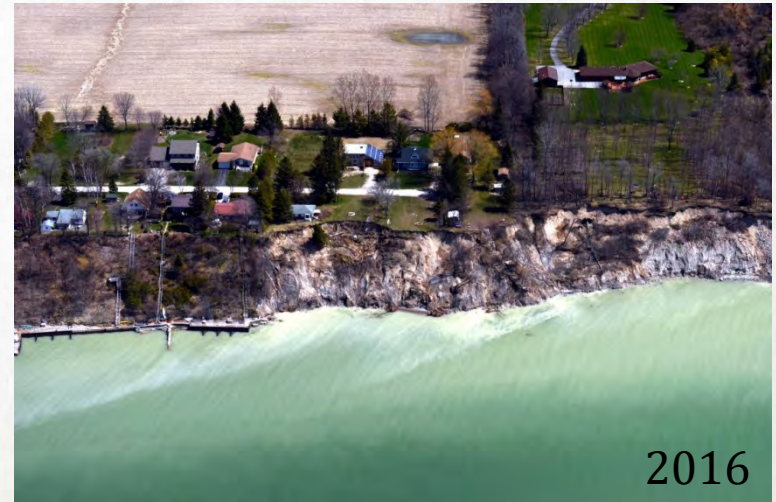
MEDIUM RECESSION RATE

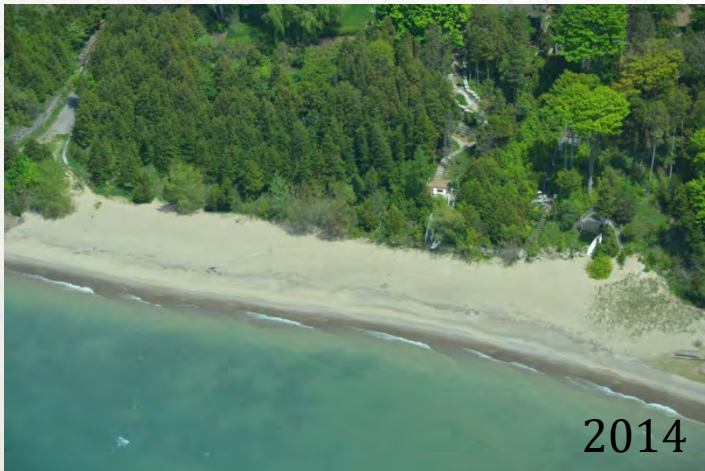
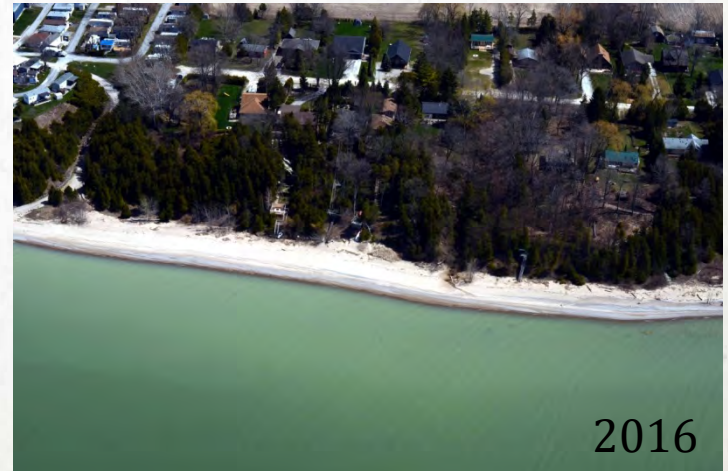
LOW RECESSION RATE

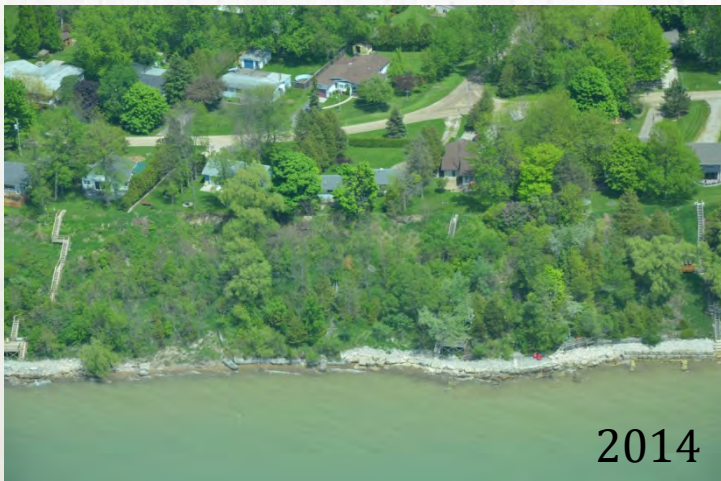
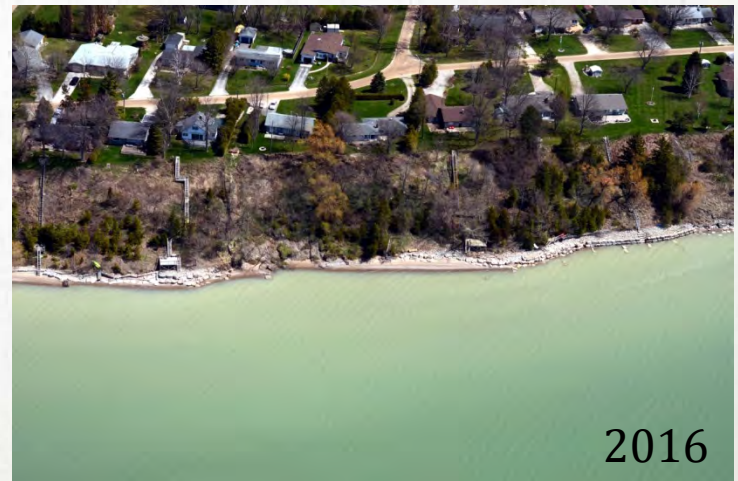
MEDIUM TO HIGH RECESSION RATE

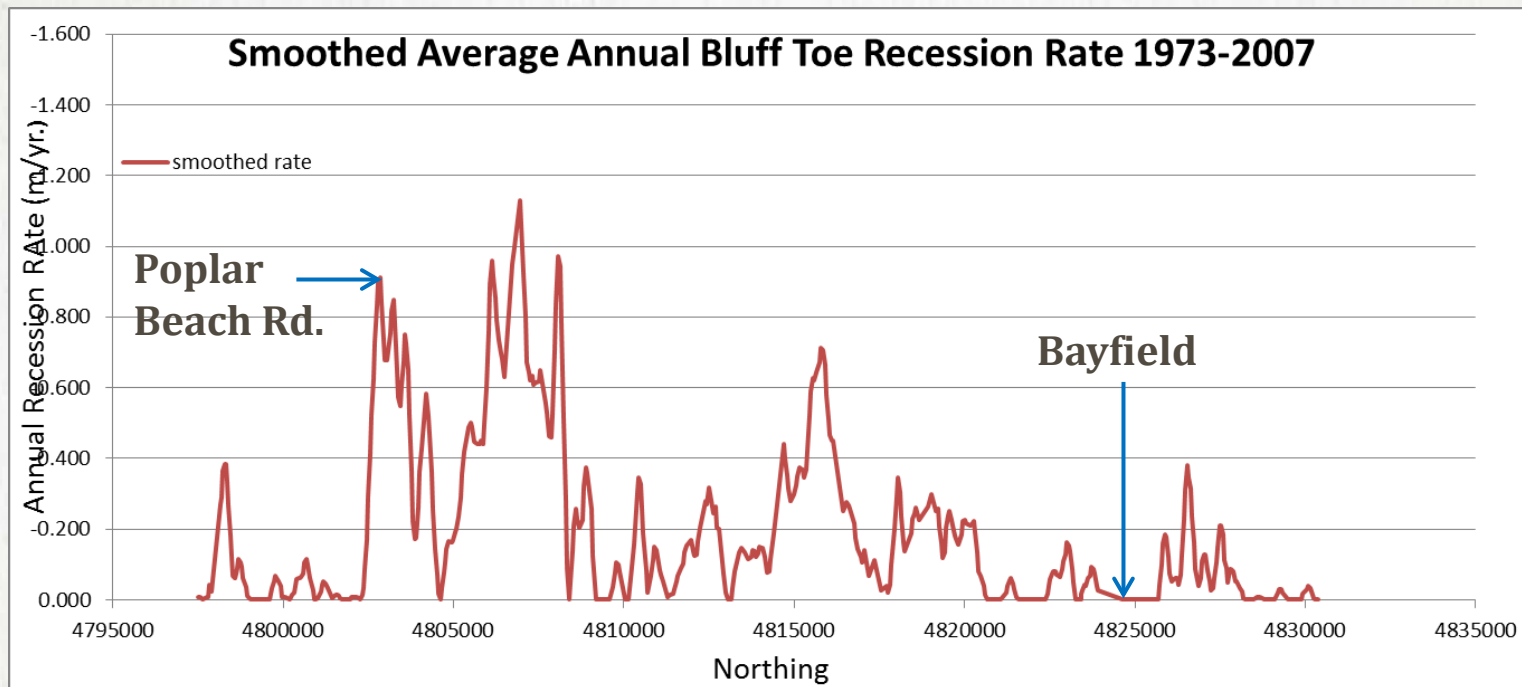
Smoothed average annual bluff toe recession rates. Value for each point is a weighted average of that point and two points on either side
