Shoreline Management Plan Update 2018

Open House – Zurich

August 18, 2018

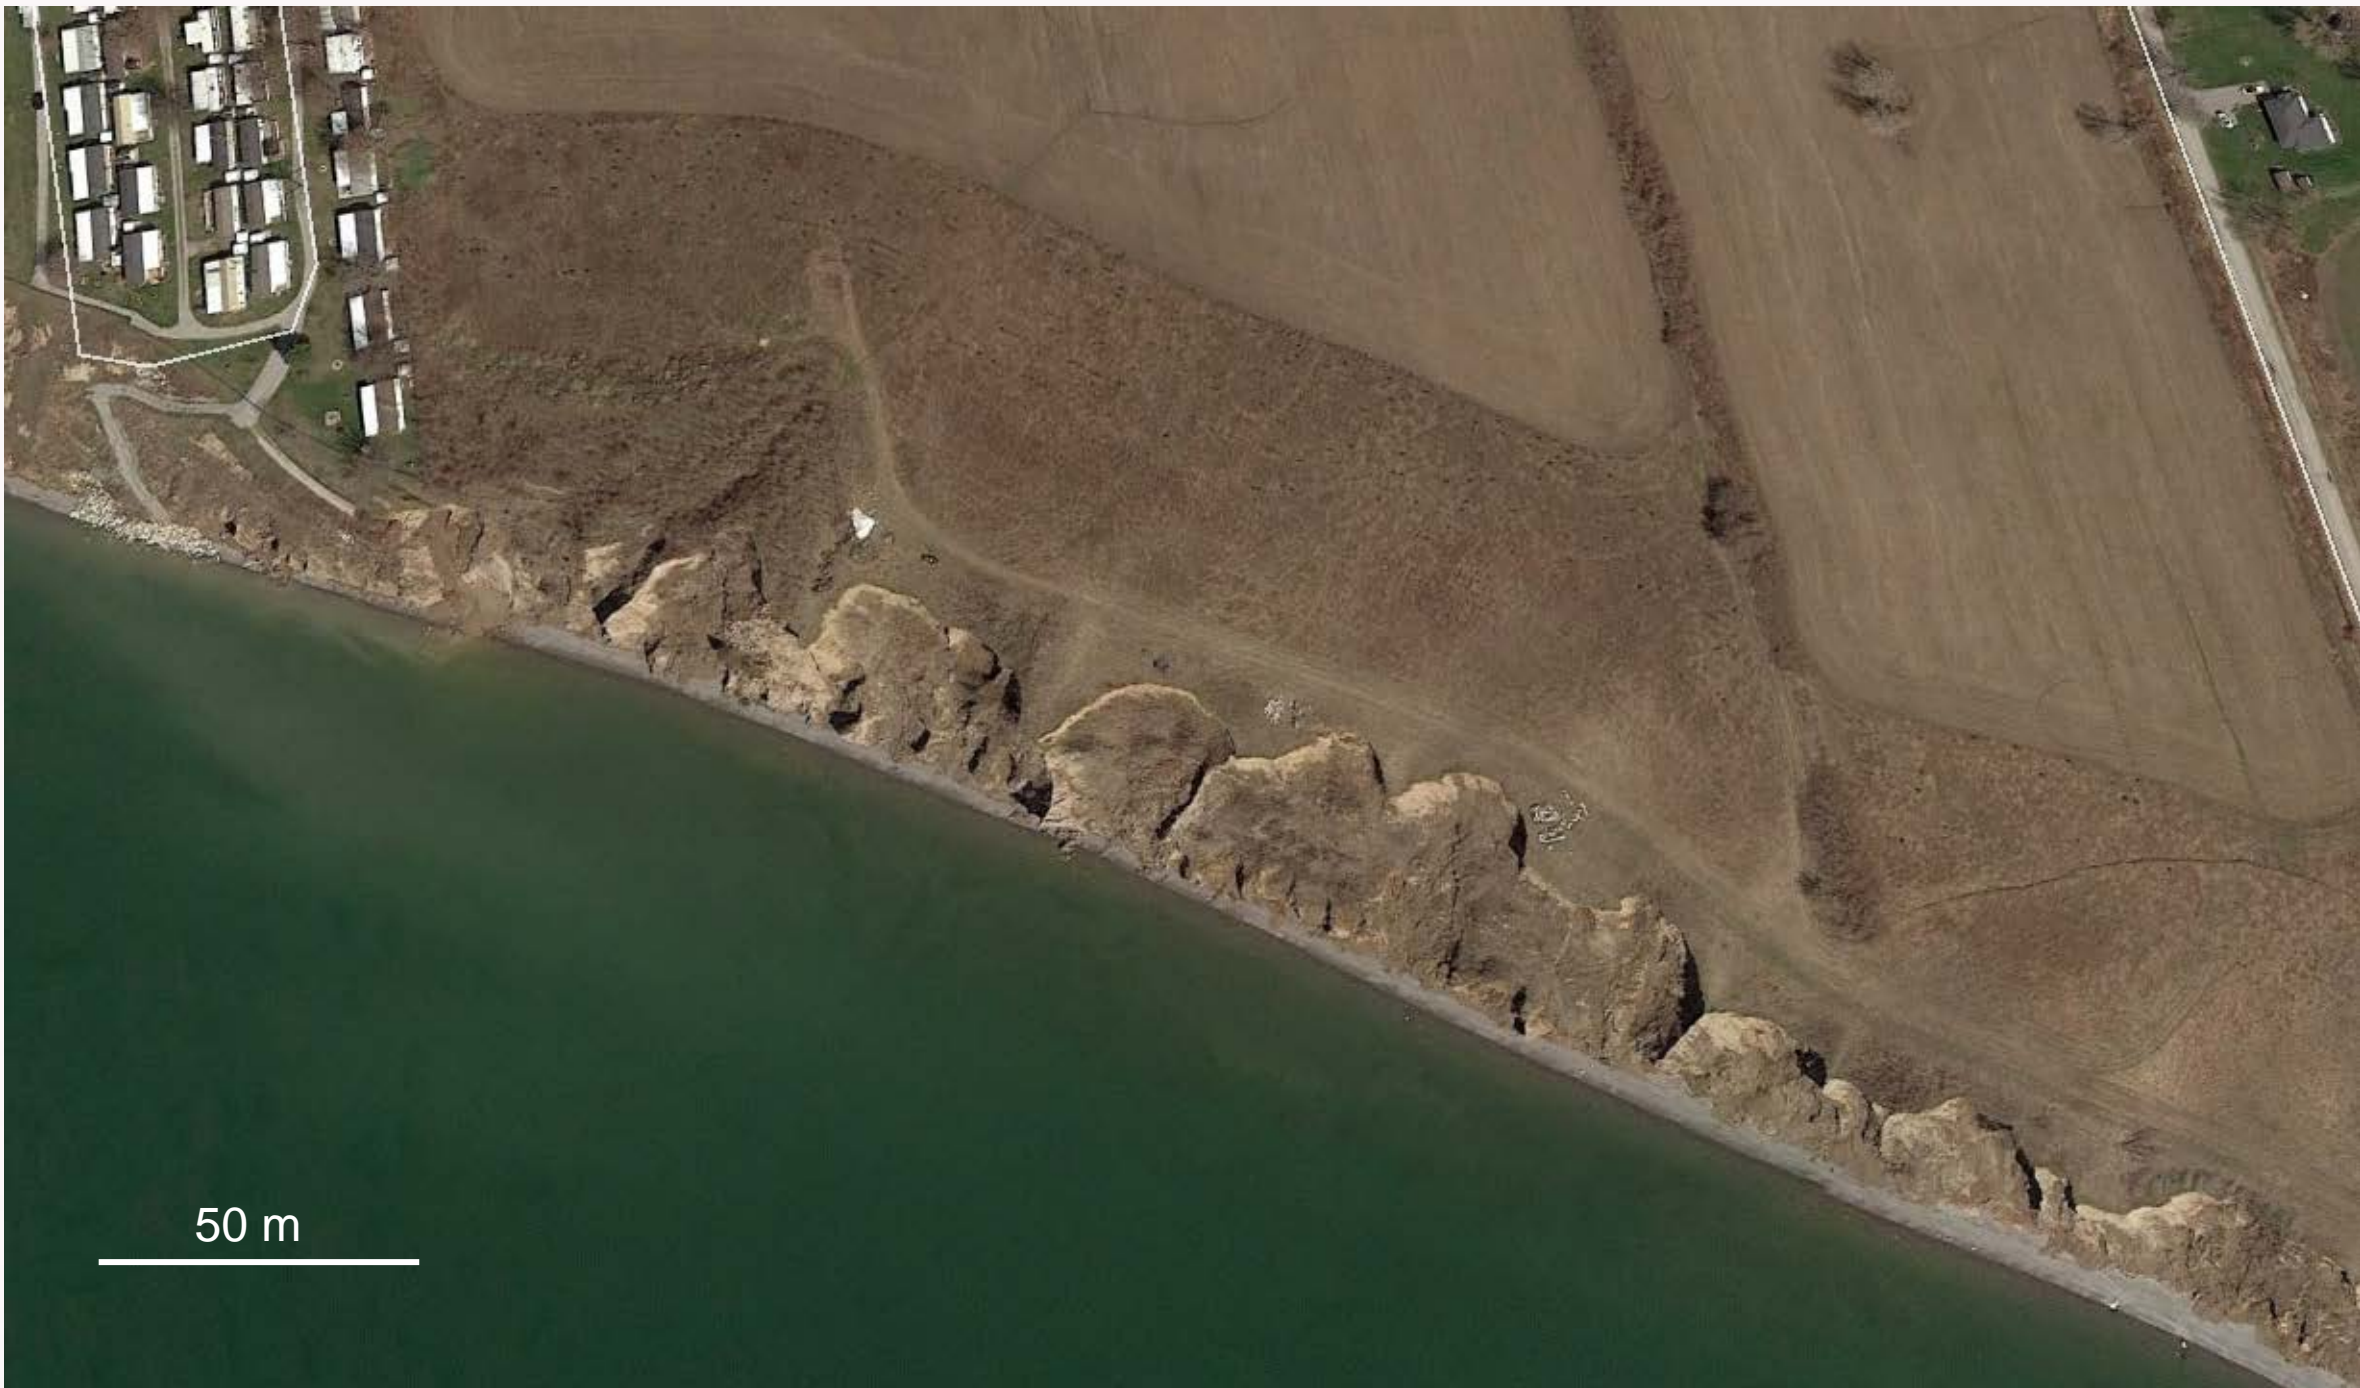
Regional erosion rates are considered. It is not acceptable to measure the rate at an individual property in isolation. The bluff retreats at a consistent rate, though failures may occur at different times.

50 m
