# **Ausable Bayfield Conservation Authority**

## Considerations for Shoreline Protection Structures

December 7 2017 | 12646.101

W.F. Baird & Associates Coastal Engineers Ltd.

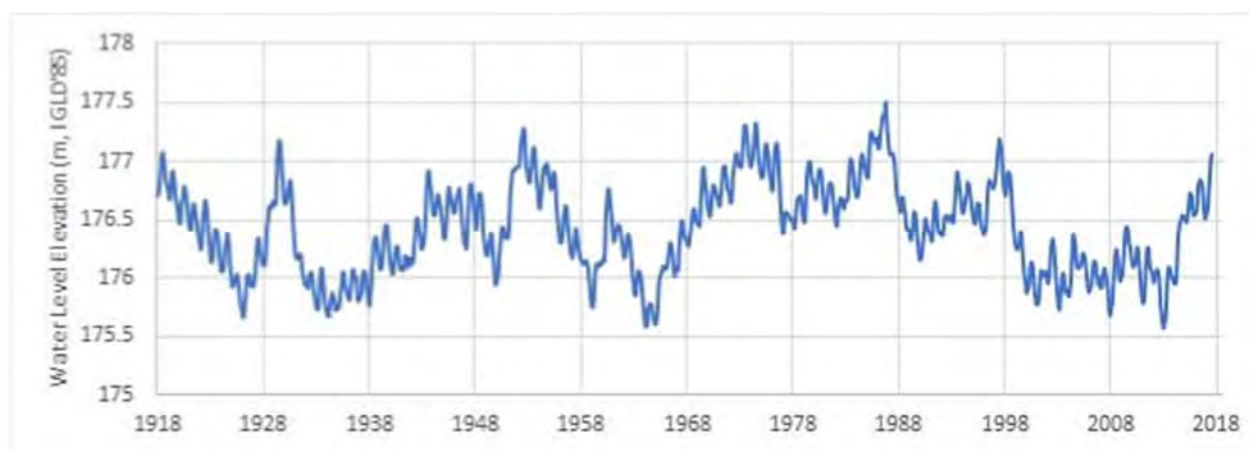
**Figure 3.1: Lake Huron monthly mean lake levels (1918 to 2017)**

Monthly mean lake levels for the period 1918 to 2017 are shown in Figure 3.1. The most recent period of high lake levels was 1985-86, and the highest monthly mean water level is 177.50 m International Great Lakes Datum (IGLD) 1985, in October 1986. Water levels in this report are referenced to IGLD 1985. Chart Datum is 176.0 m IGLD 1985. The lowest monthly mean water level was 175.58 m IGLD 1985, recorded in March 1964, giving a maximum range of close to 2 m. There was a sustained period of low water levels from 2000 to 2012, however the lowest monthly mean was marginally higher than the lowest value recorded in 1964. Studies have shown a lowering of water levels on Lake Huron in response to dredging in the St. Clair River in the late 1800's and during periods in the 1900's, see for example Baird (2005). The International Joint Commission (2009) concluded that lowering water levels due to increased conveyance in the St. Clair River is not ongoing and that climate is the main driver of lake level.

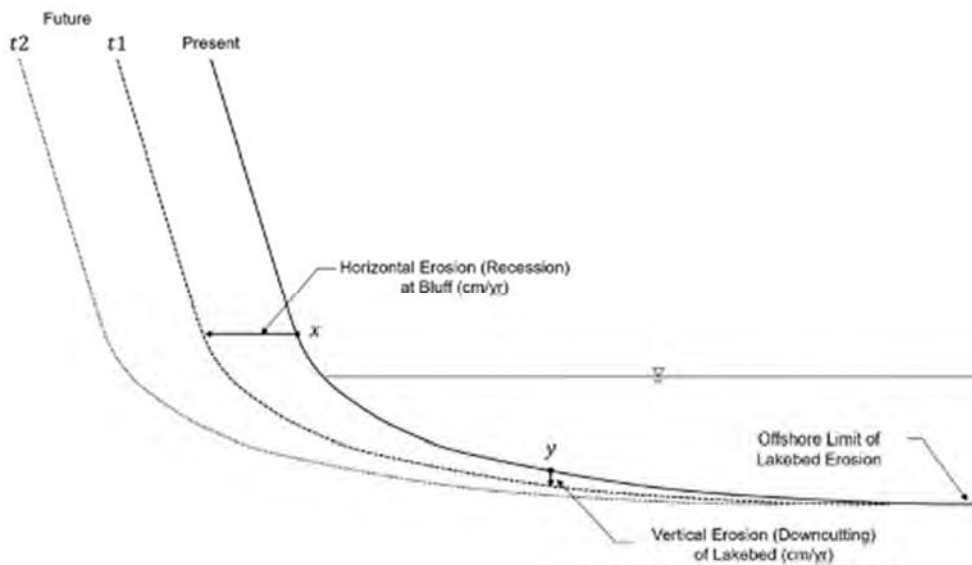
**Figure 3.3: Schematic diagram of nearshore profile erosion**

The topic of lakebed erosion has been the subject of several studies at different locations around the Great Lakes by various organizations. These include Edil and Vallejo (1980), Carter and Guy (1988), Nairn and Baird (1992), Brown et al. (2005), Davidson-Arnott (1986, 2010, 2016), and Baird (1994, 2015). Many of these studies indicate that the horizontal recession of the shoreline is directly related to, and controlled by, the vertical erosion or downcutting of the nearshore lakebed. The shoreline in the ABCA region is characterized by cohesive bluffs (soft, erodible cliffs), with observed horizontal (landward) recession rates in the order of 0.2 m/yr to 1.0 m/yr (Davidson-Arnott, 2016). The horizontal and vertical erosion are related through the nearshore profile, which shifts landward but remains in dynamic equilibrium over the long term. This process is illustrated in Figure 3.3.

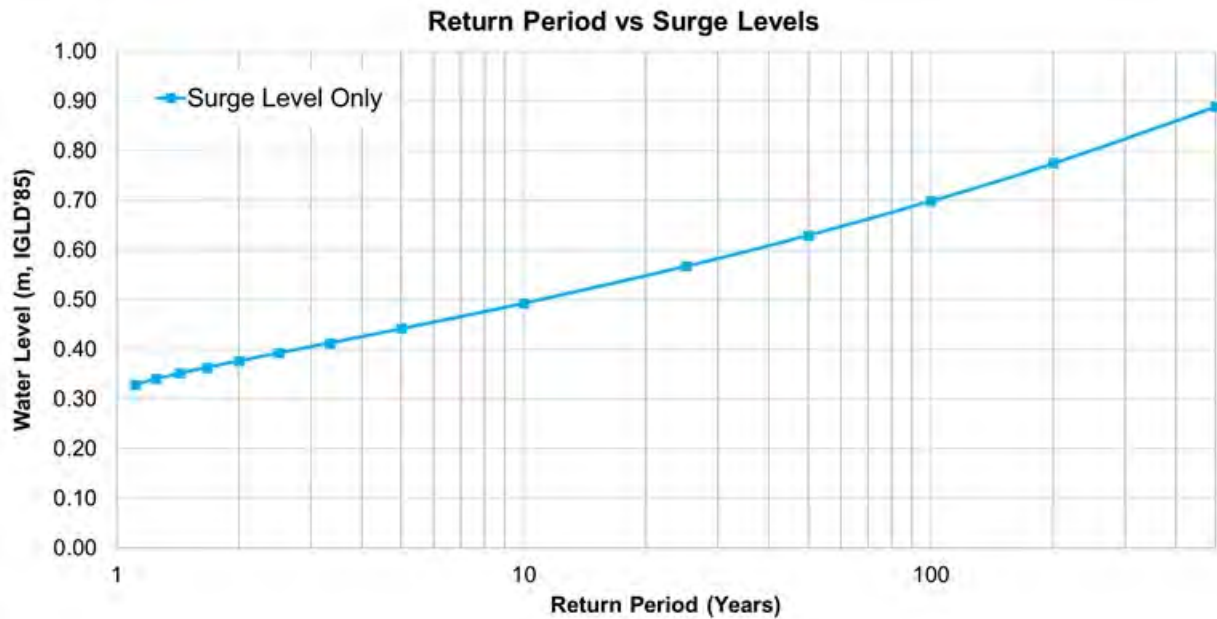
Figure B.2: Probability distributions of surge at Goderich
