Ausable Bayfield

SURFACE WATER QUALITY

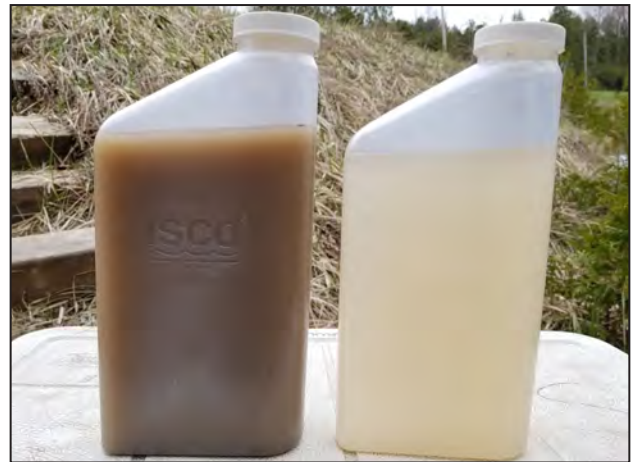
High sediment levels (bottle at left) can be associated with elevated phosphorus concentrations.
