Ausable Bayfield Watershed Report Card 2023

This report is about the state of your forests, wetlands, and water resources.

Watt, C., H. Brock, E. Balfour, and M. Veliz. 2023. Ausable Bayfield Watershed Report Card 2023. Ausable Bayfield Conservation Authority. Exeter, Ontario. 103 pp.

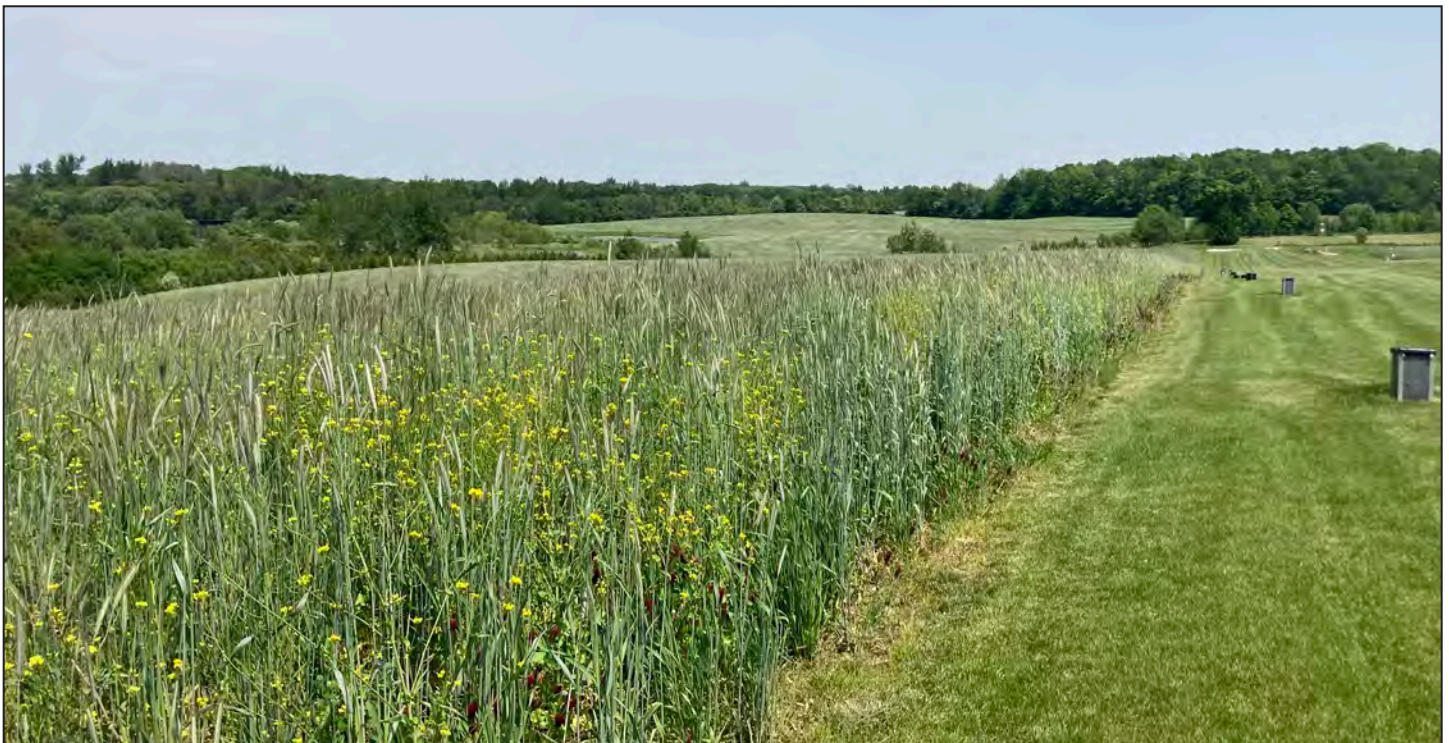
An overwintered, eight-species cover crop grown at the Huronview Demonstration Farm, near Clinton, helped to protect the gently sloping fields, adjacent to the Bayfield River, from erosion. It also contributed nutrients to the soil, which helped grow the soybeans that were planted into it in the spring.

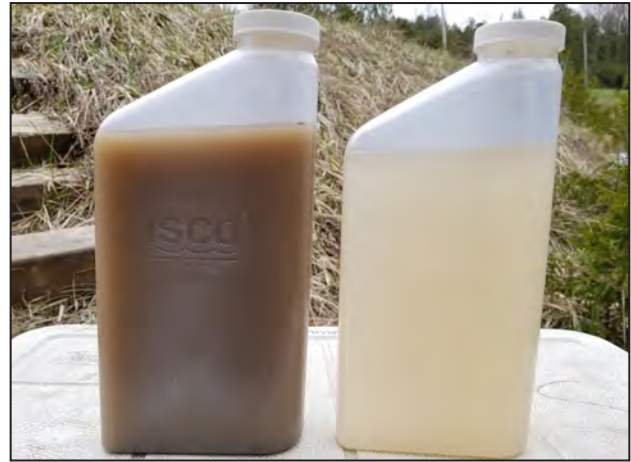
High sediment levels (bottle at left) can be associated with elevated phosphorus concentrations.

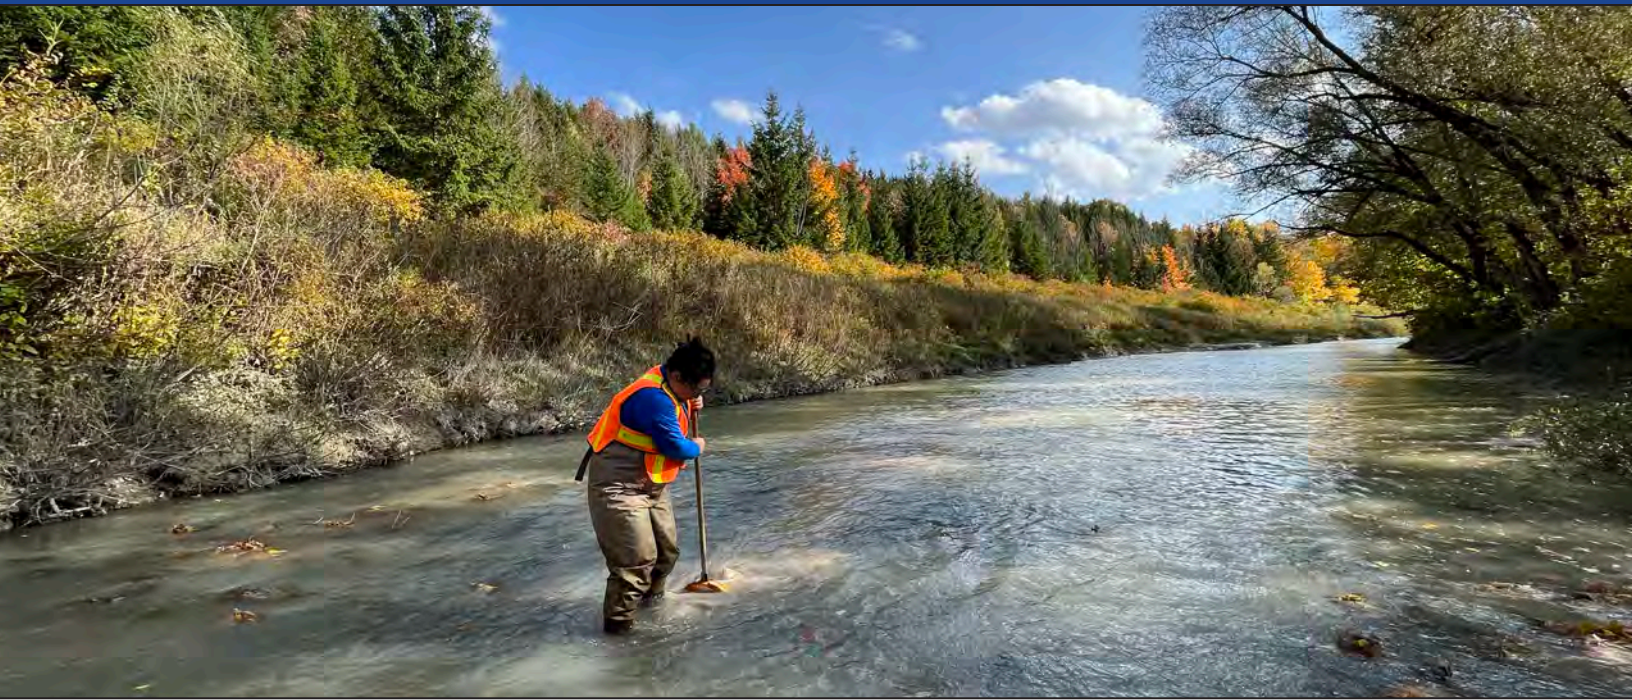
Ausable Bayfield Conservation Authority staff kick up sediment on the bottom of a river to collect benthic invertebrates in a net, which are then identified to determine water quality.

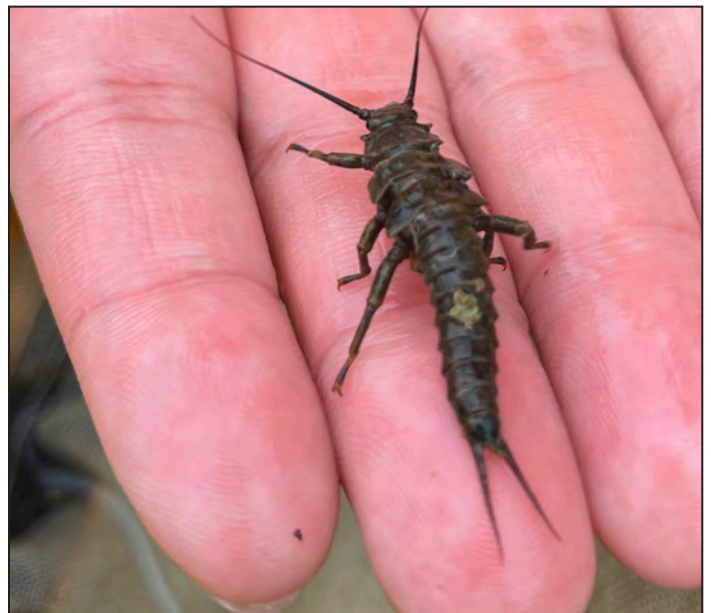
A stonefly is an example of a benthic macroinvertebrate that indicates good water quality.

Each species that makes up a benthic community will have a different tolerance to the variety of stressors and pollutants that may be present in the local environment. Tolerance values between zero and 10 can be assigned to these animals, with zero meaning intolerant to pollution and 10 meaning tolerant. The presence of pollution-intolerant species generally indicates a healthy aquatic environment.
