# Bayfield Beach Stormwater Monitoring 2018

Prepared for the Bluewater Beach Committee

Ausable Bayfield Conservation Authority (ABCA)

February 2019

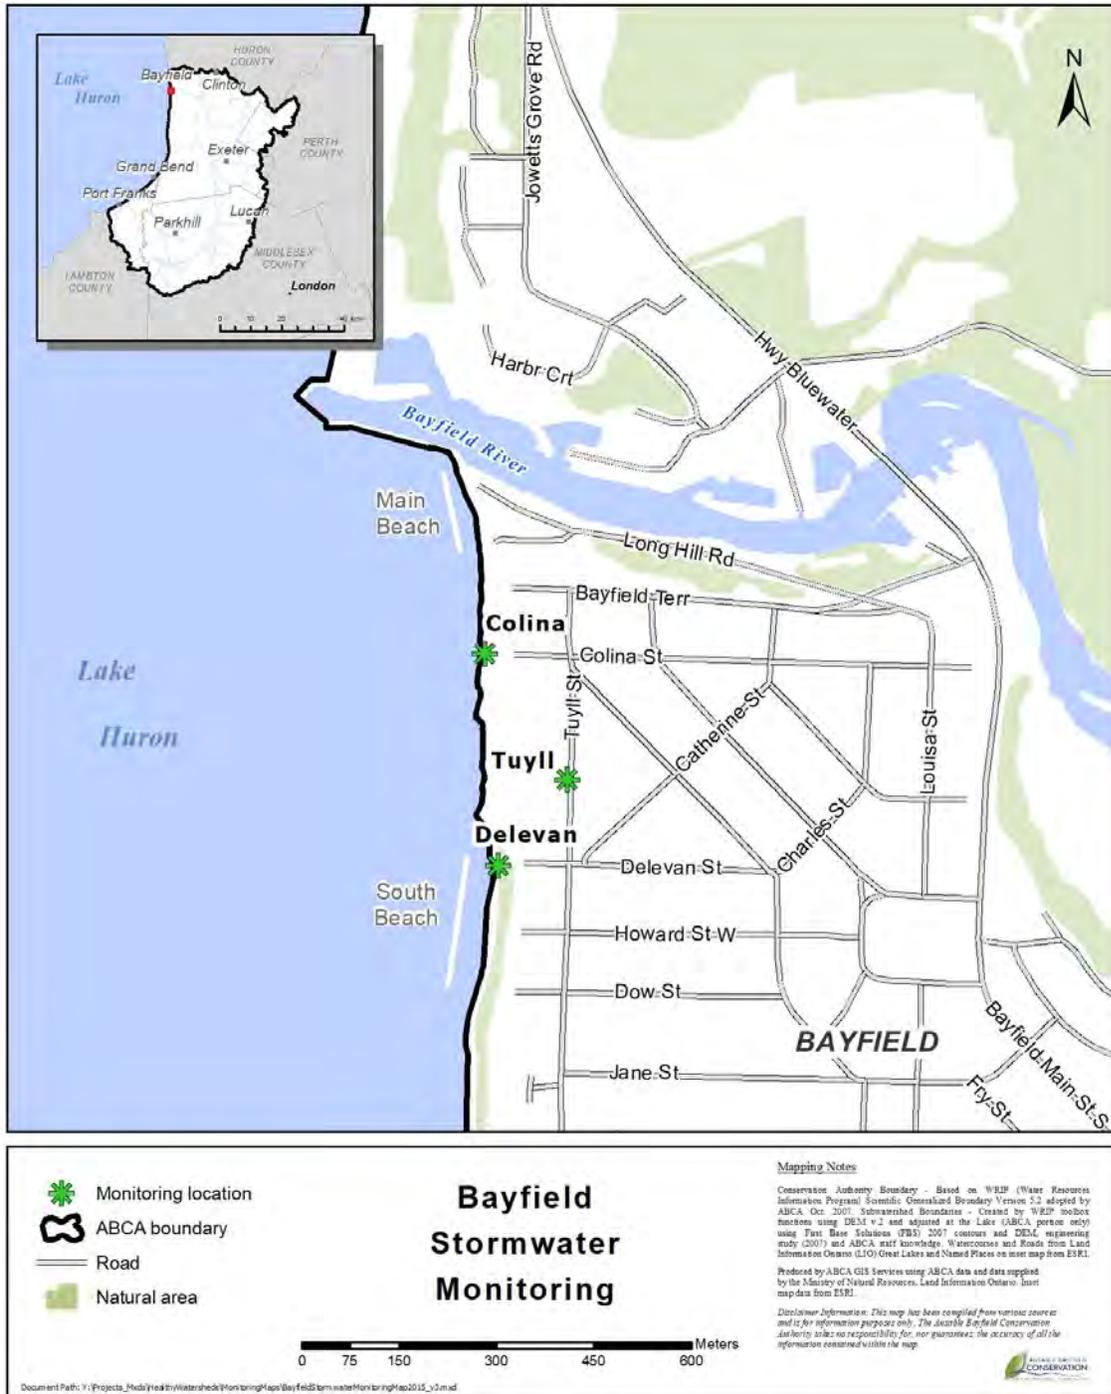
**Figure 1.** Approximate locations of three stormwater monitoring sites and public beaches along the Lake Huron shoreline in Bayfield, Ontario.

Water quality was monitored at two stormwater outfalls along the beach adjacent to the village of Bayfield, Ontario, and at one culvert along the road (Tuyll Street) adjacent to the shoreline (Figure 1). A new outlet for the Colina outfall (150 mm) was completed as part of the rain garden installation at Pioneer Park in the fall of 2016. It now outlets at the bottom of the bank, as does the Delevan outfall (750 mm). Despite the construction of the new outfall at Colina, some water still flows down the bank. The source of this ephemeral channel needs to be further investigated to determine where it originates. Both Colina and Delevan were designated stormwater outlets for the village of Bayfield (BM Ross 2014). The Tuyll site was also modified in 2016/2017, and now includes a combination of a tile (which comes from under Tuyll Street) and catch basin, which then outlets at the bottom of the bank. According to a report on storm drainage for the village of Bayfield (BM Ross 1985), existing tile drainage for the most developed portion of the village is directed towards the Delevan outfall or an open water course that discharges at the top of the bank (*i.e.*, Tuyll).
