Draft Proposed Shoreline Management Plan 2018

Ausable Bayfield Conservation Authority

November 27, 2018

W.F. Baird & Associates Coastal Engineers Ltd.

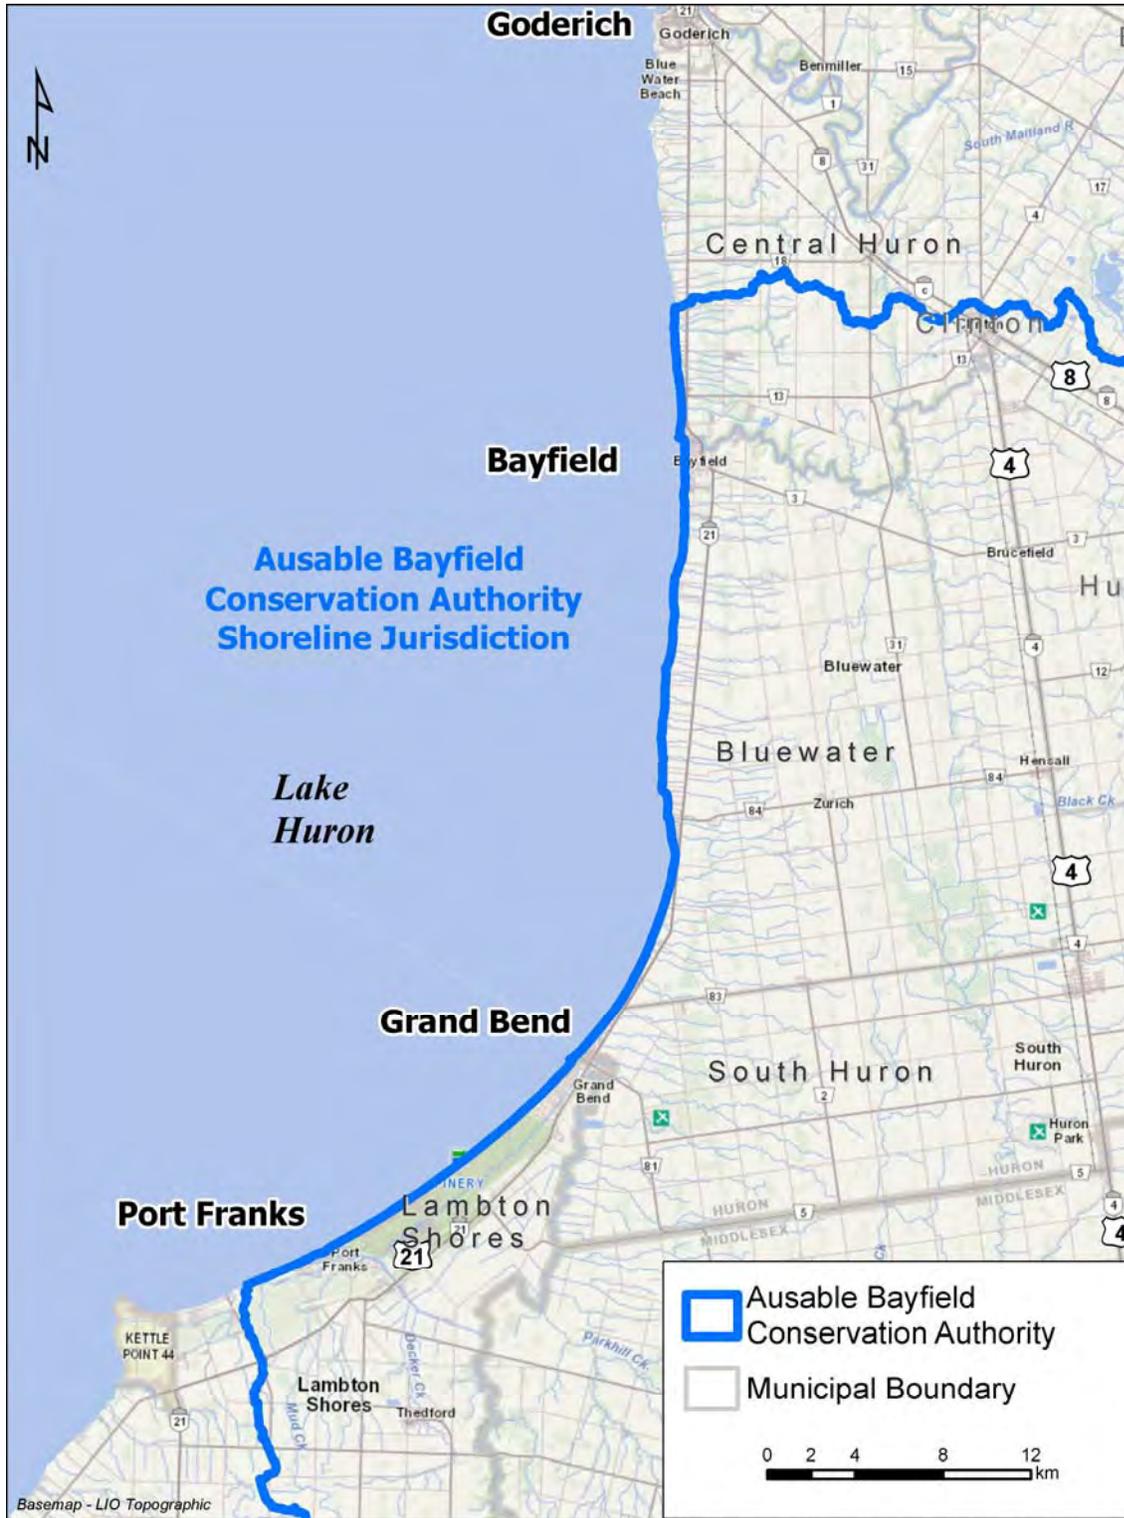
Figure 1.1: Ausable Bayfield Conservation Authority showing municipal boundaries

The Ausable Bayfield Conservation Authority shoreline is located on the southeast shore of Lake Huron in the Province of Ontario. The ABCA's jurisdiction extends from Lot 30, Concession 1, in the former Goderich Township, in the Municipality of Central Huron at the northern limit, throughout the Municipality of Bluewater and the Municipality of South Huron, to the southerly limit within the Municipality of Lambton Shores at the community of Port Franks. Refer to Figure 1.1 for a map of the jurisdictional boundaries.

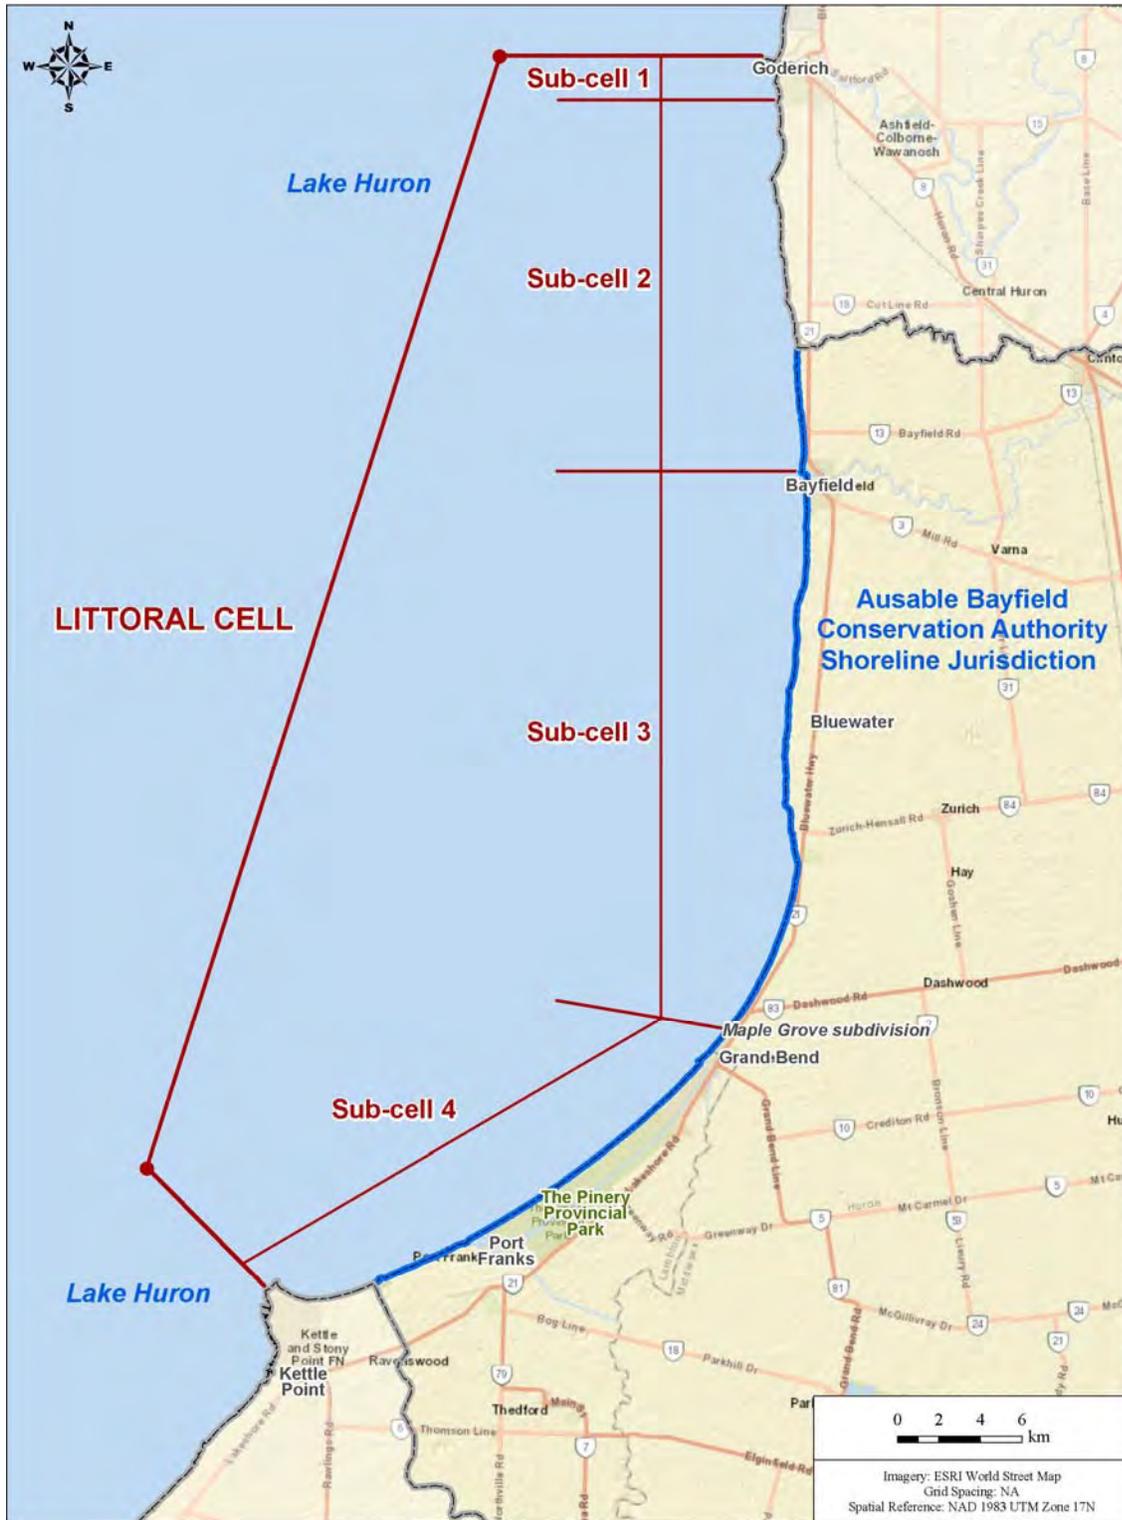
Figure 3.1: ABCA Shoreline showing littoral cell and sub-cells

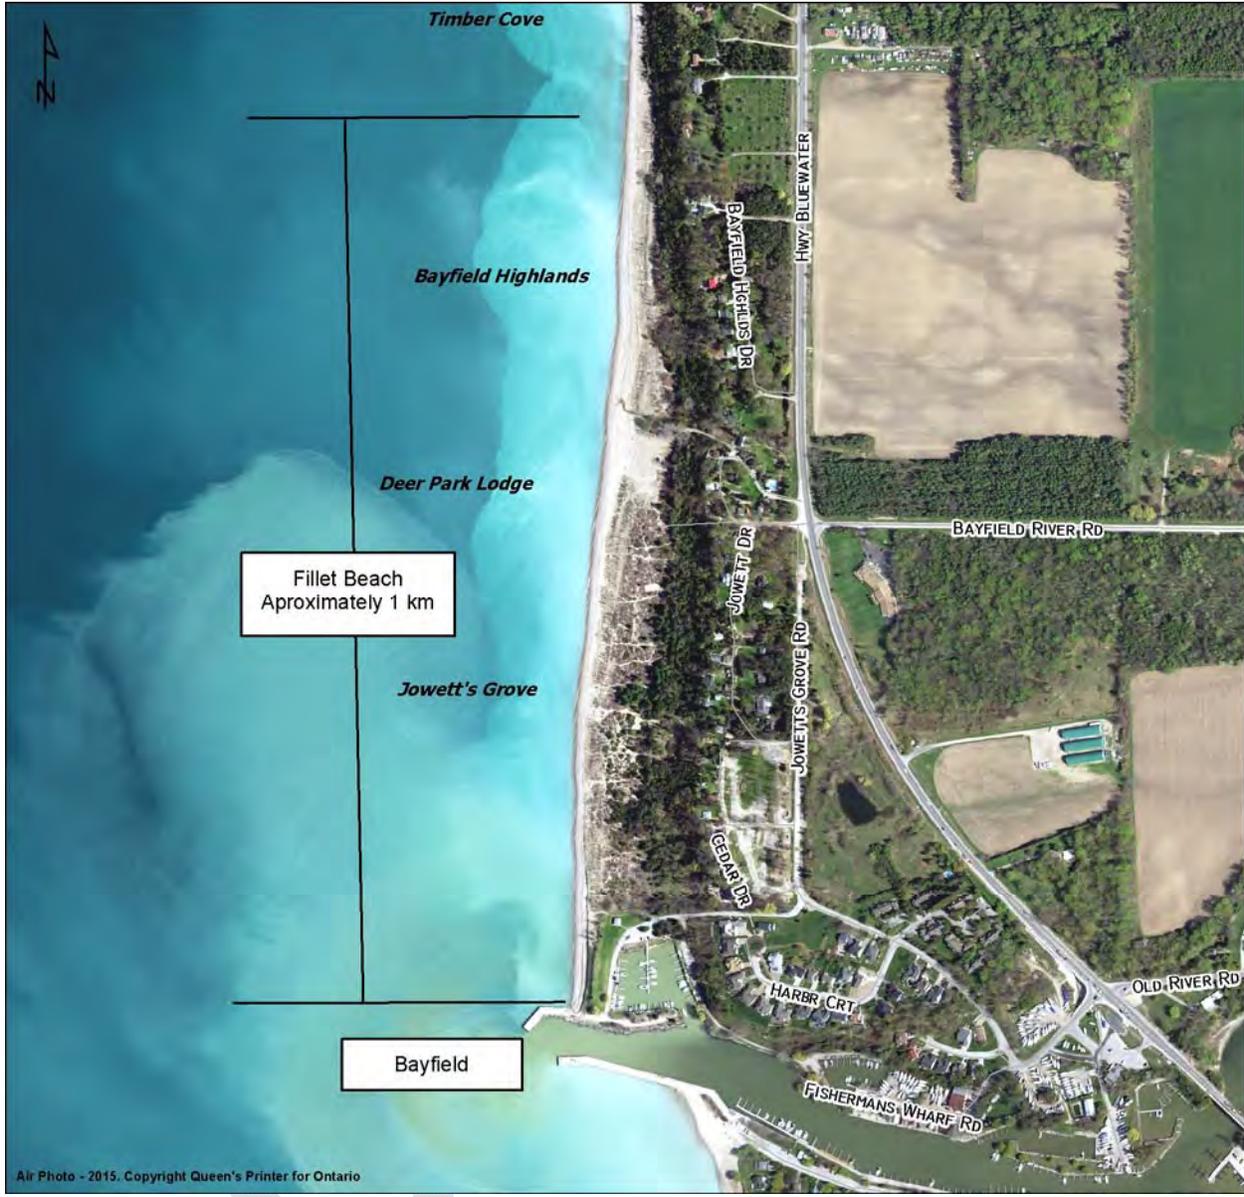
Figure 3.2: Stable shoreline at fillet beach north of Bayfield Harbour

The bluff will generally be stable where sufficient sediment has accumulated to produce wide beaches that protect the bluff toe and the nearshore till lakebed from erosion. Examples of this can be found along the 1 km stretch of shoreline where a fillet beach has developed north of Bayfield Harbour (see Figure 3.2) and just north of Grand Bend Harbour.

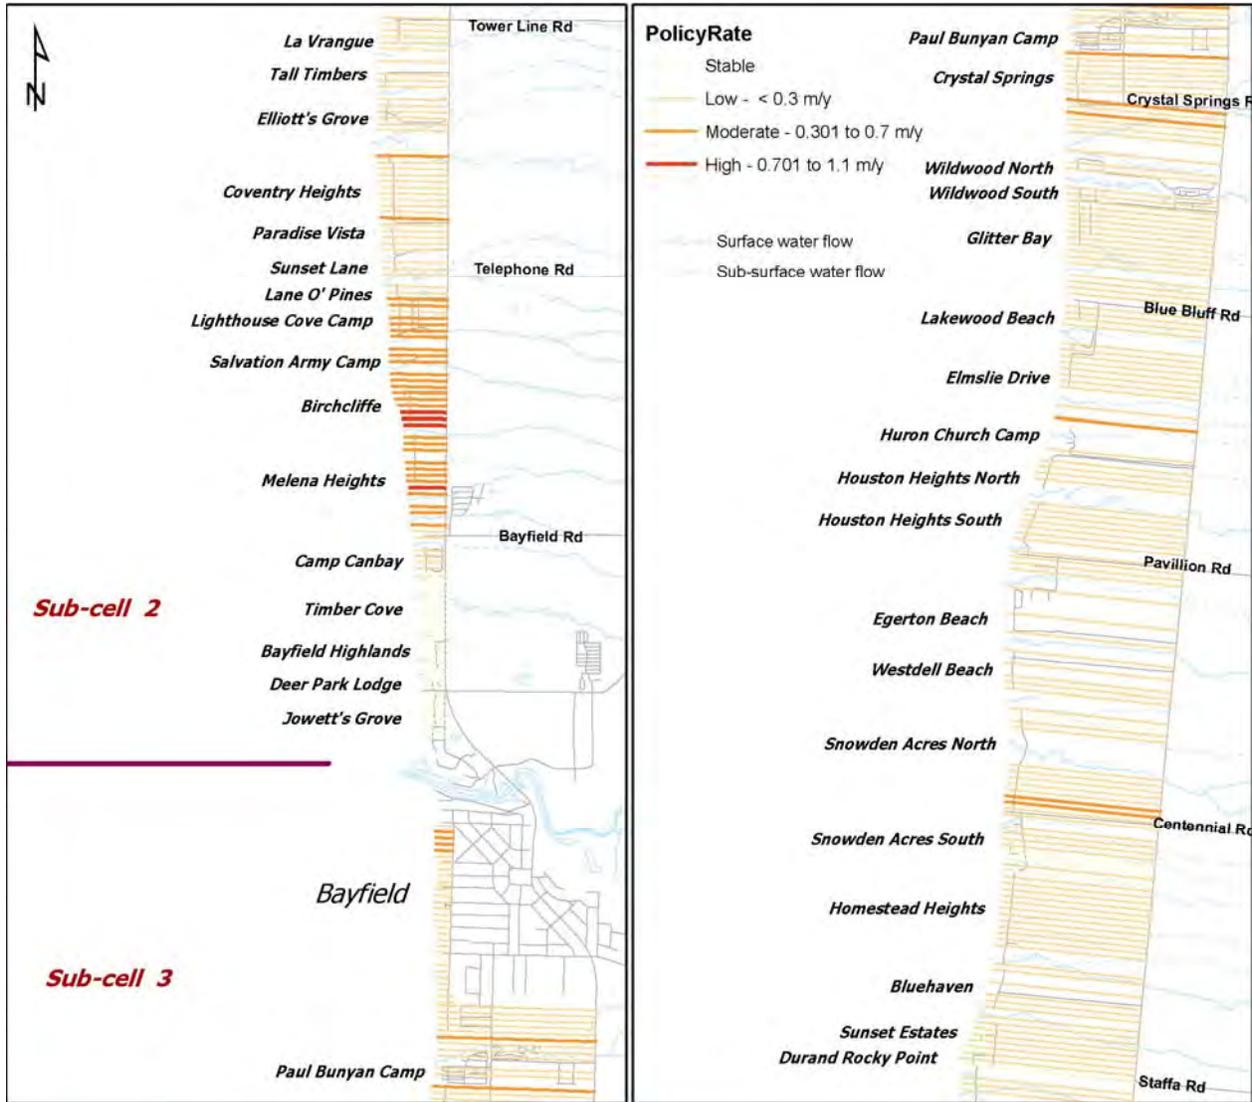
Figure 3.3: Northern recession rate map – average annual recession rates 1973 – 2007

The majority, 80.2 % (see Table 3.1), of the cohesive bluff shoreline has a low recession rate or is stable (see Figure 3.3, northern and Figure 3.4 southern recession rate maps). Shorelines with low recession rates are usually associated with beaches which offer some protection against erosion of the bluff toe and reduced rates of nearshore erosion. Low recession rates are also found at Stoney Point and Dewey Point, where there are outcrops of the stony Rannoch Till, which also acts to reduce nearshore erosion.

Two stretches of the shoreline have high recession rates: north of Bayfield in the Birchcliffe/Melena Heights area (see Figure 3.3), and Lakewood Gardens North/South, Sunnyridge, and north of Poplar Beach Road. (see Figure 3.4).

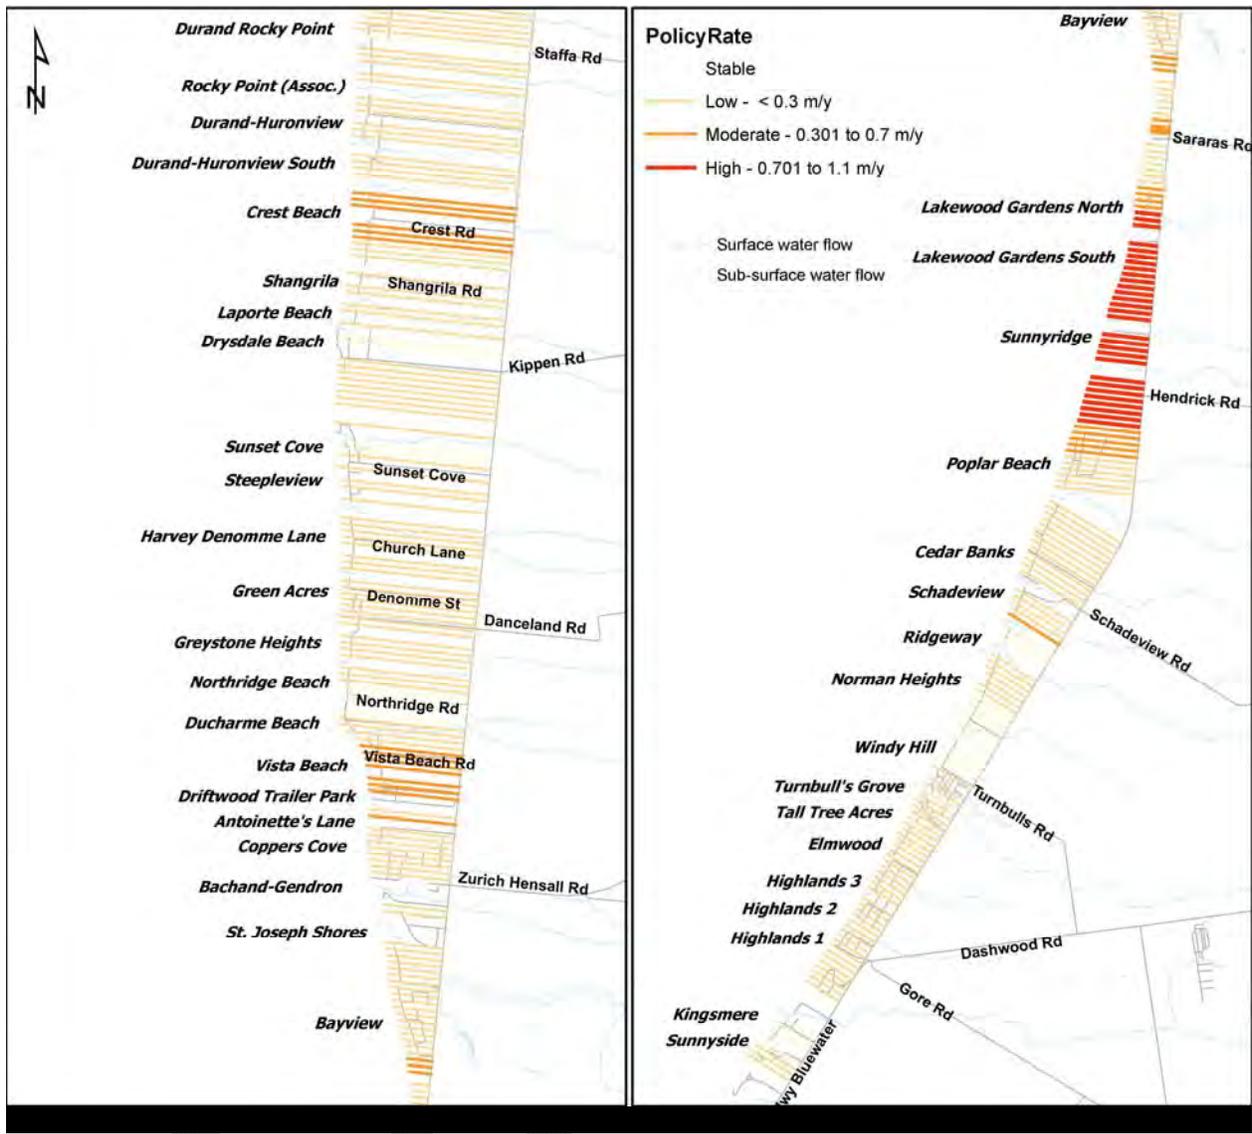
Figure 3.4: Southern recession rate map – average annual recession rates 1973-2007

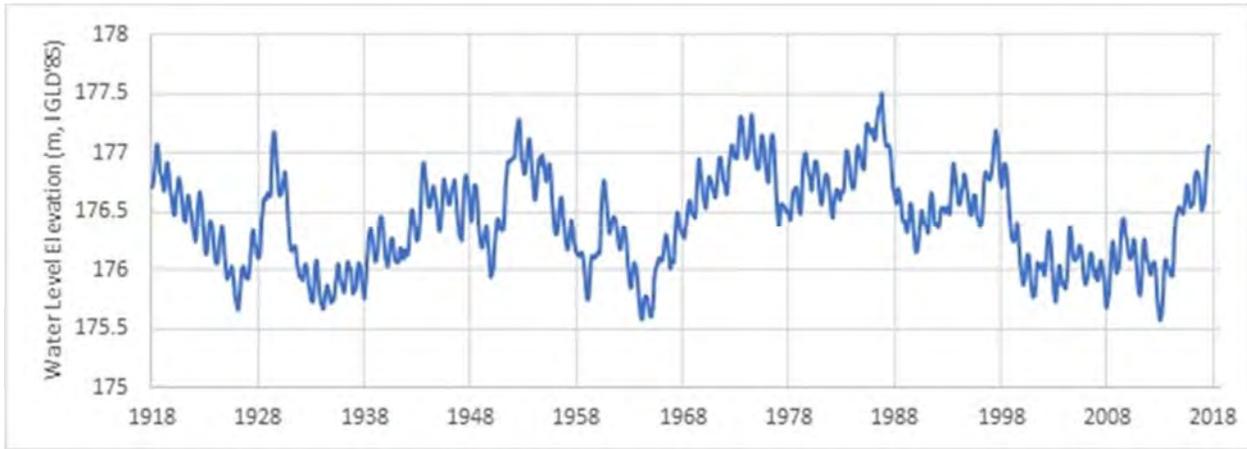
Figure 3.5: Lake Huron monthly mean lake levels (1918 to 2017)

Monthly mean lake levels for the period 1918 to 2017 are shown in Figure 3.5. The most recent period of high lake levels was 1985-86, and the highest monthly mean water level was 177.50 m International Great Lakes Datum (IGLD) 1985, in October 1986. The lowest monthly mean water level was 175.58 m IGLD 1985, recorded in March 1964, giving a total water level range of close to 2 m. There was a sustained period of low water levels from 2000 to 2012, however the lowest monthly mean in this period was marginally higher than the lowest value recorded in 1964.

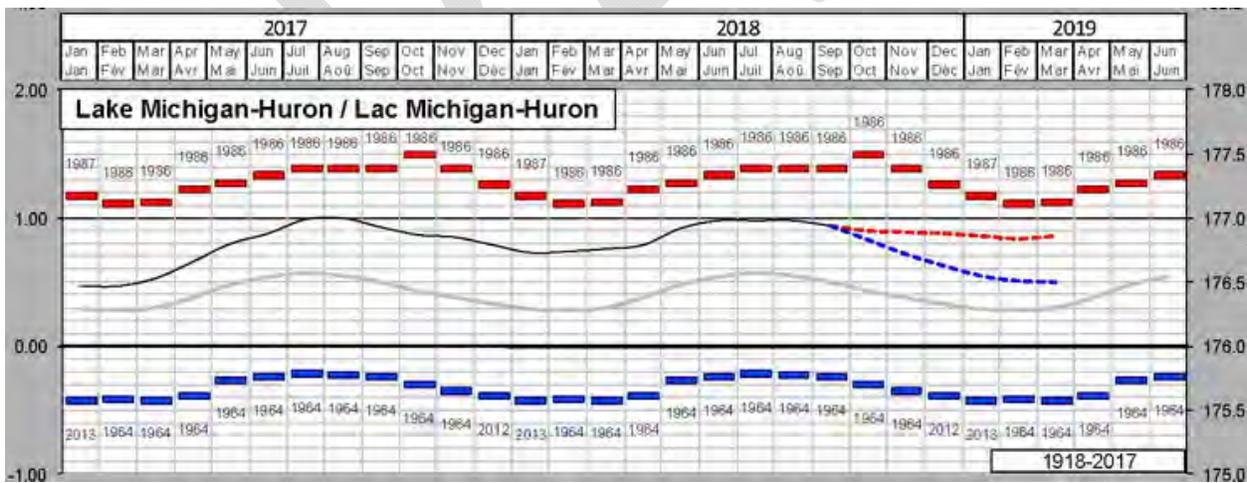
Figure 3.6: Seasonal water level fluctuations on Lake Huron (from the Canadian Hydrographic Service Monthly Water Level Bulletin)

Seasonal fluctuations in the lake level are associated with the annual weather patterns and extent and duration of ice cover, which limits evaporation. The highest lake levels typically occur in the early summer following spring runoff, then levels start to drop as evaporation and precipitation patterns change and lowest levels typically occur in the winter when most precipitation is snow and ice. On Lake Huron, the average seasonal water level fluctuation is approximately 0.3 m but does vary from year to year. Figure 3.6 shows the average seasonal fluctuations and the maximum and minimum monthly mean water levels on Lake Huron. The highest and lowest monthly means are indicated in red and blue respectively, with the year of occurrence. The long-term average monthly mean is indicated in grey and the recorded monthly mean for 2017 and 2018 to date is shown in black, with the forecast range for the next several months in dashed lines. Water levels in this report are referenced to IGLD 1985. Chart Datum is 176.0 m IGLD 1985.

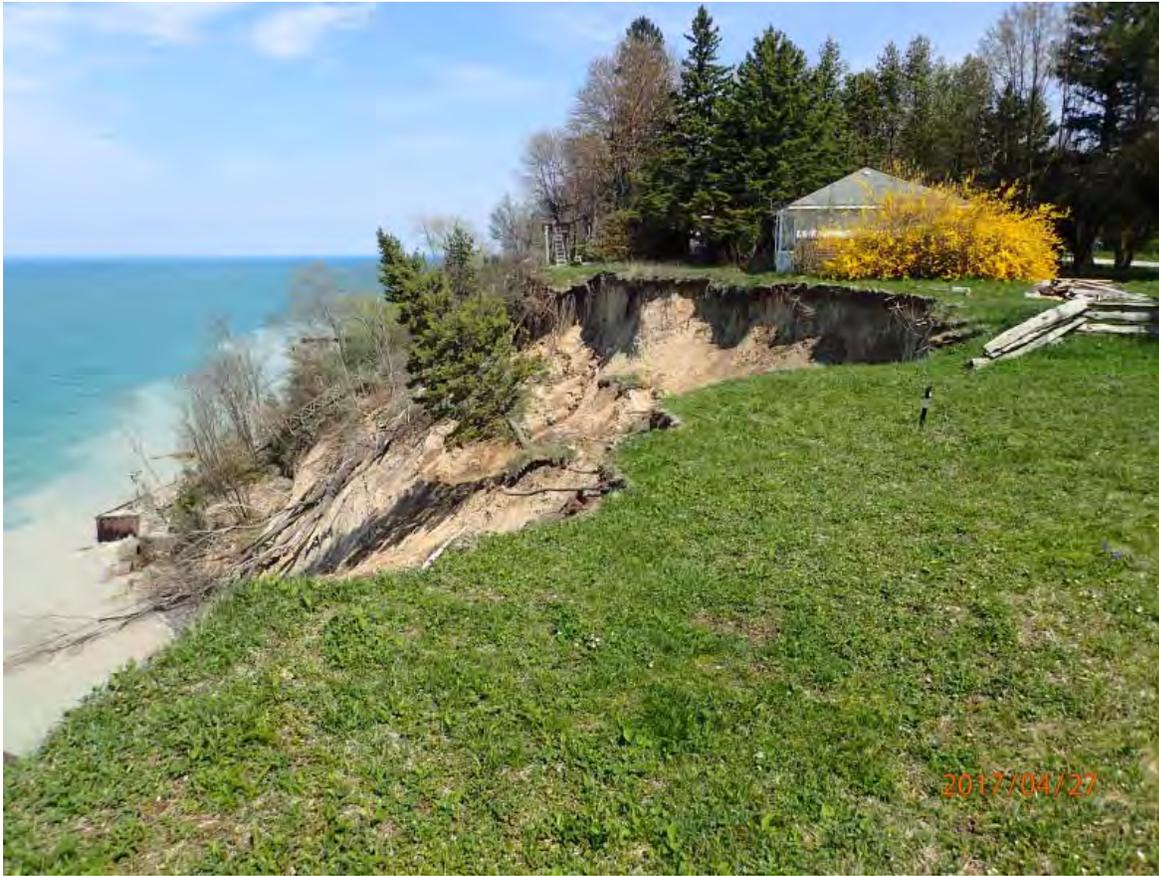
Figure 4.1: Residence located within the Erosion Hazard Limit on an actively eroding bluff on the ABCA shoreline

When development is located on the tablelands of an eroding bluff, eventually the structural stability of the buildings will be compromised due to slope instability issues. If not relocated, the building will eventually be destroyed. Figure 4.1 shows a home located within the erosion hazard limit, where the bluff is actively eroding.

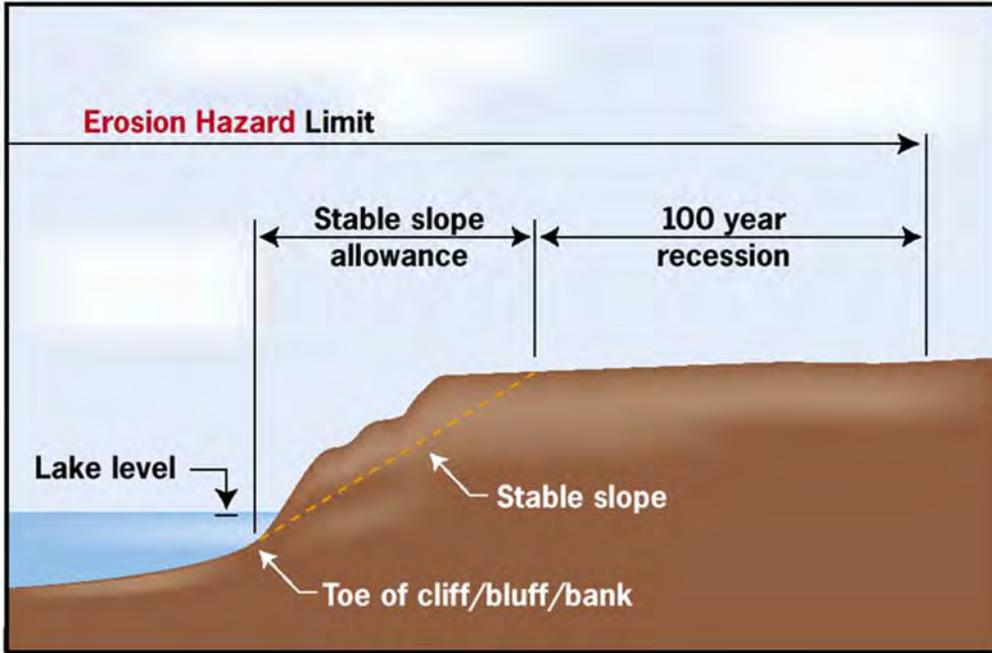
Figure 4.2: Erosion Hazard Limit defined with reliable recession data (from MNR, 2001b)

The erosion allowance is the distance the shoreline would erode in 100 years from present. It is calculated as 100 times the average annual recession rate (AARR). In the absence of a minimum 35 years of reliable data, a

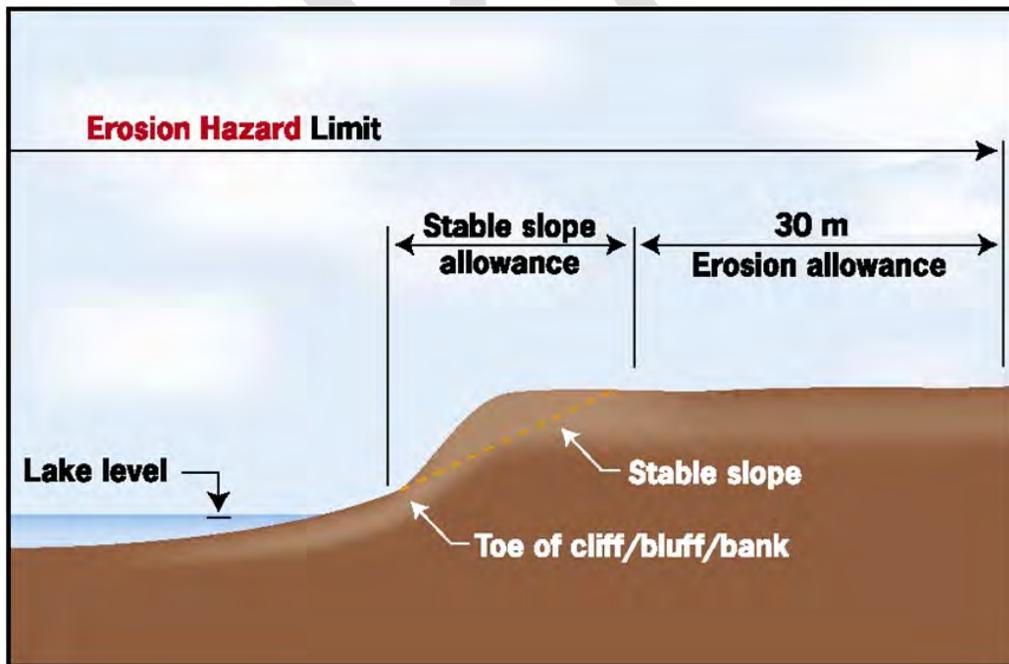
Figure 4.3: Erosion Hazard Limit defined where reliable recession data not available (from MNR, 2001b)

30 metre erosion allowance is used (as shown in Figure 4.3). This may also apply in areas where the shoreline has been protected and an erosion allowance cannot be determined.

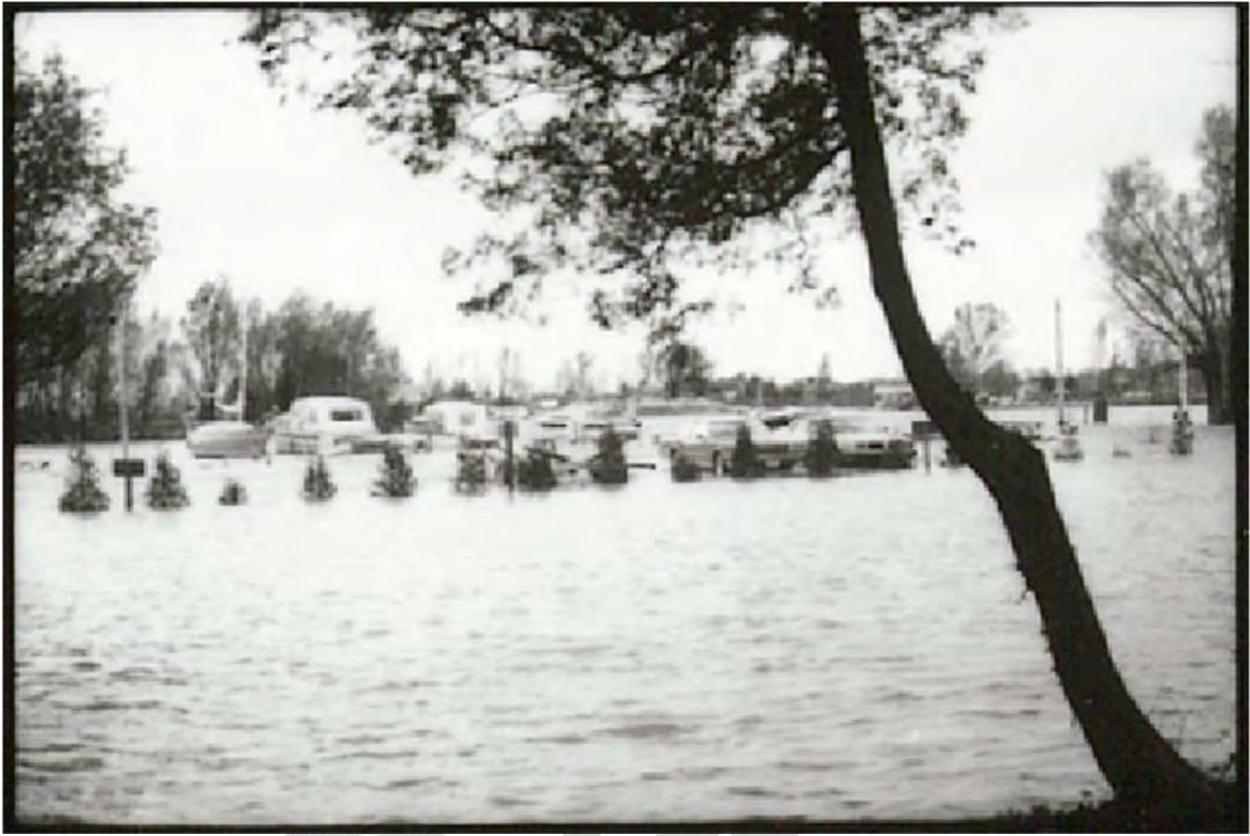
Figure 4.4: Example of shoreline flooding Port Franks 1987 (photo courtesy of ABCA)

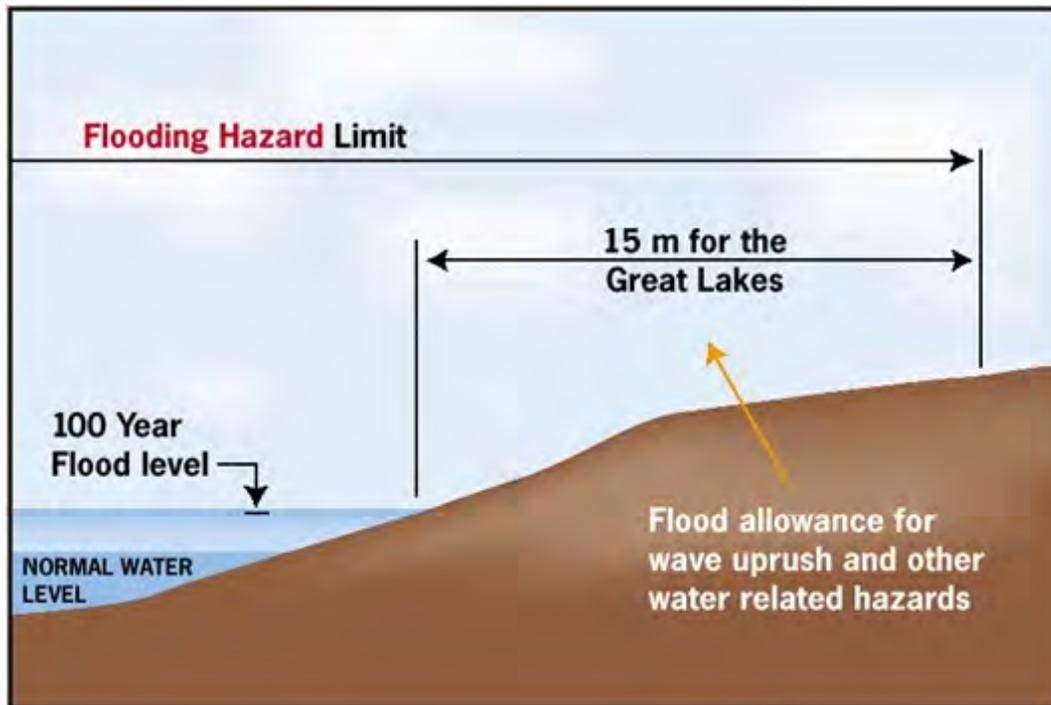
Figure 4.5: Flooding Hazard Limit for the Great Lakes (from MNR, 2001b)

When shorelines are exposed to wave action, wave uprush and overtopping occur, driving water above the 100-year water level. Other water-related hazards may include ship generated waves and ice. Site specific studies may be used to assess the allowance for wave uprush and water related hazards. The *Technical Guide* (MNR, 2001a) requires a flooding allowance of 15 m, measured horizontally from the location of the 100-year flood level, as shown in Figure 4.5, if a study using accepted engineering and scientific principles is not undertaken. The standard 15 m setback was adopted for the ABCA shoreline.

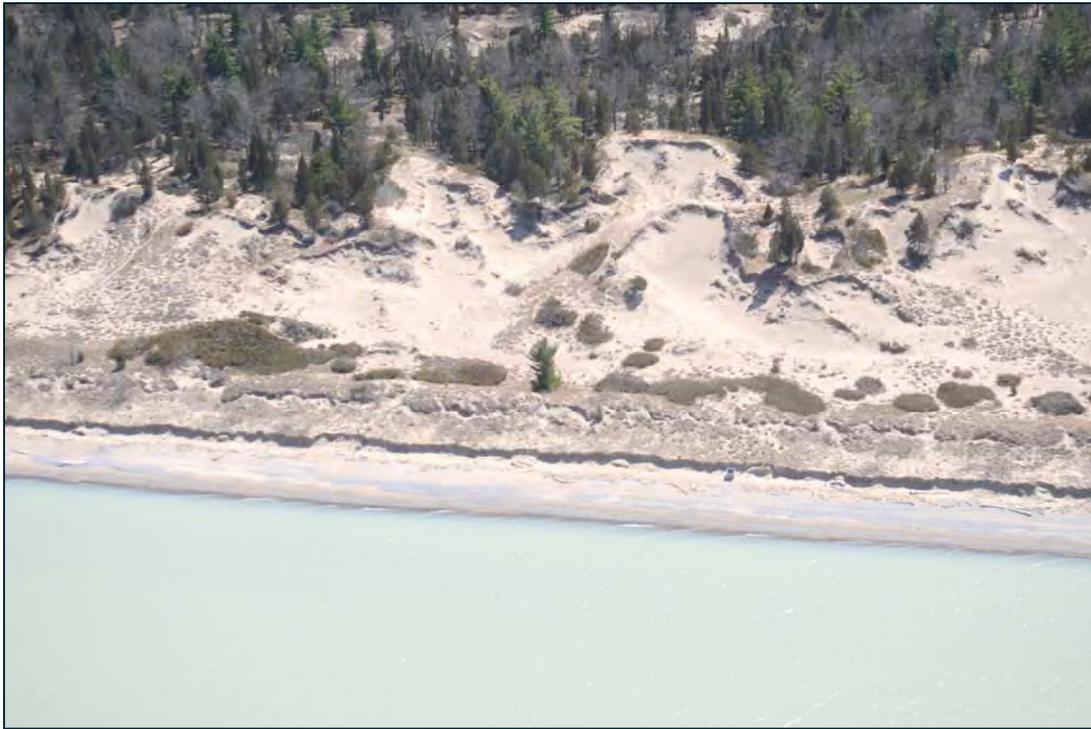
Figure 4.6: Dynamic Beach with Developed Dune at Pinery Provincial Park (photo courtesy of ABCA)

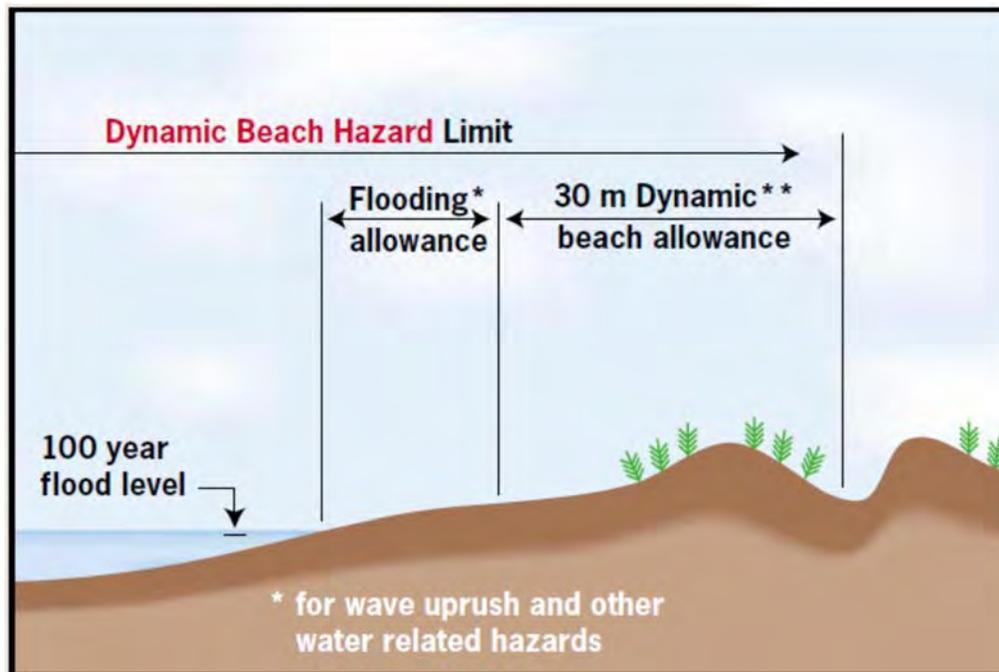
Figure 4.7: Dynamic Beach Hazard Limit (from MNR, 2001b)

The dynamic beach hazard limit is defined as the landward limit of the flooding hazard (100-year flood level plus a flood allowance for wave uprush and other water related hazards) plus a 30 m dynamic beach allowance or a distance determined by an accepted coastal study, plus 100-year erosion allowance if the shoreline is eroding (see Figure 4.7).

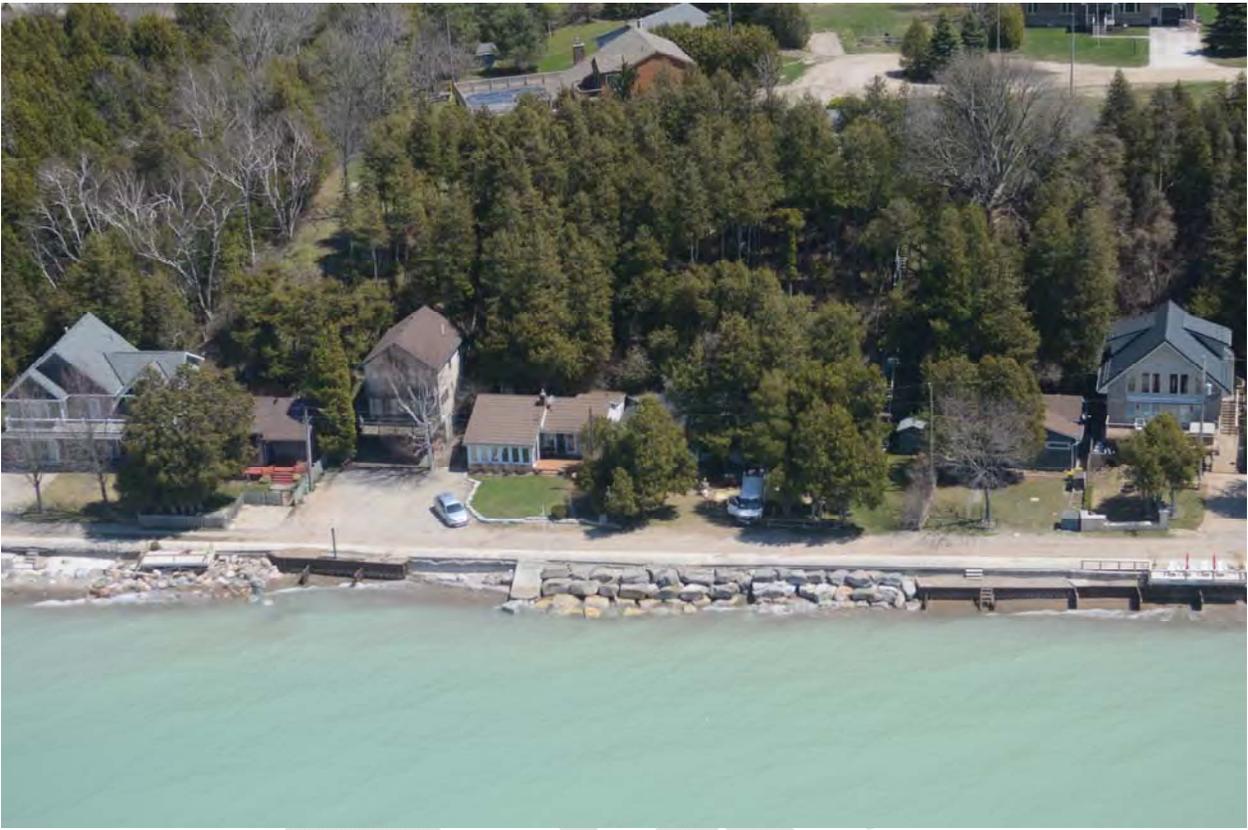
Figure 5.1: Drysdale Beach Road with development located along the toe of the bluff

There are a number of locations along the shoreline where dwellings have been constructed at the base of the cohesive bluff on what would once have been a beach; examples include Drysdale beach Road and Sandy Beach Road (see Figure 5.1). The 2015-2016 consulting team (Aqua Solutions 5 Inc. et al., 2016) found that these dwellings “may be subject to flooding due to wave uprush during periods of high lake level.”

These dwellings are located on a dynamic beach and are exposed to erosion and flooding during periods of high lake level where the shoreline is unprotected; many of these properties have constructed shore protection. All three hazards: erosion, flooding and dynamic beach are applicable at these sites and the most landward hazard limit is applicable.

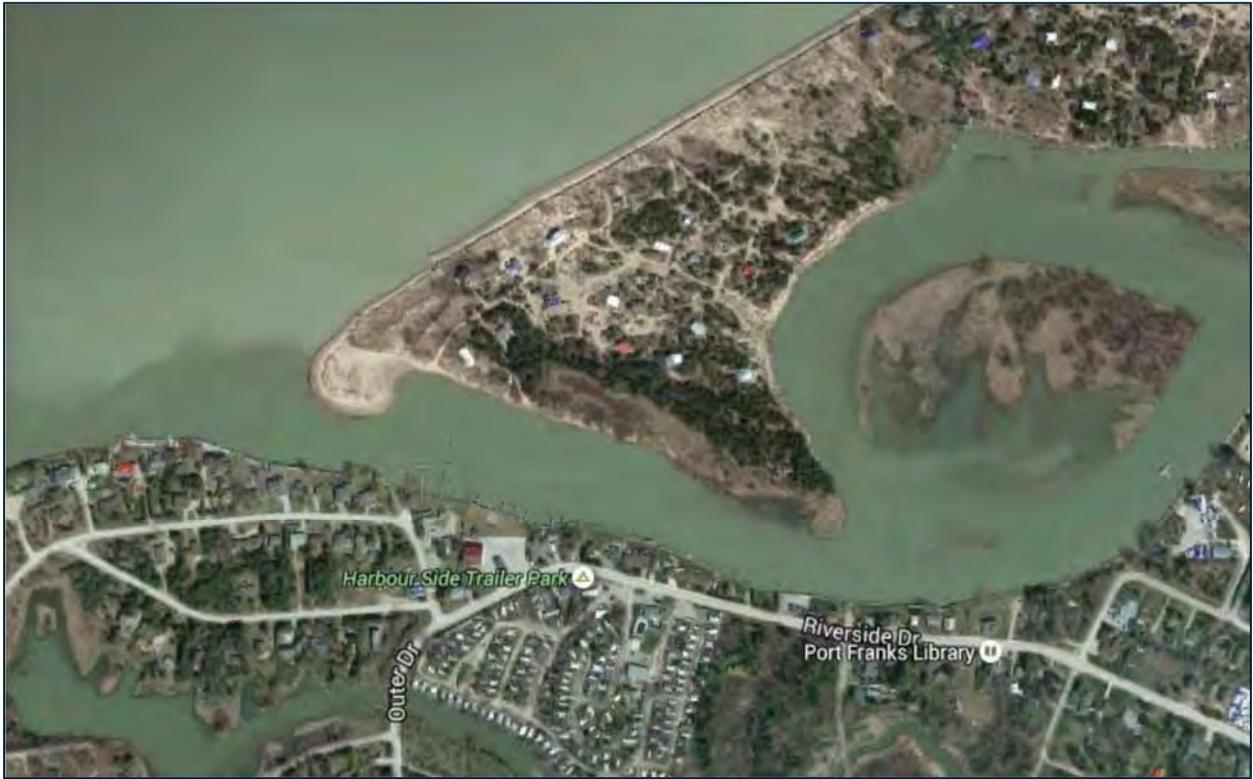
Figure 5.2: Development around the mouth of the Ausable River

The area around the mouths of the Ausable River (Figure 5.2) and Mud Creek at Port Franks is highly dynamic as a result of shifting of the river channel (Figure 5.3) and the interaction of the discharge of the Ausable River with sand transport along the shoreline. Flooding from the river can impact development close to the shoreline. Heavy onshore winds at times of high lake levels can lead to water backup that can add to that flooding impact. Dredging of the Ausable River mouth may also contribute to movement of the shoreline. The situation is complex and in some areas a site-specific study may be required to determine the best approach to hazard management (Aqua Solutions 5 Inc. et al., 2016).

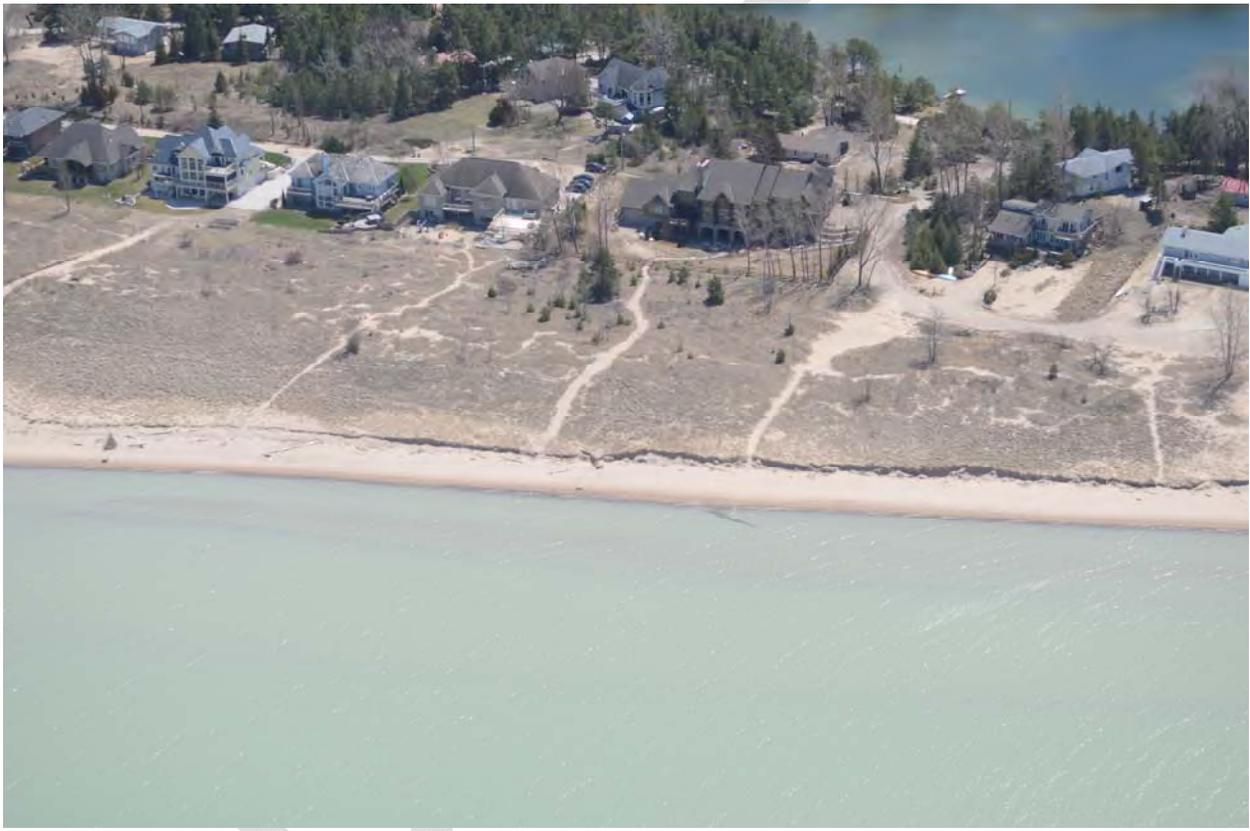
Figure 5.4: Development setback inland from the Dynamic Beach Hazard at Port Franks

Development has historically been set back, landward of the dynamic beach hazard limit, in many areas along the dynamic beach shoreline of the ABCA watershed area. This has resulted in a well-vegetated dune zone in front of dwellings in areas such as Oakwood, north of Grand Bend, and south of the Grand Bend harbour to the border of Pinery Provincial Park. This is also present along sections of the Port Franks shoreline (Figure 5.4).

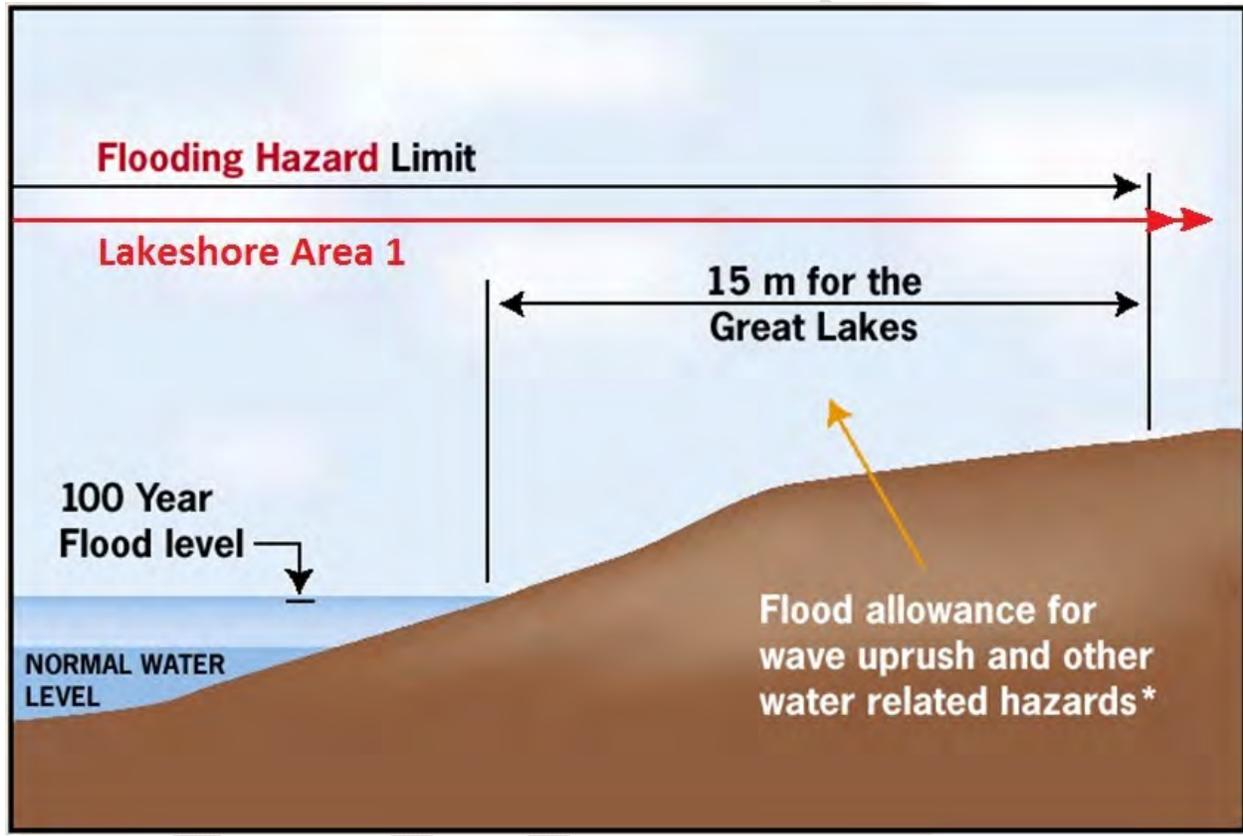
Figure 5.5: Lakeshore Area 1 for the Flooding Hazard

Lakeshore Area 1: That area of the shoreline landward (or inland) from the water’s edge, including the 100-year flood level plus an allowance for wave uprush and other water related hazards (which is 15 m in the absence of a site-specific study). This is also known as the Flood Hazard Limit. The entire flooding hazard is considered to be in Lakeshore Area 1 (Lakeshore Area 2 is not applicable for the flooding hazard). Figure 5.5 depicts the Lakeshore Area 1 Flood Hazard Limit.

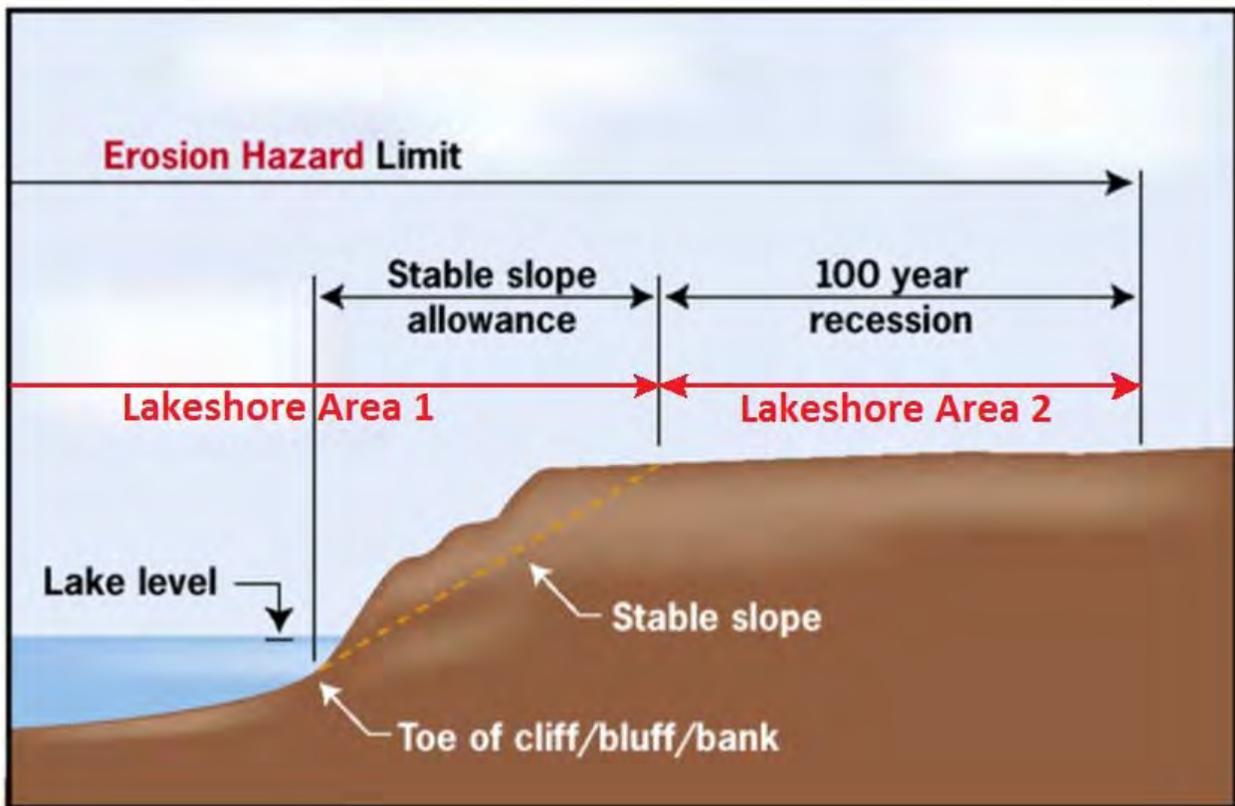
Figure 5.6: Lakeshore Areas 1 and 2 for the Erosion Hazard

Lakeshore Area 1: That area of the shoreline landward (or inland) from the water’s edge, including the stable slope allowance (3H:1V), from the toe of the bank, unless defined by a site-specific study undertaken by a geotechnical engineer. The Erosion Hazard for Lakeshore Area 1 is shown in Figure 5.6.

Lakeshore Area 2: That area of the shoreline located landward (or inland) from Lakeshore Area 1 extending landward to the greater of; a 100-year erosion setback (based on the 100 years times AARR) or 30 m. The Erosion Hazard for Lakeshore Area 2 is shown in Figure 5.6.
