Draft Proposed Shoreline Management Plan 2018

Ausable Bayfield Conservation Authority

November 27, 2018

W.F. Baird & Associates Coastal Engineers Ltd.

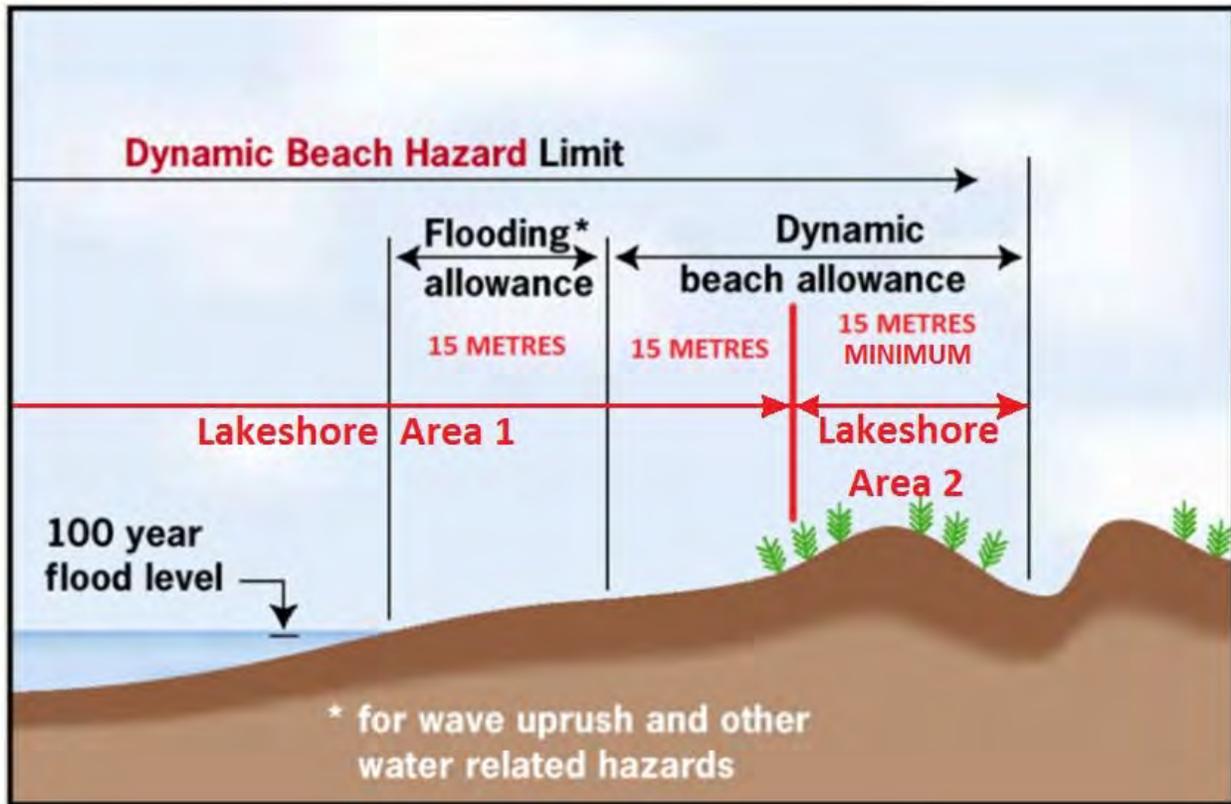
Figure 5.7: Lakeshore Areas 1 and 2 for the Dynamic Beach Hazard

Lakeshore Area 2: That area landward (or inland) from Lakeshore Area 1 to the inshore limit of the dynamic beach (further 15 m landward from the inshore limit of Lakeshore Area 1). This area is also part of the active beach zone and dune complex that would be affected by wave action during extreme events including the 100-year event. The Dynamic Beach Hazard for Lakeshore Area 2 is shown in Figure 5.7.
