Ausable Bayfield Conservation Authority

Considerations for Shoreline Protection Structures

December 7 2017 | 12646.101

W.F. Baird & Associates Coastal Engineers Ltd.

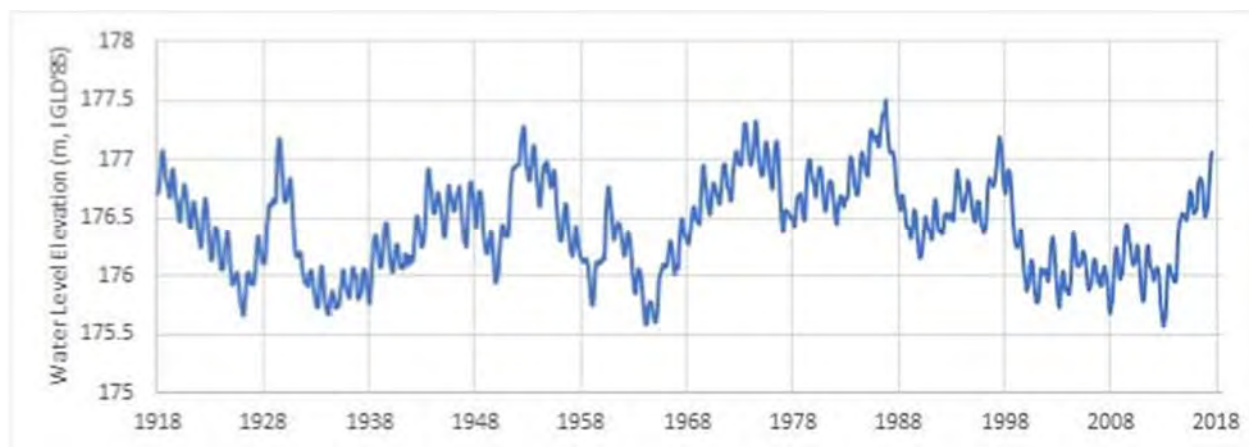
Figure 3.1: Lake Huron monthly mean lake levels (1918 to 2017)

Monthly mean lake levels for the period 1918 to 2017 are shown in Figure 3.1. The most recent period of high lake levels was 1985-86, and the highest monthly mean water level is 177.50 m International Great Lakes Datum (IGLD) 1985, in October 1986. Water levels in this report are referenced to IGLD 1985. Chart Datum is 176.0 m IGLD 1985. The lowest monthly mean water level was 175.58 m IGLD 1985, recorded in March 1964, giving a maximum range of close to 2 m. There was a sustained period of low water levels from 2000 to 2012, however the lowest monthly mean was marginally higher than the lowest value recorded in 1964. Studies have shown a lowering of water levels on Lake Huron in response to dredging in the St. Clair River in the late 1800's and during periods in the 1900's, see for example Baird (2005). The International Joint Commission (2009) concluded that lowering water levels due to increased conveyance in the St. Clair River is not ongoing and that climate is the main driver of lake level.

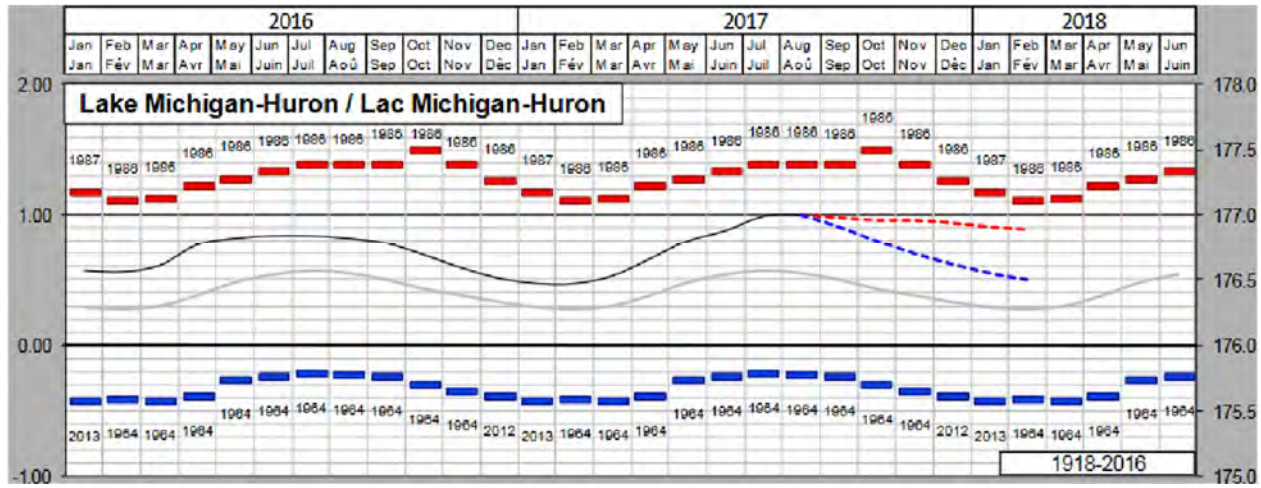
Figure 3.2: Seasonal water level fluctuations on Lake Huron (from the Canadian Hydrographic Service Monthly Water Level Bulletin)

Seasonal fluctuations in the lake level are associated with the annual weather patterns and ice cover limits evaporation. The lowest levels typically occur in the winter when most precipitation is snow and ice, while the highest lake levels typically occur in the summer following spring runoff. On Lake Huron, the average seasonal water level fluctuation is approximately 0.3 m but does vary from year to year. Figure 3.2 shows the seasonal

fluctuations in the average, maximum and minimum monthly mean water levels on Lake Huron for 1918 and 2017. The highest and lowest monthly means are indicated in red and blue respectively, with the year of occurrence. The long-term average monthly mean is indicated in grey and the recorded monthly mean for 2016 and 2017 to date is shown in black, with the forecast range for the next several months in dashed lines.

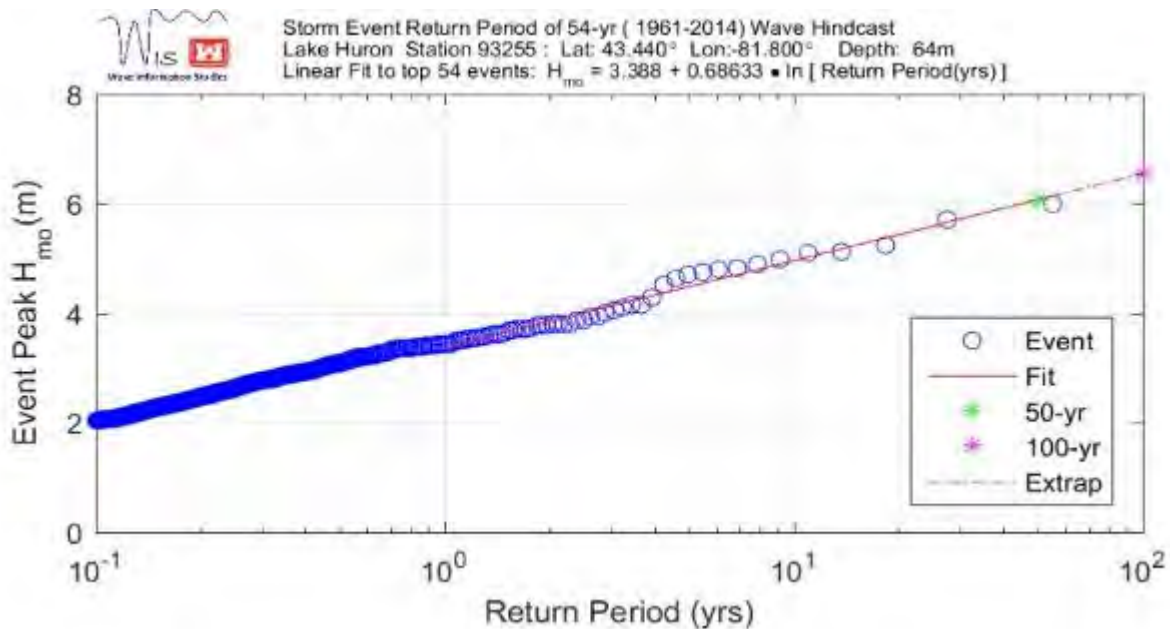
Figure 3.4: Deepwater extreme wave height analysis (WIS Data: 1961 to 2014)

the ABCA shoreline. Time series data, scatter plots, wave roses, exceedance probability tables and extreme value analyses of wave height, period, direction and wind speed are available. Figure 3.4 shows the results of an extreme value analysis of significant wave height for a location immediately offshore from the ABCA shoreline in 64 m water depth. From Figure 3.4, the 100-year offshore significant wave height (H_s) for the region is approximately 6.5 m. The peak period (T_p) associated with the 100-year event is on the order of 10-12 seconds.
