Chapter 2: Methods and Results

2.0 The Process

2.1 Measurements of Ecosystem Quality

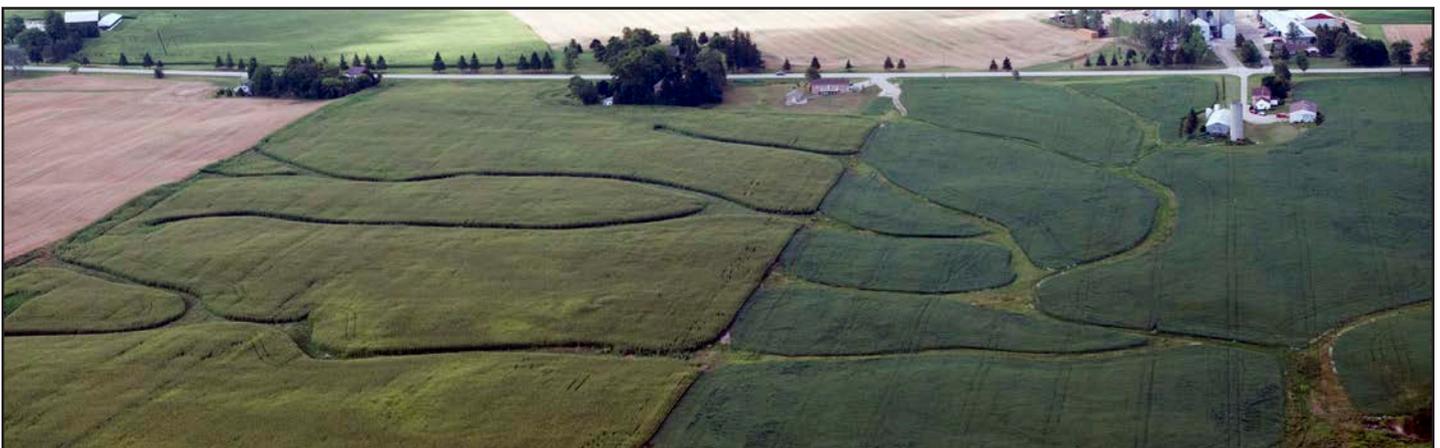
Grassed waterways can reduce phosphorus and suspended sediment concentrations in downstream watercourses.
