**Erosion Investigation
Armstrong West Revetment - Ausable River, Port Franks, Ontario**

Ecosystem Recovery Inc.

Project Number: 2050

Date: February 1, 2021

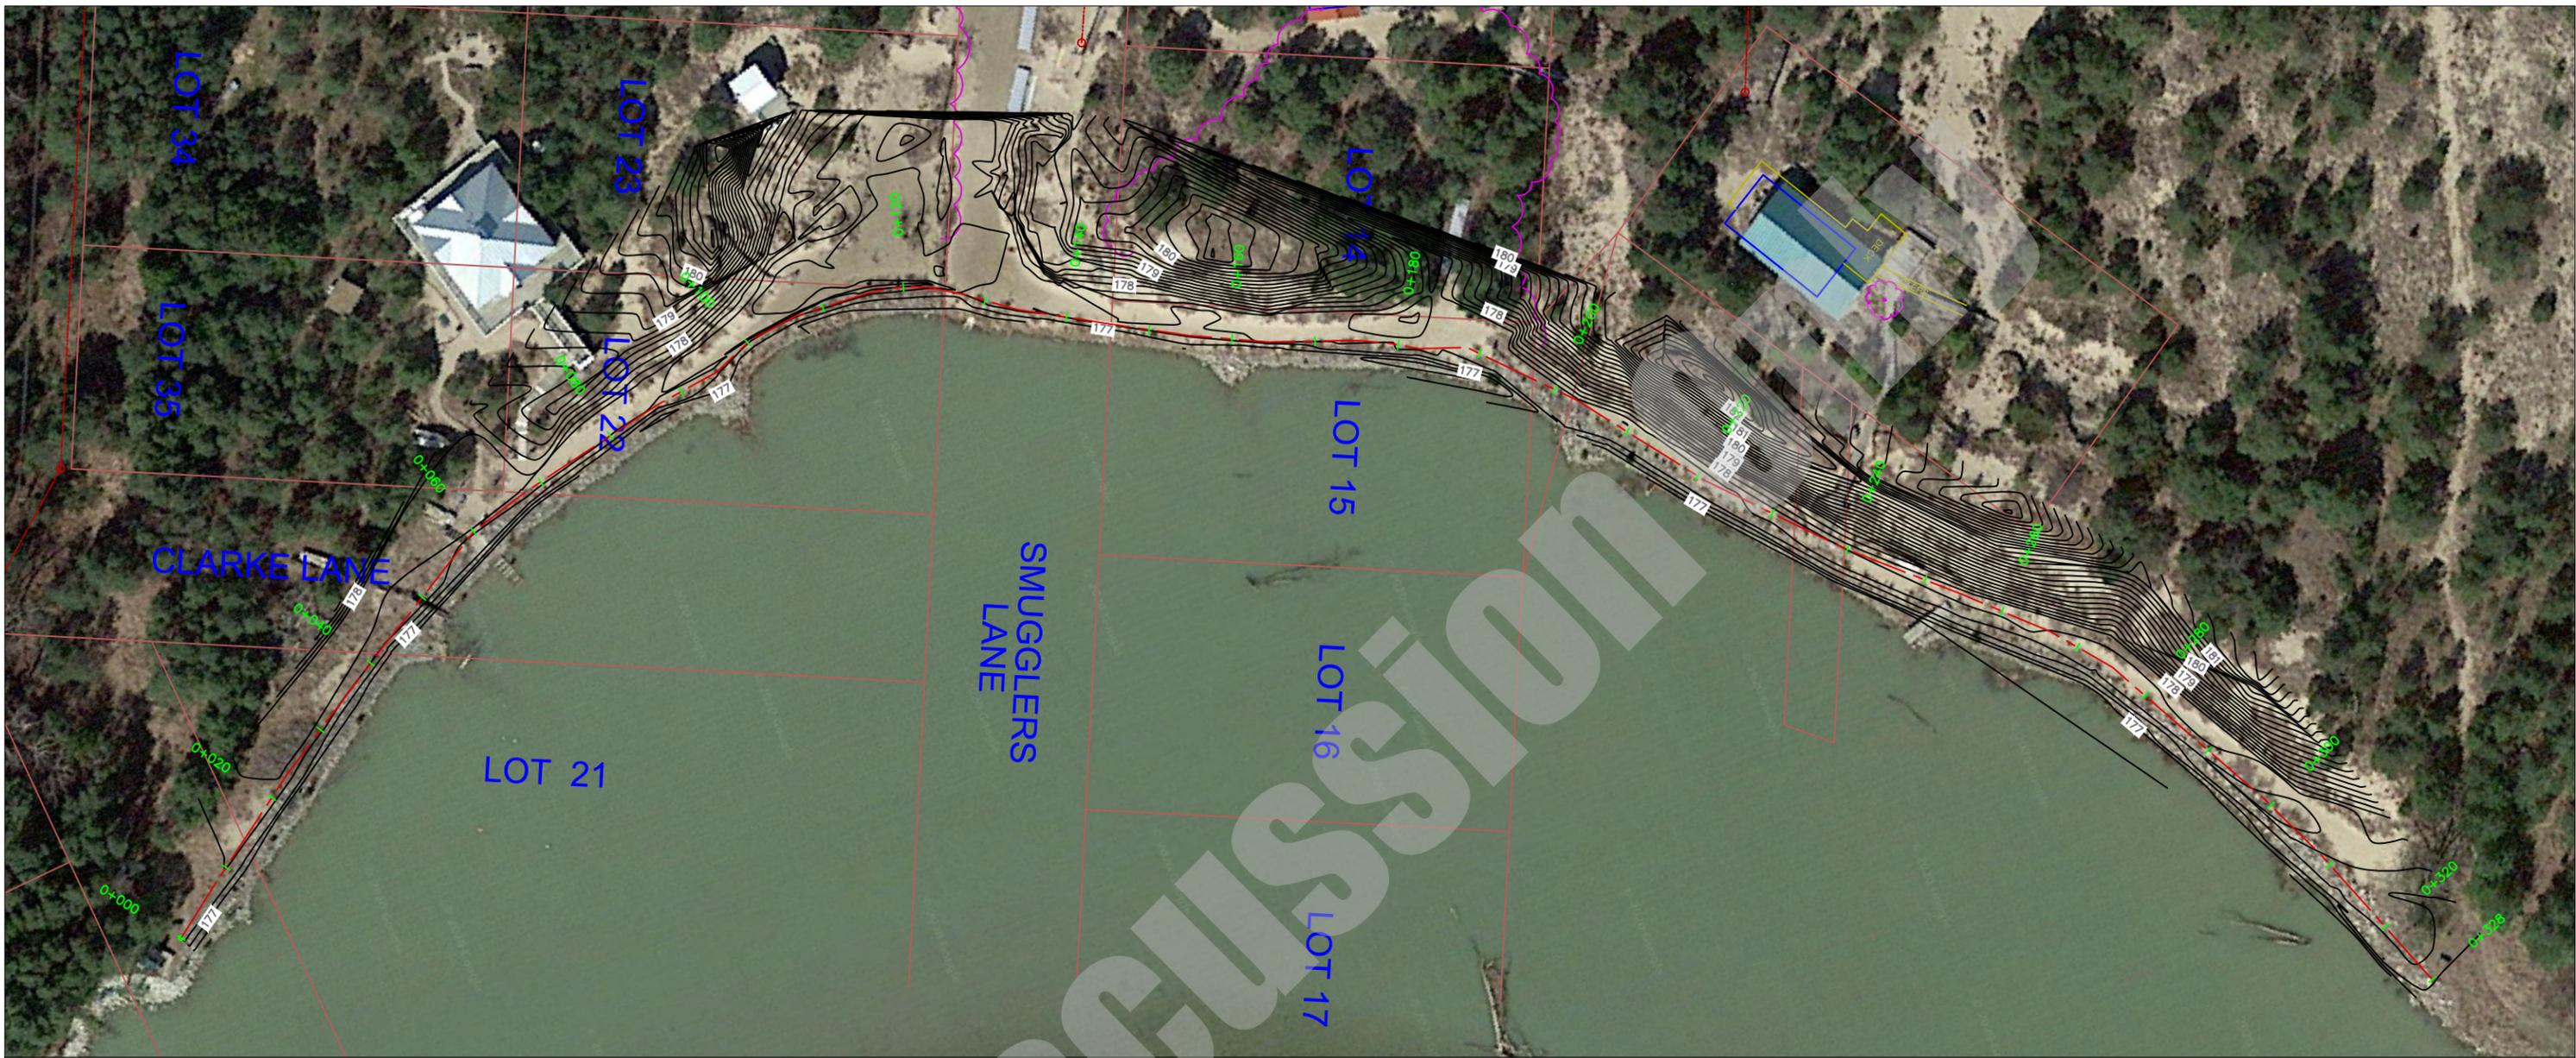
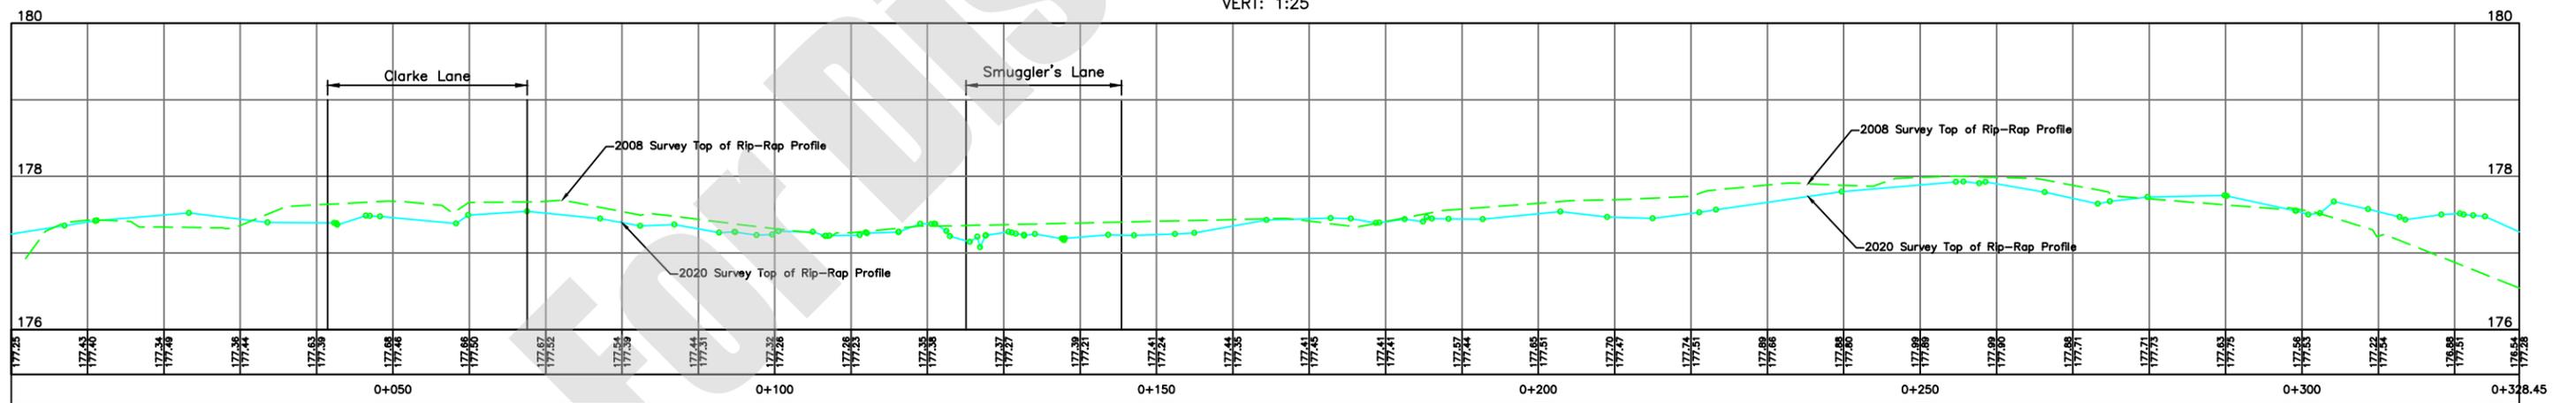
FIGURE
1

Upon completion of the survey and post-survey data processing the current and as-built top-of-revetment profiles were carefully examined. The comparison process involved plotting several top of revetment profiles for the 2008 and 2020 versions of the surveyed revetment surfaces and using cross-sectional information generated in Autodesk Civil3D to verify that representative points along the revetment were included in the profile data. Several iterations of the 2008 and 2020 top-of-revetment profiles were examined prior to establishing the final horizontal and vertical alignment for the Armstrong West revetment structure. **Figure 1** illustrates the final 2008 and 2020 versions of the top-of-revetment profiles along the full length of the Armstrong West structure. It is noted that despite the fact that the horizontal alignment of the top-of-revetment profiles differed slightly within Reach 2 of the Armstrong West structure the 2008 as-built survey top-of-revetment elevations were compared directly to the profile generated by the 2020 survey points. **Table 1** summarizes the elevations of the 2008 and 2020 top-of-revetment surveys on ten-meter intervals for the full length of the Armstrong West structure. The horizontal alignment stationing starts at the southerly end of the structure and follows the 2020 survey points defining the limit of the existing rip-rap. The table is broken up into the subject reaches (1-3) for clarity. A negative value indicates that the 2020 top-of-revetment survey points were found to be at a lower elevation than the 2008 as-built survey. The purpose of this examination

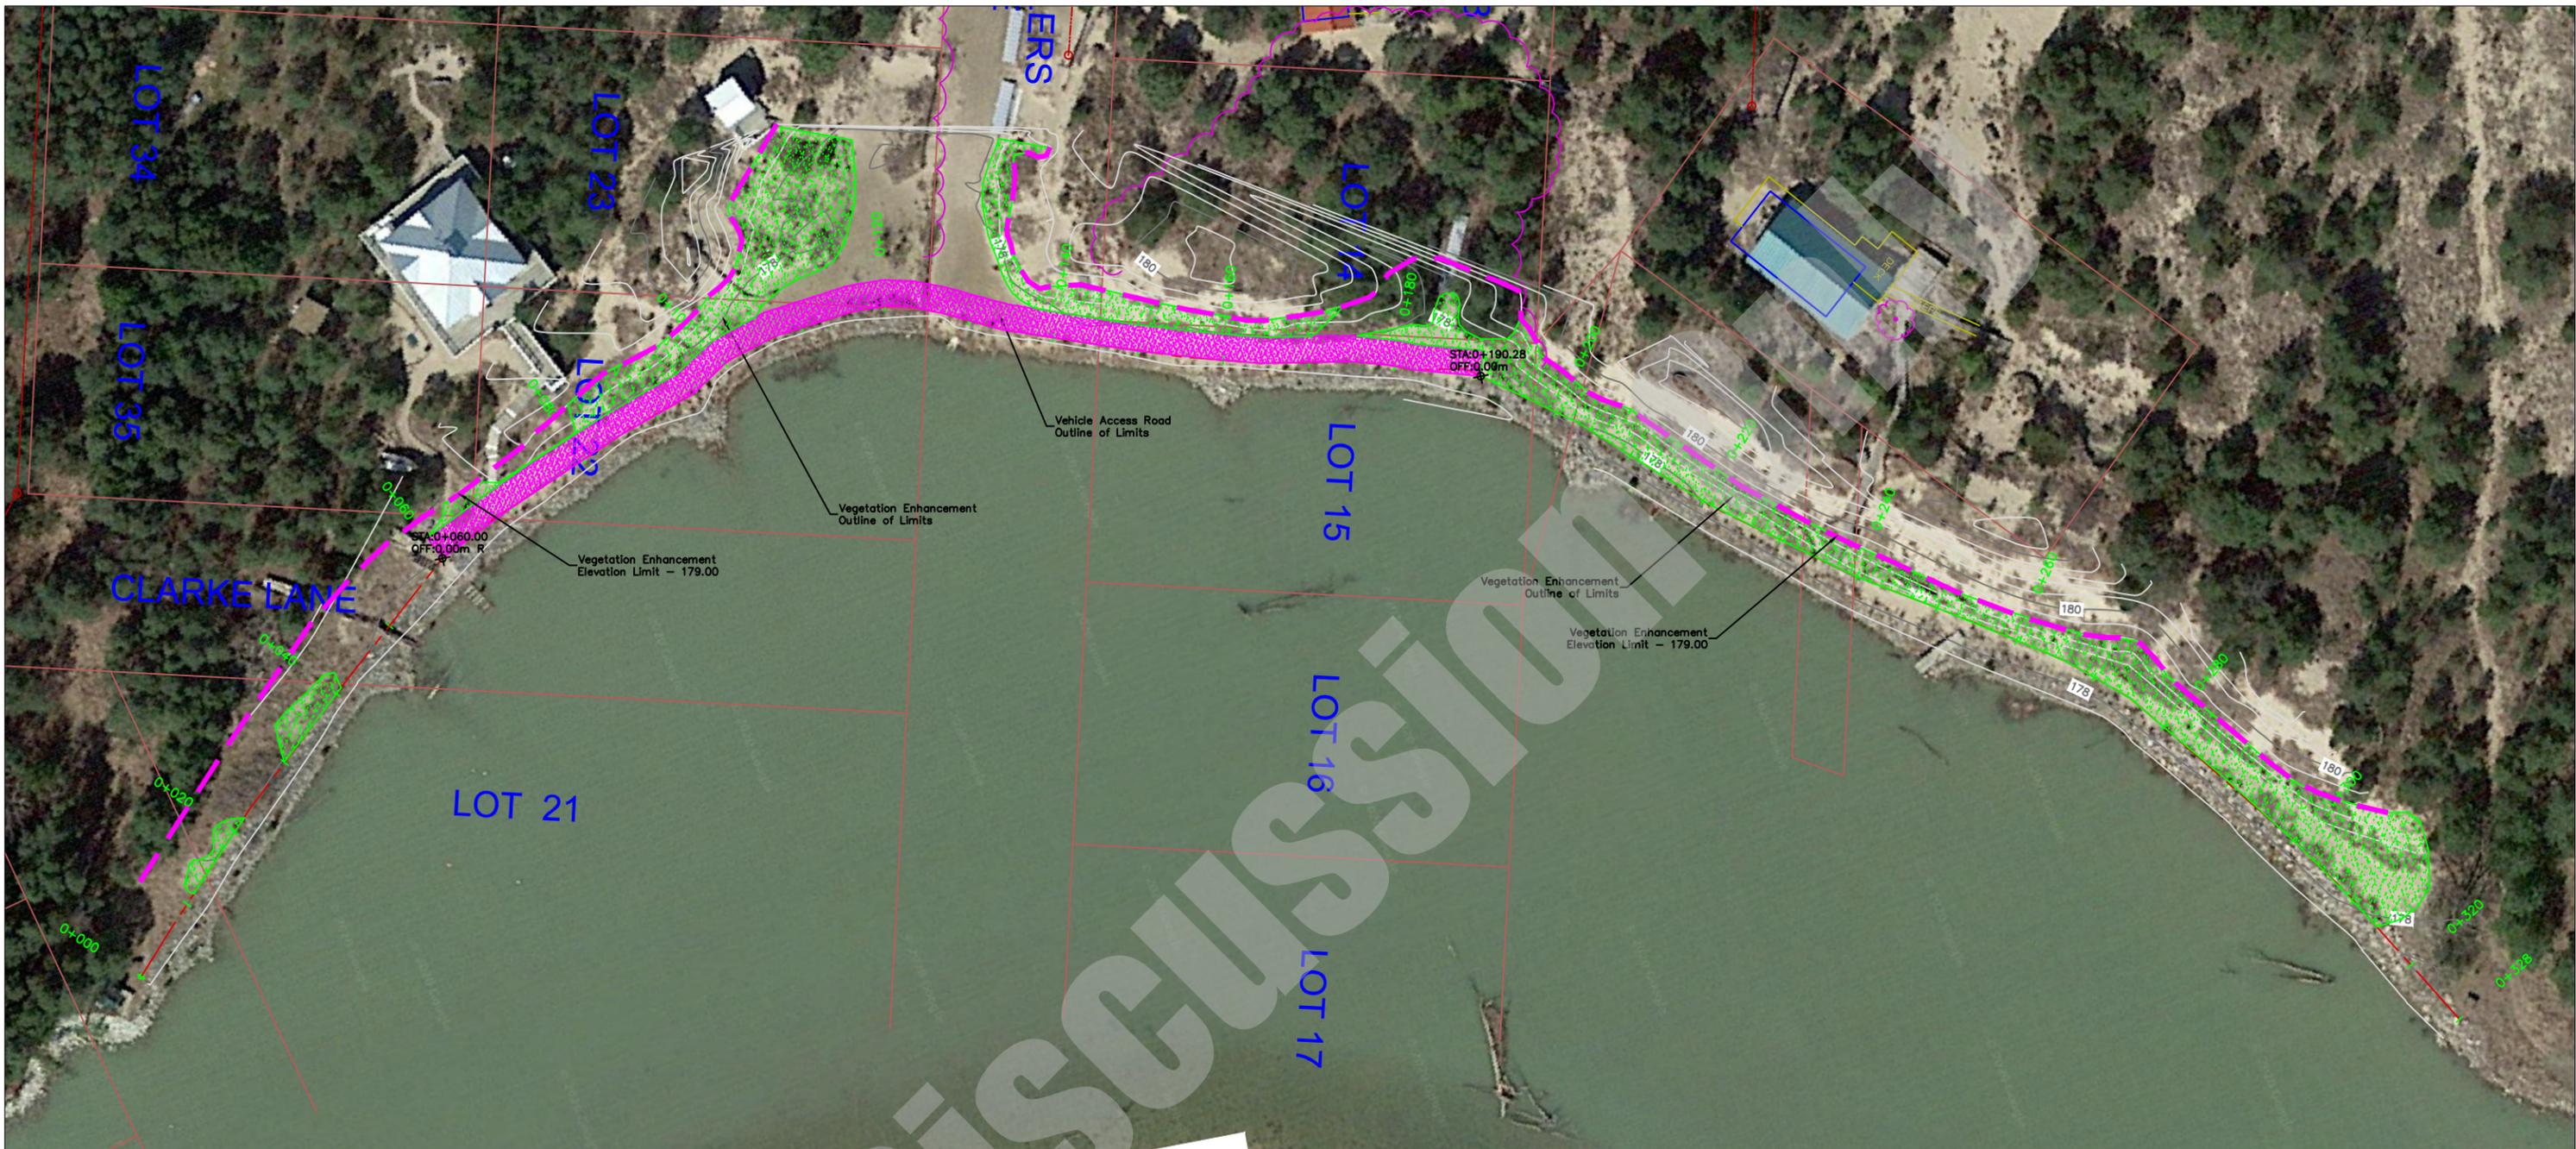
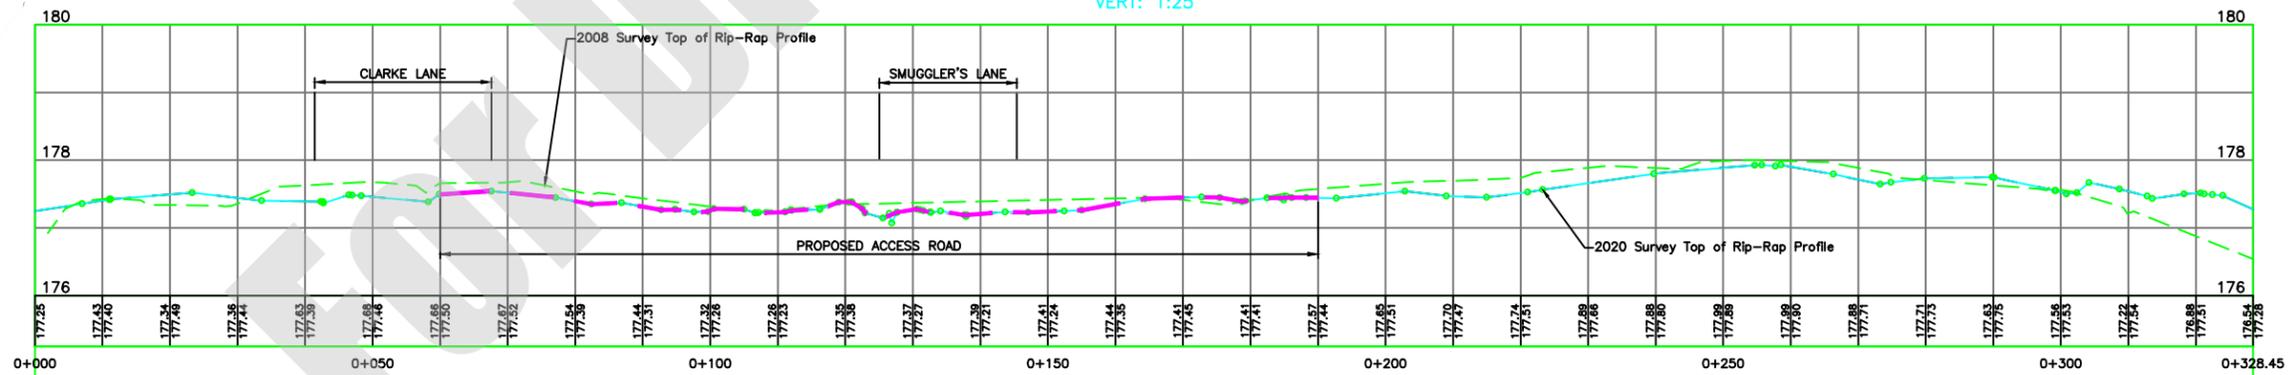
FIGURE
7

ARMSTRONG WEST REVETMENT
ALTERNATIVE 4 PLAN-PROFILE
