Ausable Bayfield Conservation Authority (ABCA)

# Shoreline Slope Stability Risks and Hazards

## Fact Sheet for Property Owners

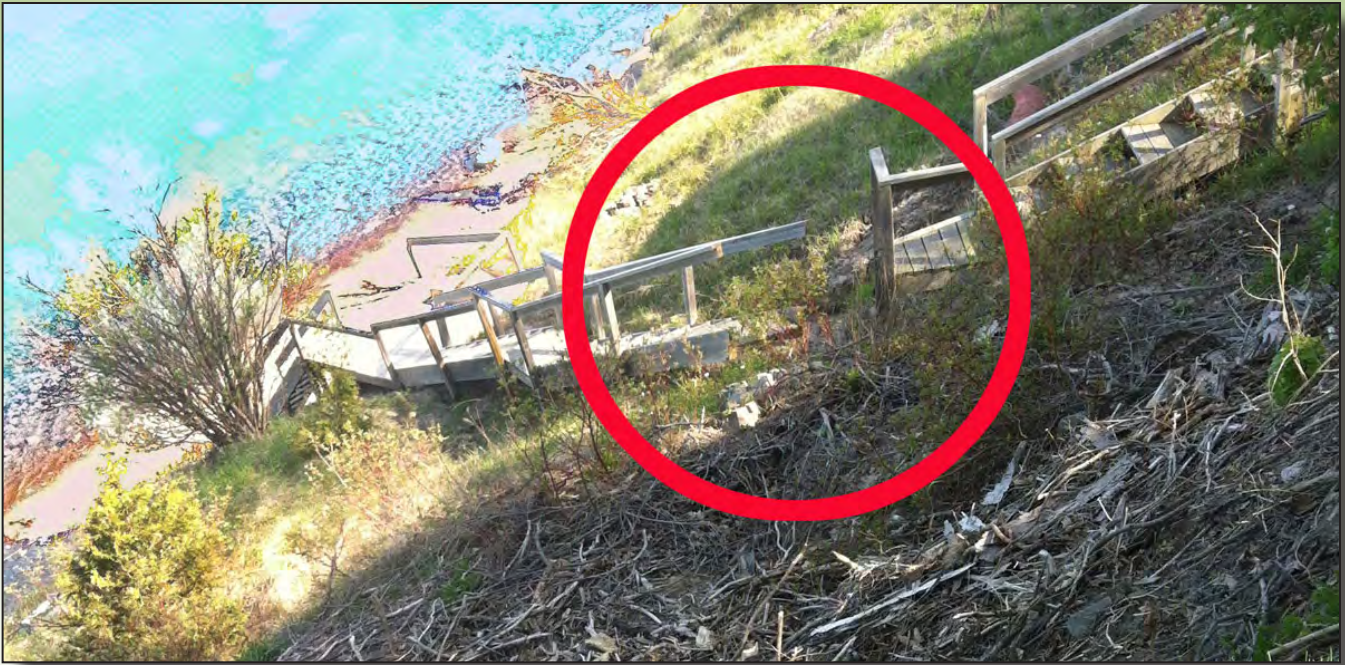
Slope instability indicators include displaced posts and fences, poles, monuments, guardrails, broken or displaced retaining walls, and stairs, among other indicators mentioned in this fact sheet. Please read the Recommended Management Practices panel inside.

- Displaced posts/fences, poles, monuments, guardrails, broken/displaced retaining walls, and stairs.

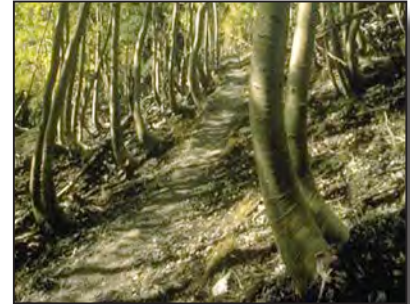
## Bent Trees

- Bent and bowed trees may be due to slope soil creep, however, it may also be due to initial root development and twisting or bowing growth in response to reaching for sunlight.

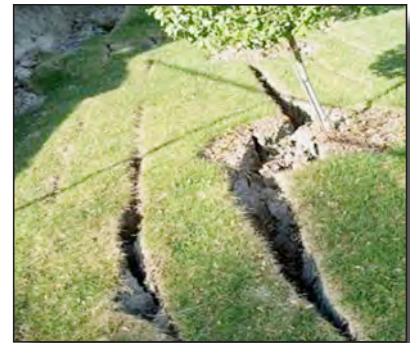
## Tension cracks

- A tension crack formation close to the top of slope may indicate a pending slope failure.
- A tension crack is a void that generally runs parallel to the slope face. It can significantly affect the future stability of the slope because a crack filled with water reduces the stability due to the hydrostatic pressure.
- Ice formation within the crack during sub-zero temperature expands and loosens the slope soil in the vicinity.

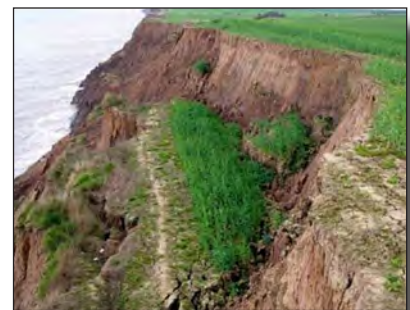
## Irregular Slope Surfaces, Slumps, Scarps, Bumps, Bulges

- A presence of irregular slope surfaces such as slumps, scarps, bumps, bulges, etc. generally indicates a soil movement.
- Slumps and scarps result in an over-steepened (even near vertical) and bare zone at the 'head' or 'crown' where the sliding mass has separated from the slope.
- A slump or slide may also result in tension cracks above the slide.

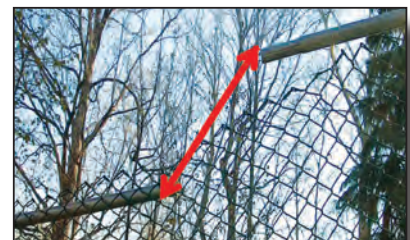
## Other Indicators

Other slope instability indicators include:

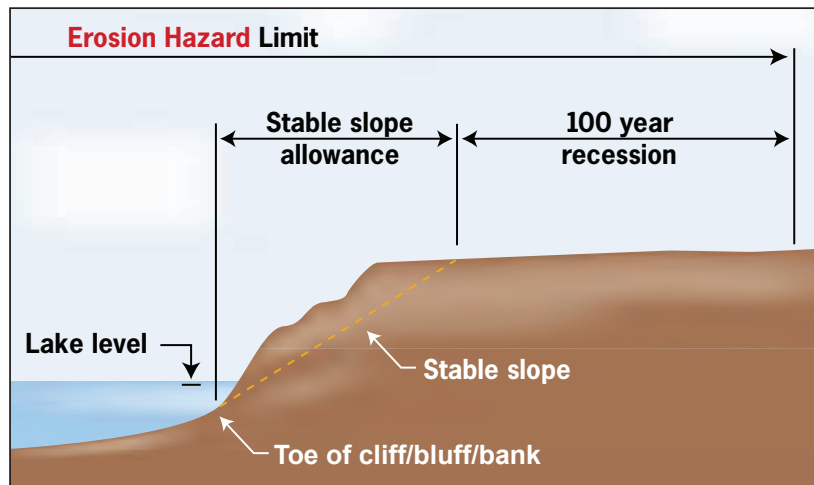
The Erosion Hazard Limit is established based on Stable Slope Allowance, Average Annual Recession, and Erosion Allowance as described below:

IMAGE SOURCE: Ontario Ministry of Natural Resources and Forestry

**1. Stable Slope Allowance (Stable Slope Inclination Setback)** is a horizontal allowance measured landward from the toe of the shoreline cliff, bluff, or bank. It is:

- a) Dependent on slope soil types, soil strengths, and groundwater conditions
- b) Assumed to be three times the height of cliff/bluff in absence of site-specific study, or, is determined by a detailed site investigation (boreholes) and analysis (typically minimum Factor of Safety of 1.5 required)

New developments are generally directed to be outside of the Erosion Hazard Limit to avoid the risks associated with slope instability and erosion hazards.
