Appendix E

Shoreline Slope Stability Risks and Hazards Fact Sheet

Shoreline Slope Stability Risks and Hazards

Fact Sheet for Property Owners

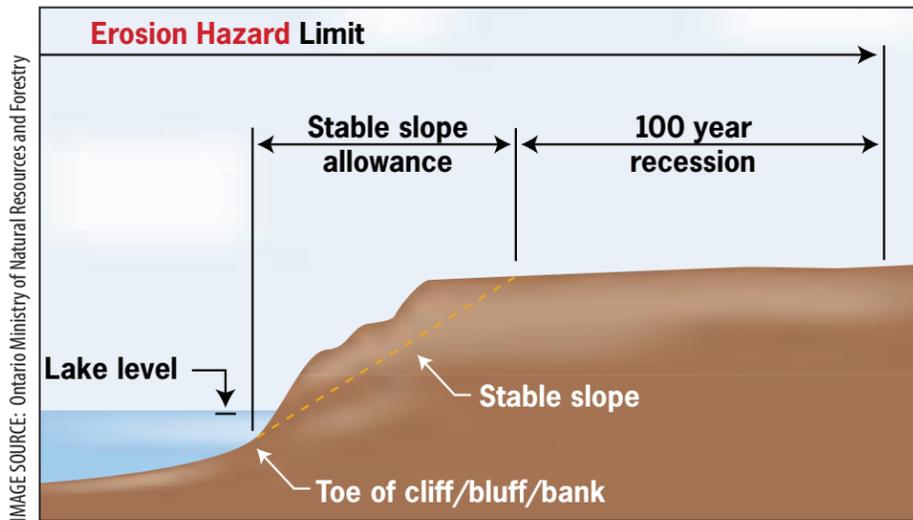
Erosion Hazard Limit and New Development

The Erosion Hazard Limit is established based on Stable Slope Allowance, Average Annual Recession, and Erosion Allowance as described below:

1. Stable Slope Allowance (Stable Slope Inclination Setback) is a horizontal allowance measured landward from the toe of the shoreline cliff, bluff, or bank. It is:

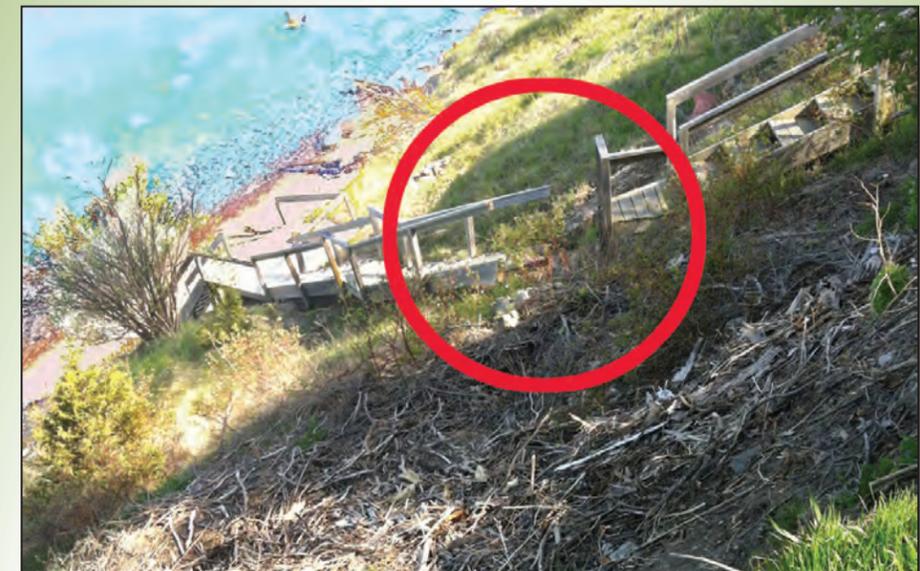
Slope instability indicators include displaced posts and fences, poles, monuments, guardrails, broken or displaced retaining walls, and stairs, among other indicators mentioned in this fact sheet. Please read the Recommended Management Practices panel inside.

- Displaced posts/fences, poles, monuments, guardrails, broken/displaced retaining walls, and stairs.

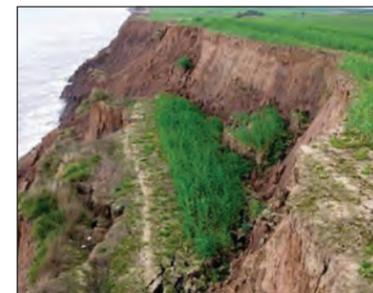
Other Indicators

Other slope instability indicators include:
