Ausable Bayfield Conservation Authority (ABCA)

Shoreline Slope Stability Risks and Hazards

Fact Sheet for Property Owners

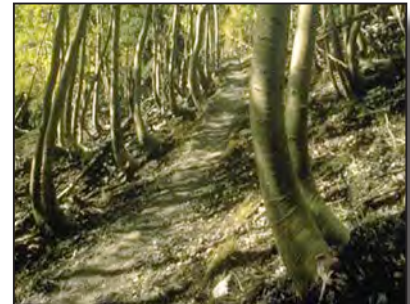
Bent Trees

- Bent and bowed trees may be due to slope soil creep, however, it may also be due to initial root development and twisting or bowing growth in response to reaching for sunlight.

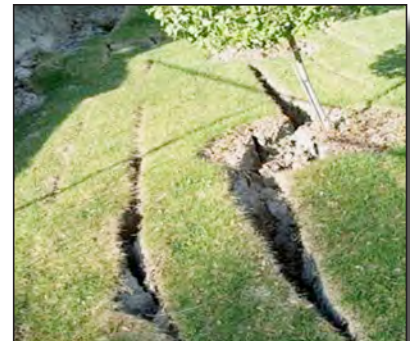
Tension cracks

- A tension crack formation close to the top of slope may indicate a pending slope failure.
- A tension crack is a void that generally runs parallel to the slope face. It can significantly affect the future stability of the slope because a crack filled with water reduces the stability due to the hydrostatic pressure.
- Ice formation within the crack during sub-zero temperature expands and loosens the slope soil in the vicinity.

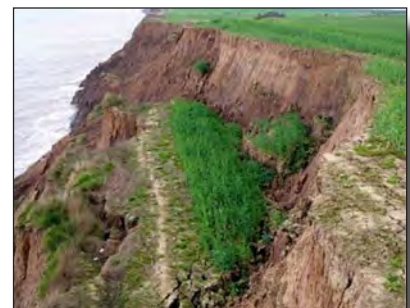
Irregular Slope Surfaces, Slumps, Scarps, Bumps, Bulges

- A presence of irregular slope surfaces such as slumps, scarps, bumps, bulges, etc., generally indicates a soil movement.
- Slumps and scarps result in an over-steepened (even near vertical) and bare zone at the 'head' or 'crown' where the sliding mass has separated from the slope.
- A slump or slide may also result in tension cracks above the slide.

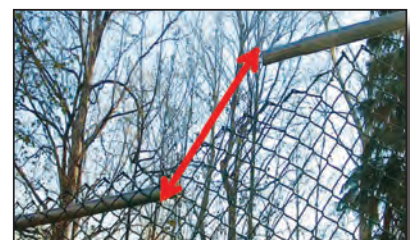
Other Indicators

Other slope instability indicators include:

- Displaced posts/fences, poles, monuments, guardrails, broken/displaced retaining walls, and stairs.

Slope instability indicators include displaced posts and fences, poles, monuments, guardrails, broken or displaced retaining walls, and stairs, and other indicators mentioned in this fact sheet. Please read the Recommended Management Practices panel inside.

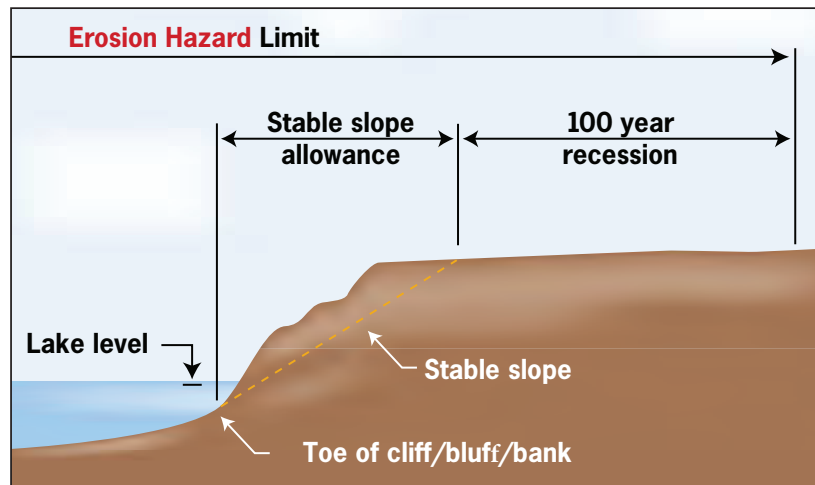
The Erosion Hazard Limit is established based on Stable Slope Allowance, Average Annual Recession, and Erosion Allowance as described below:

IMAGE SOURCE: Ontario Ministry of Natural Resources.

- 1. Stable Slope Allowance (Stable Slope Inclination Setback)** is a horizontal allowance measured landward from the toe of the shoreline cliff, bluff, or bank. It is:
 - a) Dependent on slope soil types, soil strengths, and groundwater conditions
 - b) Assumed to be three times the height of cliff/bluff in absence of site-specific study, or, is determined by a detailed site investigation (boreholes) and analysis (typically minimum Factor of Safety of 1.5 required)

New developments are generally directed to be outside of the Erosion Hazard Limit to avoid the risks associated with slope instability and erosion hazards.
