Ausable Bayfield Conservation Authority (ABCA)

Shoreline Slope Stability Risks and Hazards

Fact Sheet for Property Owners

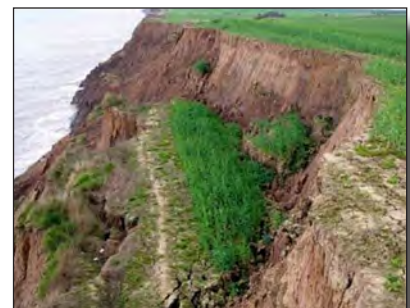
Other Indicators

Other slope instability indicators include:

- Displaced posts/fences, poles, monuments, guardrails, broken/displaced retaining walls, and stairs.

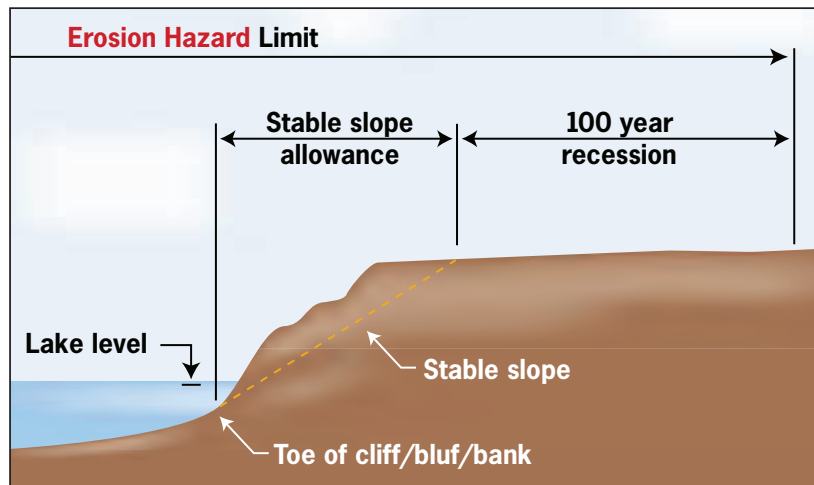
The Erosion Hazard Limit is established based on Stable Slope Allowance, Average Annual Recession, and Erosion Allowance as described below:

IMAGE SOURCE: Ontario Ministry of Natural Resources and Forestry

- 1. Stable Slope Allowance (Stable Slope Inclination Setback)** is a horizontal allowance measured landward from the toe of the shoreline cliff, bluff, or bank. It is:
 - a) Dependent on slope soil types, soil strengths, and groundwater conditions
 - b) Assumed to be three times the height of cliff/bluff in absence of site-specific study, or, is determined by a detailed site investigation (boreholes) and analysis (typically minimum Factor of Safety of 1.5 required)

New developments are generally directed to be outside of the Erosion Hazard Limit to avoid the risks associated with slope instability and erosion hazards.
