Little Ausable Watershed Report Card

Ausable Bayfield Watershed Report Card 2007

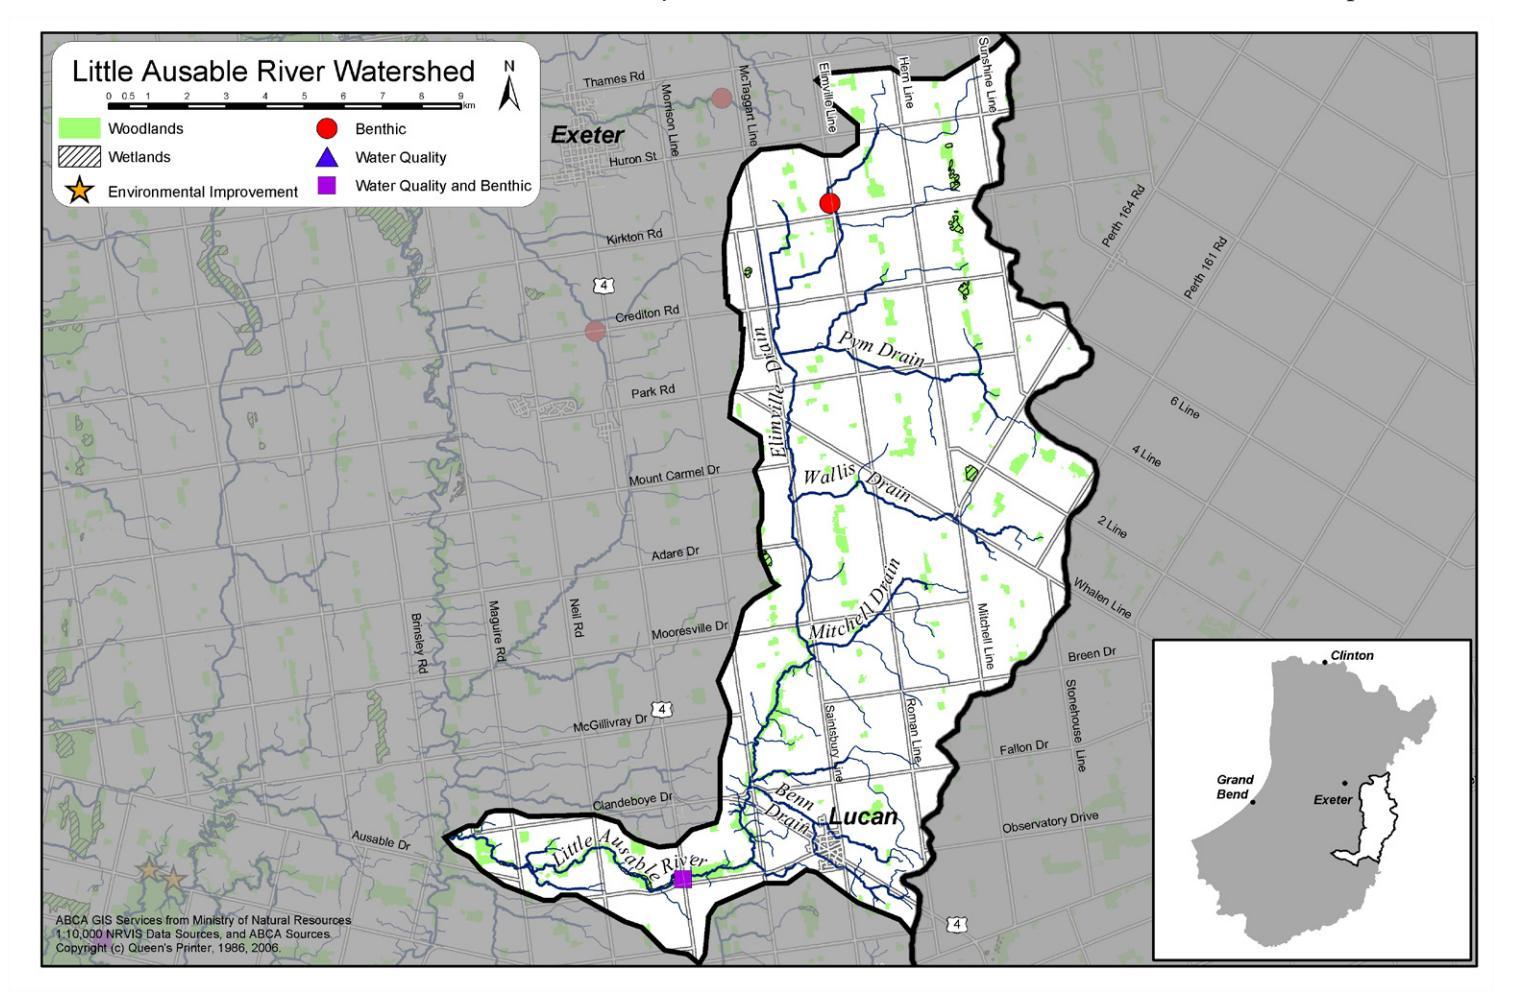
This report card summarizes water quality and forestry information for the Little Ausable watershed (*the highlighted area on the map below*). This map also shows water quality stations and example environmental improvement locations. For consistency across watersheds, Conservation Ontario has recommended the use of specific water quality and forestry indicators that are described in the following tables. The summary is intended to provide landowners, groups, municipalities and agencies with information to protect, enhance and improve natural features of the watershed. The ongoing monitoring will be reported on a five-year cycle which will help local people manage their natural features. This report card is part of a larger report entitled **The Ausable Bayfield Conservation Authority Watershed Report Card** available at: **www.abca.on.ca**. Further information, including methodology, comparisons to the other 15 Ausable Bayfield watersheds and references are also found in the report.
