AUSABLE-BAYFIELD CONSERVATION AUTHORITY

SHORELINE MANAGEMENT PLAN

SECOND EDITION

2000

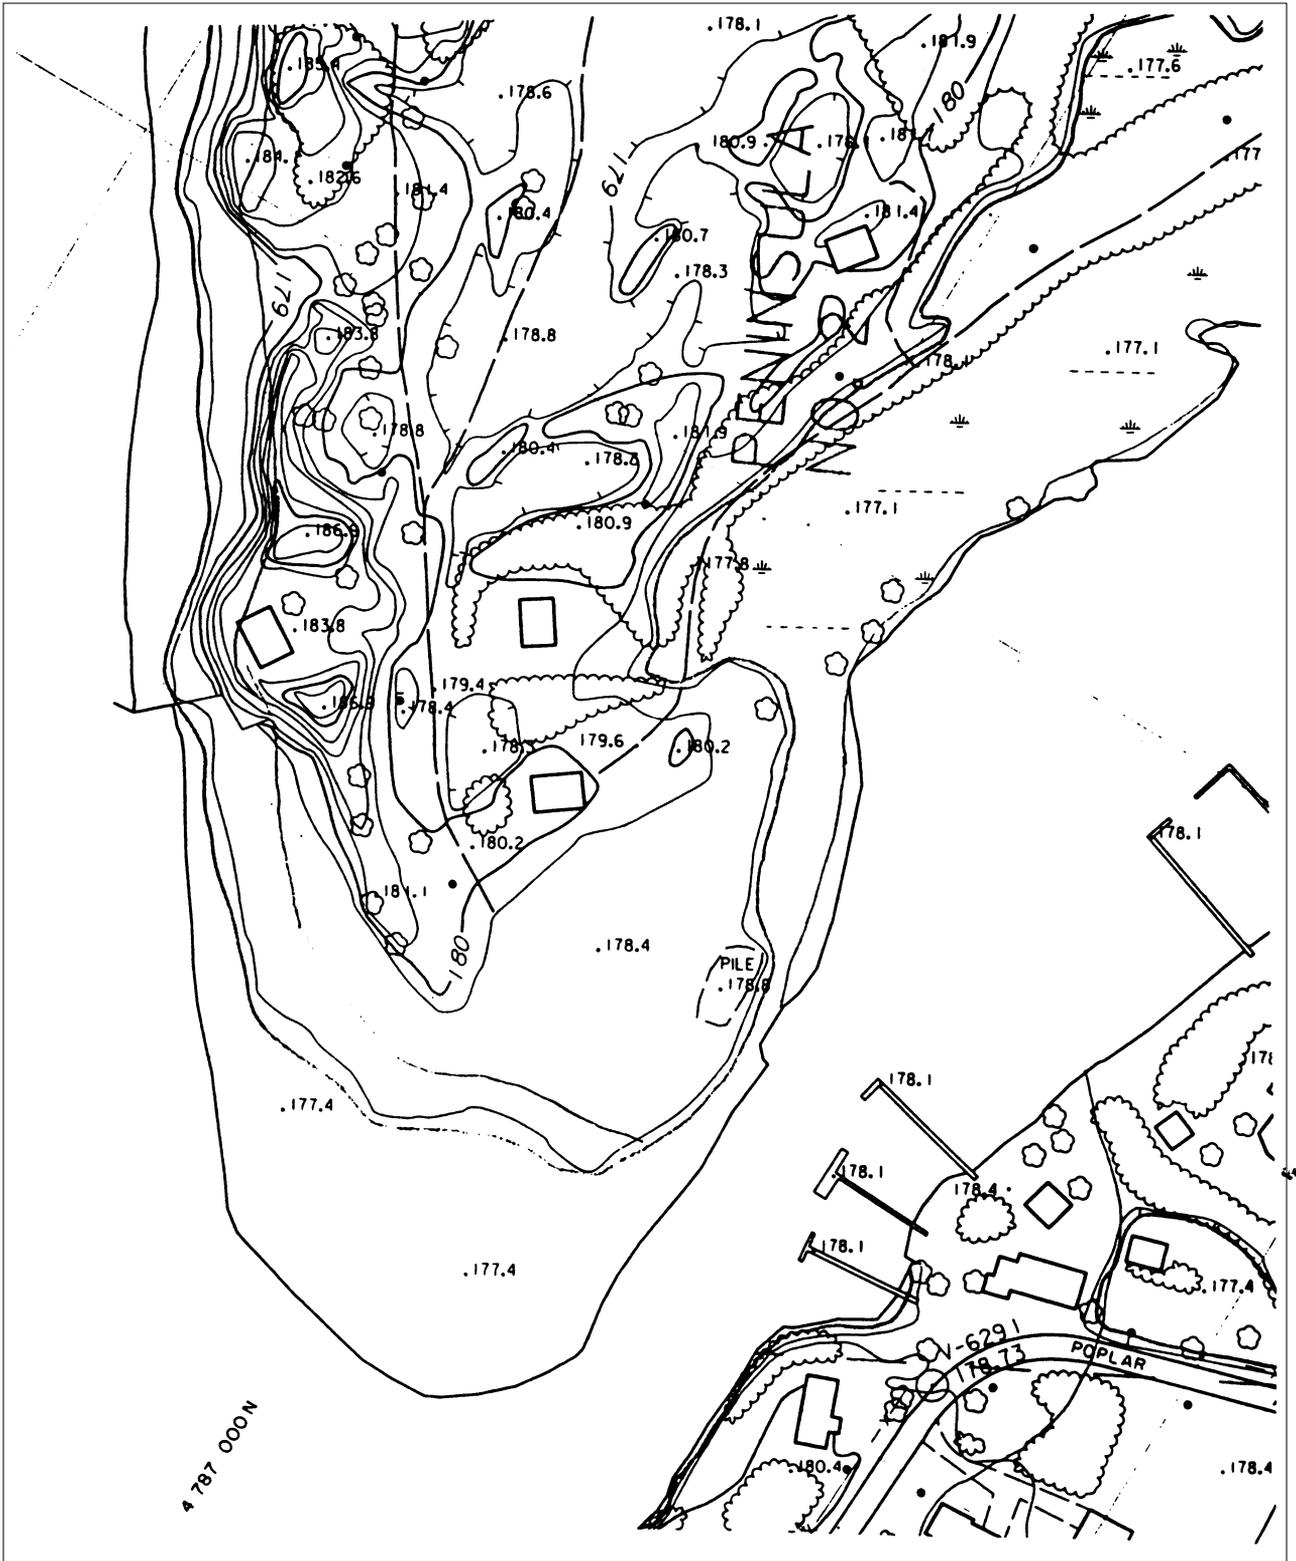
Figure 8 - 1988 Shoreline Mapping

The maps portray the shoreline in a continuous strip with full contour detail (one metre contour interval with 0.5 metres interpolated) from the shoreline to a minimum distance of 250 metres landward from top of bluff. Where gullies occur, they are mapped a minimum distance inland to Highway 21, with topographic detail measured 50 metres back from top of bank. (Figure 8, on page 26, shows an example of shoreline mapping and Appendix D provides maps at a reduced scale. These smaller scale maps show the area affected by the Regulatory Lakeshore defined in Section 3.3, Lakeshore Development Guidelines.)

The process of long-term erosion and accretion that has occurred to the shoreline was determined and erosion hazard areas were defined; this was completed using a 1935 shoreline survey and recent 1988 photogrammetric mapping. Lines were drawn on 1:2,000 scale maps to indicate the probable future shoreline position in 100 years, based on an extrapolation of the 1935-to-1988 shoreline comparison.
